HISTORY AND CURRENT CONDITIONS  
OF  
BIG BEND POWER PLANT  
Rapid City, SD

### Building Condition

The building is in fair to poor condition, but is certainly salvageable if there is foreseeable useful purpose. The fact that it is not more than a shell allows for more flexibility in selecting a new use and reduces the cost of rehabilitation.

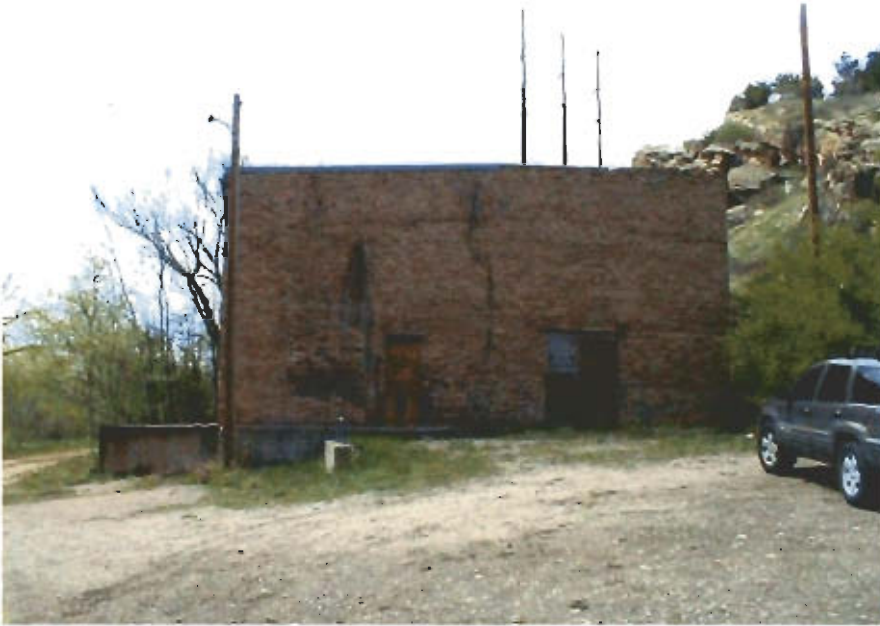
**VIEW FROM EAST**

The east wall has a large crack in the masonry, which runs from top to bottom in the approximate center of the wall. The wall appears to be leaning slightly inward at the top center. Previous openings have been in-filled with a variety of masonry materials. Some brick has been broken to allow access to the interior.

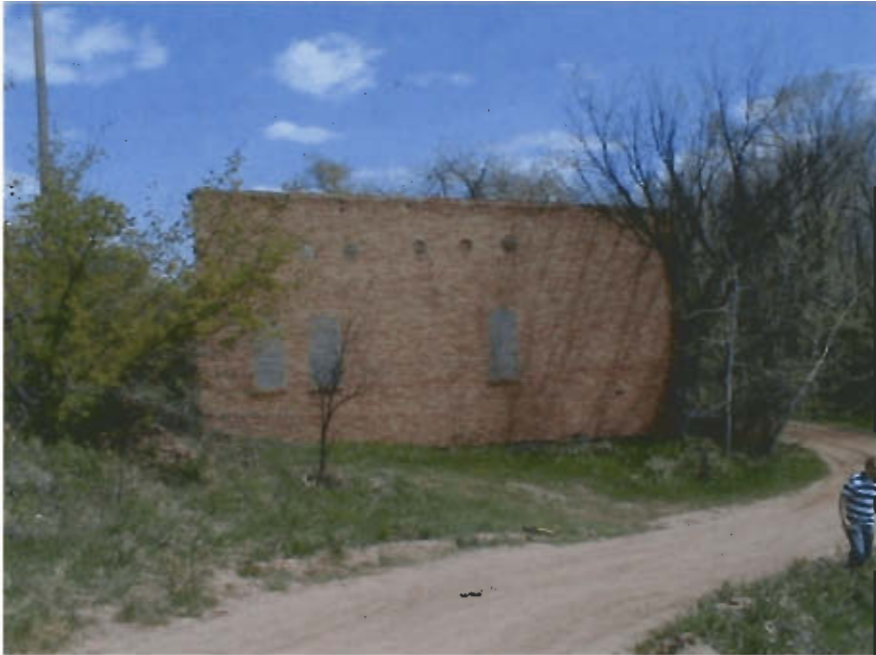
**VIEW FROM WEST**

The west wall is in generally good condition with two notable exceptions. The wall top has deteriorated as a result of the absence of metal cap flashing. At the southwest corner, a tree has grown to the point where it has begun to displace vertically the concrete foundation and the masonry. Previous openings have been in-filled with concrete block and/or brick.

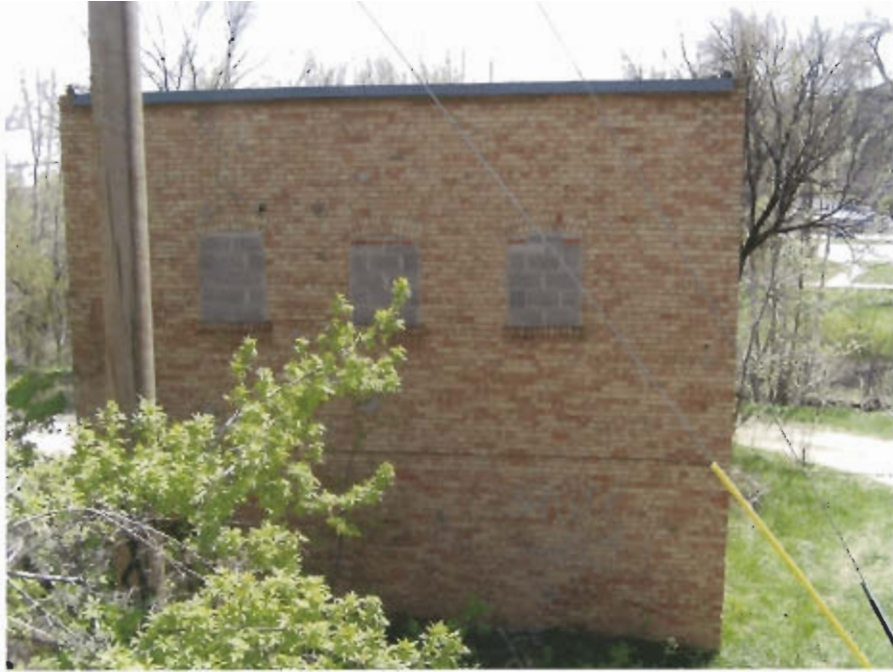
**VIEW FROM NORTH**

The north wall is in generally good condition. Some repair has been done to the lower north east corner. The three original window openings have been in-filled with concrete block.

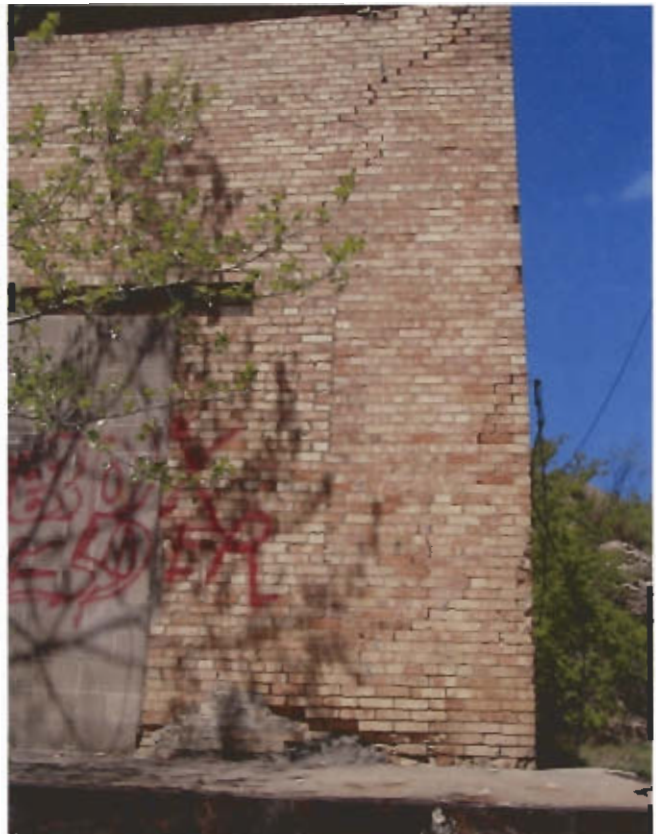
**SOUTHEAST CORNER**

The south wall has some masonry deterioration at the bottom of the southeast corner, but is otherwise in generally good condition. The large opening has been in-filled with concrete block and a steel framed passage door.

- Remove roofing and roof deck; replace roof deck and roofing, flashing and wall cap.
- Repair masonry at top of wall and parapets.
- Install gutter and downspout.
- Remove tree at the southwest corner. Underpin footing if necessary.
- Repair deteriorated masonry and mortar.
- Stabilize east wall and bring back into vertical plane.
- Repair large cracked area of east wall with either masonry, steel ties or both.
