CANYON LAKE DAM STUDY/REPORT

PROJECT Canyon Lake Dam Maintenance Project

PROJECT NUMBER DR04 - 1433

DATE February 4th, 2008

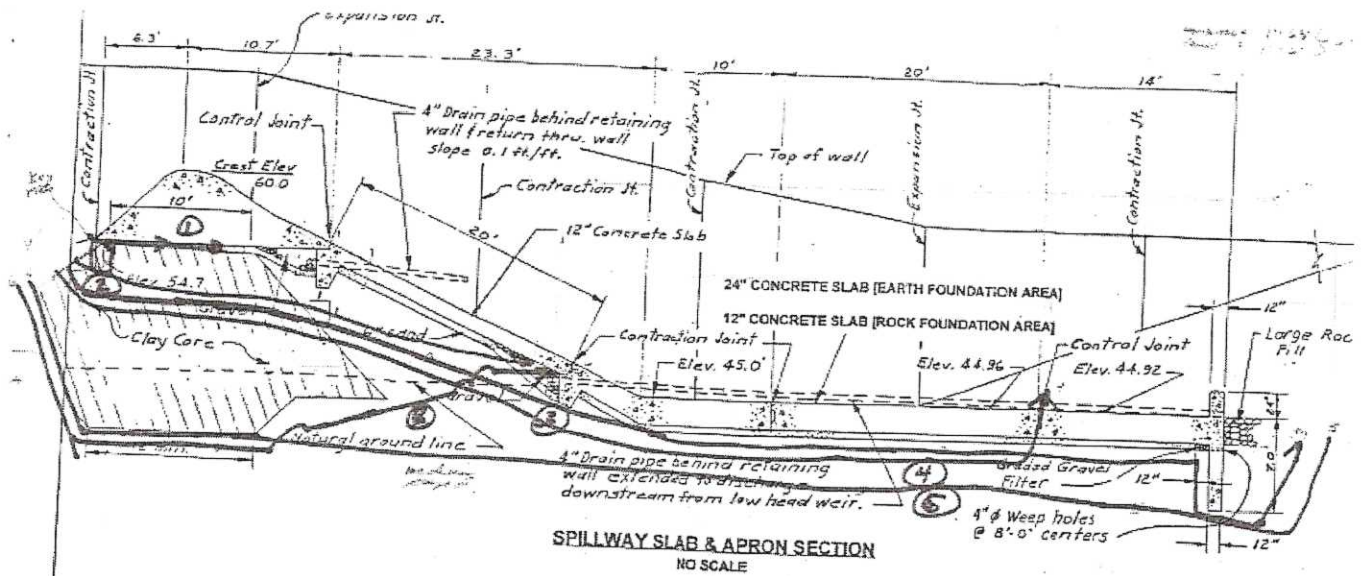
Figure 2 – Seepage Pathways

1. Path 1 - The weighted creep ratio is very marginal. Piping should occur along the mass concrete and clay core as evident in the 1986 repair.
2. Path 2 - The analysis also indicates that the 4 feet deep core when combined with the blown sand in the piped areas does not meet the recommended values but is close. Deficiencies and leakage would be expected in the long term.

3. Path 3 and 4 – The weighted creep ratio is 3.39 and 2.66. If the clay core is a hard clay and the native soil is not overly susceptible to seepage, the seepage path should be adequate. Beyond the direct analysis, construction deficiencies and geologic flaws like cracking and jointing would be a likely cause for extensive seepage that could make the problem worse than indicated in the analysis.

4. Path 5 – The weighted creep ratio is 1.38 which is less than the recommended. This would indicate that seepage could occur along the bedrock clay core interface and overwhelm the ability of the drain to handle the seepage amount.

5. Path 6 – The weighted creep ratio is 3.62. Beyond the direct analysis, the difficulty in preparing and compacting the subgrade with both water and freezing conditions could make the problem worse than indicated. The adequacy depends on the native soil material. If medium gravel to very hard clay or hardpan is present (number 6-12), the seepage would be considered adequate. However, if fine sand/silt to fine gravel (number 1-5) is present, then the design is not adequate.

6. Path 7 – The weighted creep ratio is 2.24. Similar but more critical to Path 6 the adequacy depends on the soil type beneath the clay core and the effectiveness in placing and compacting the soil during the original construction. However only medium to hard clay or soil with boulder and cobbles would be considered adequate. Soil types 8, 10, 11 and 12.

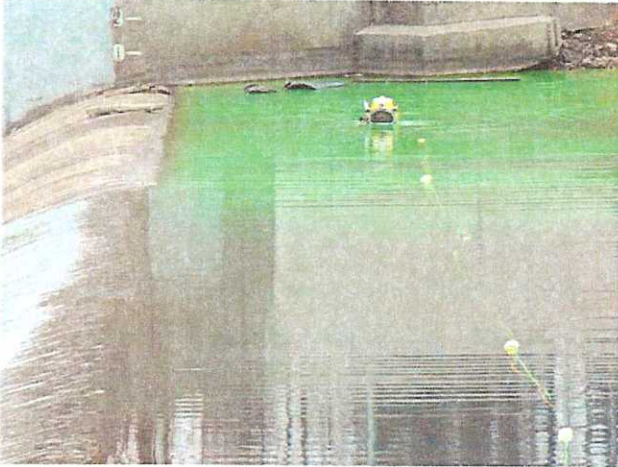
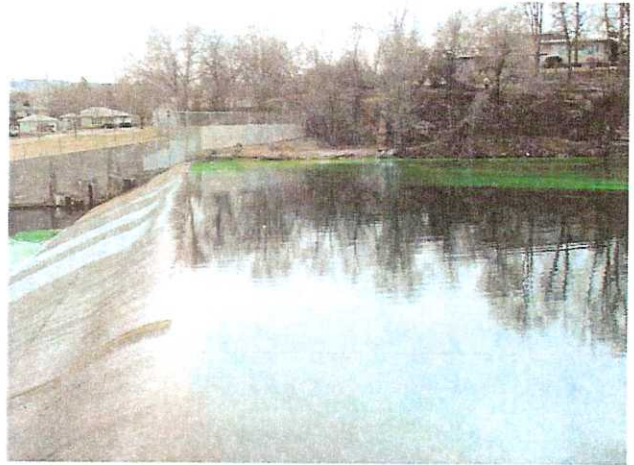
Photos 1 & 2 – March 2005, Midco Diving releasing the dye for seepage testing near the upstream sinkhole.

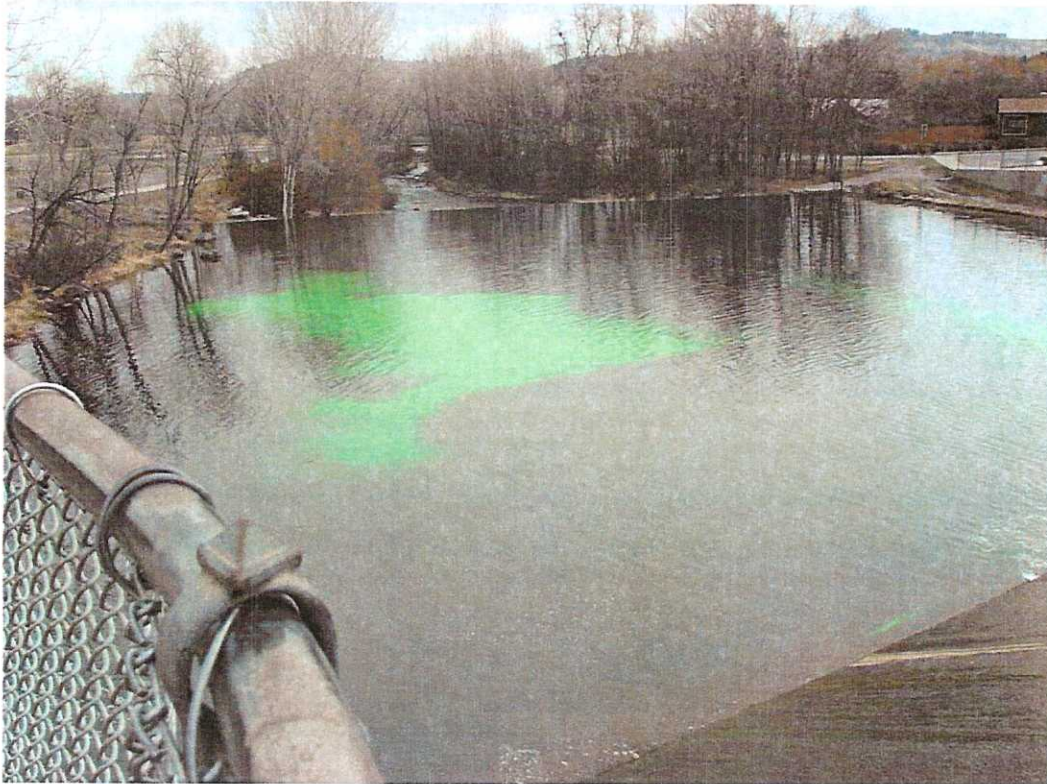
Photo 3 – March 2005, Midco Diving dye testing reveals a dark plume of dye at the area around the existing boil downstream prior to the dye flowing over the spillway.

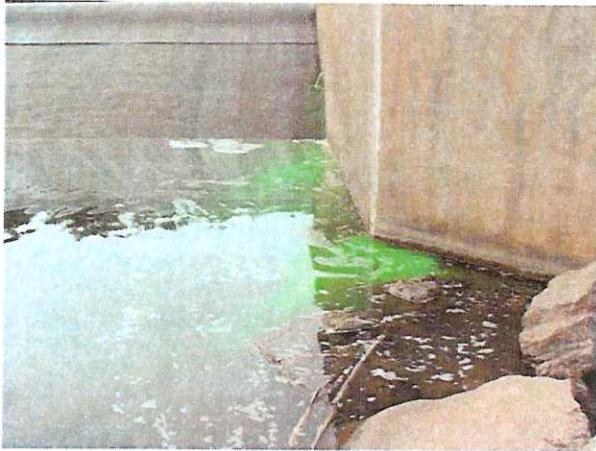
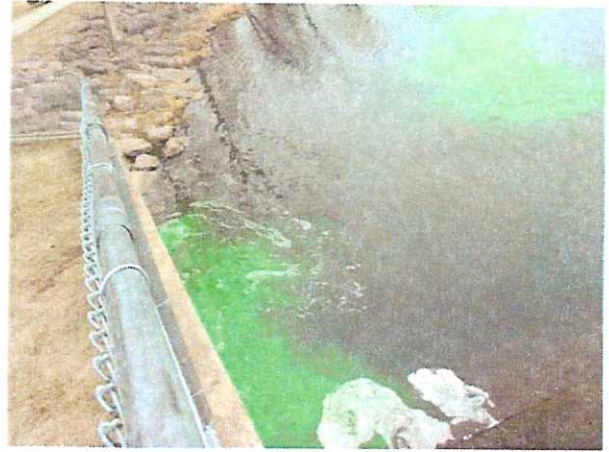
Photos 4 & 5 – March 2005, Midco Diving dye testing reveals plumes of dye emerging from the weep holes and areas along the spillway wing walls.

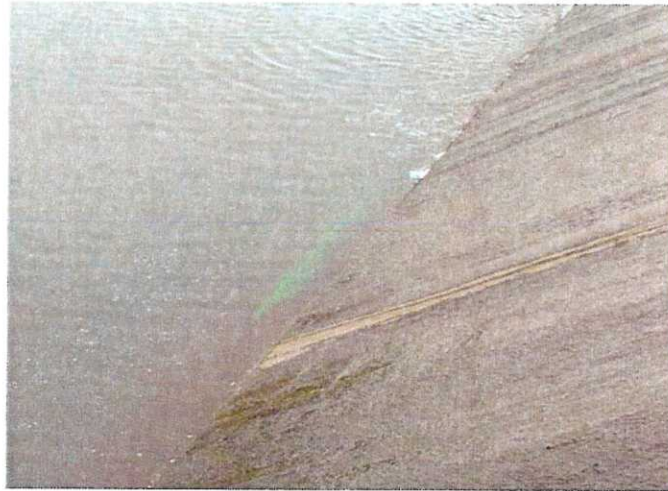
Photo 6 – March 2005, Midco Diving dye testing reveals a small plume of dye at the base of the spillway face prior to the dye flowing over the spillway.

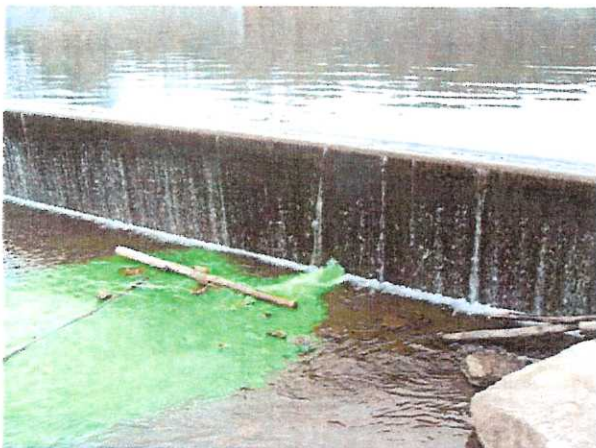
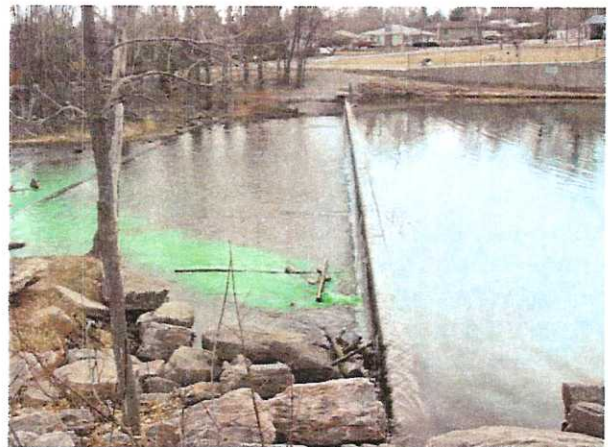
Photos 7 & 8 – March 2005, Midco Diving dye testing shows an extensive amount of dye exiting the underdrain pipe outlet at the base of the concrete apron downstream of the spillway.

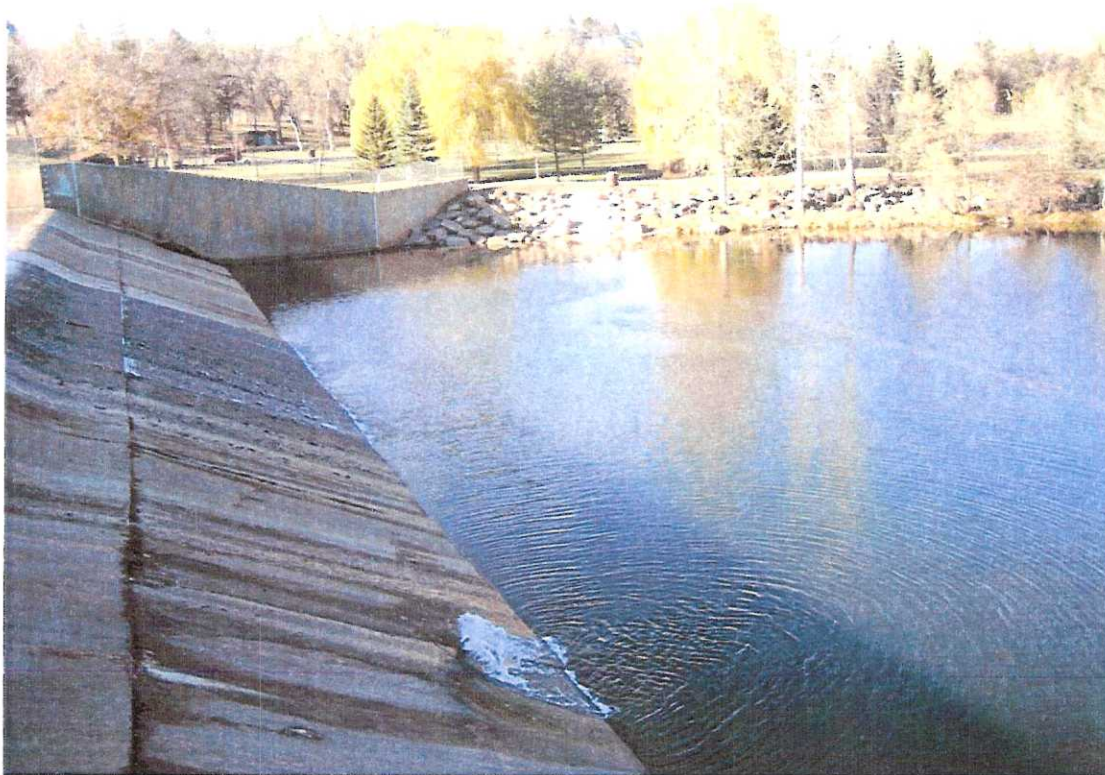
Photo 15 – Fall 2007, Photo looking north showing both the roostertail leak in the concrete spillway and the boil in the downstream apron.

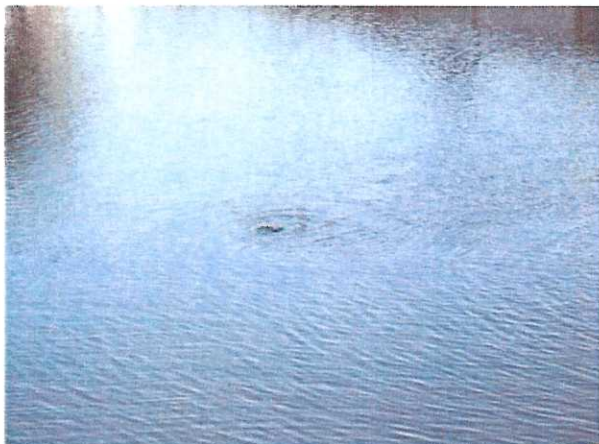
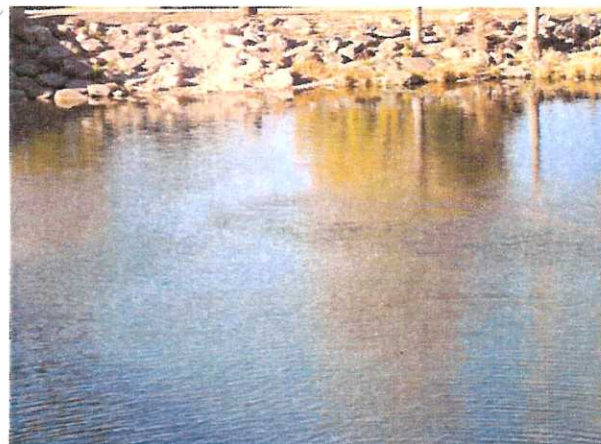
Photos 16 & 17 – Fall 2007, showing the noticeable flow from the seepage boil in the downstream apron.

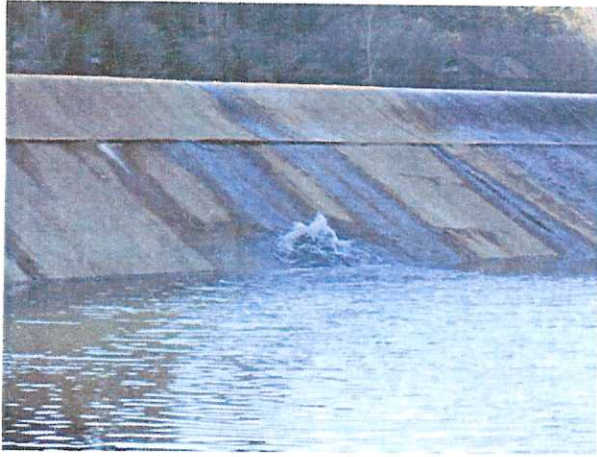
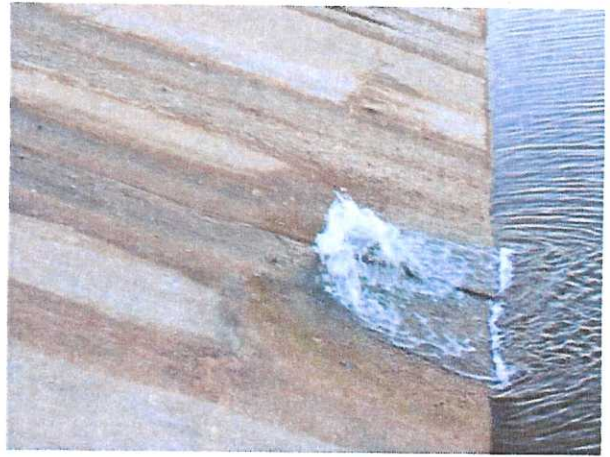
Photos 9 & 10 – Fall 2007, “Roostertail” leak in the concrete face of the spillway.

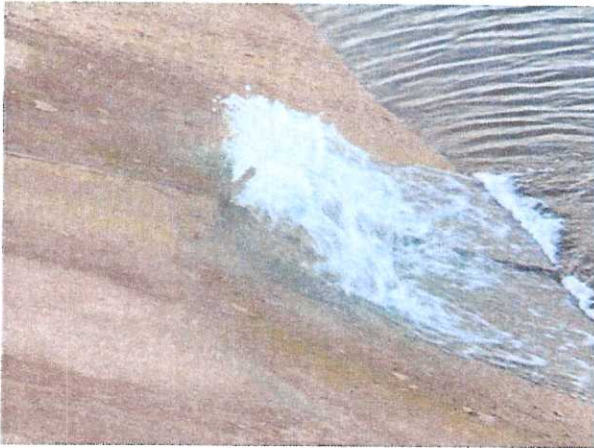
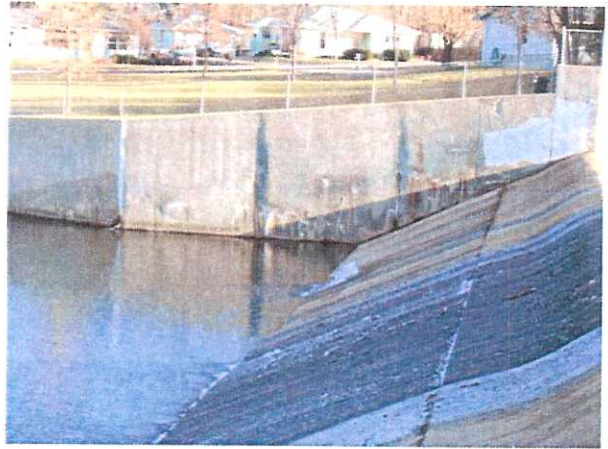
Photos 11 & 12 – Fall 2007, “Roostertail” leak in the concrete face of the spillway.

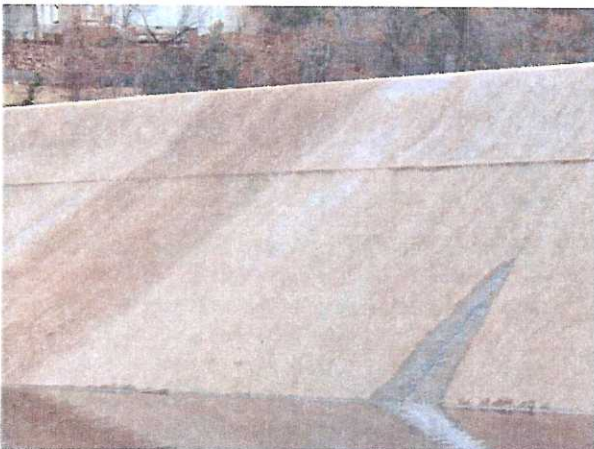
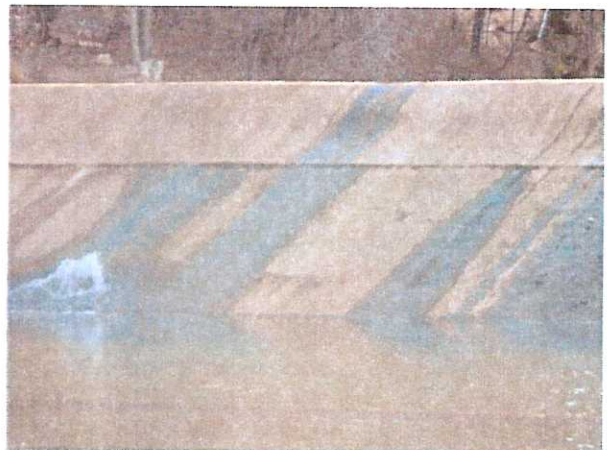
Photos 13 & 14 – Fall 2007, Additional seepage shown by wetted areas around the concrete spillway joints.
