October 31, 2013

**Project: City of Rapid City 2011 Storm Damage Recovery Project**

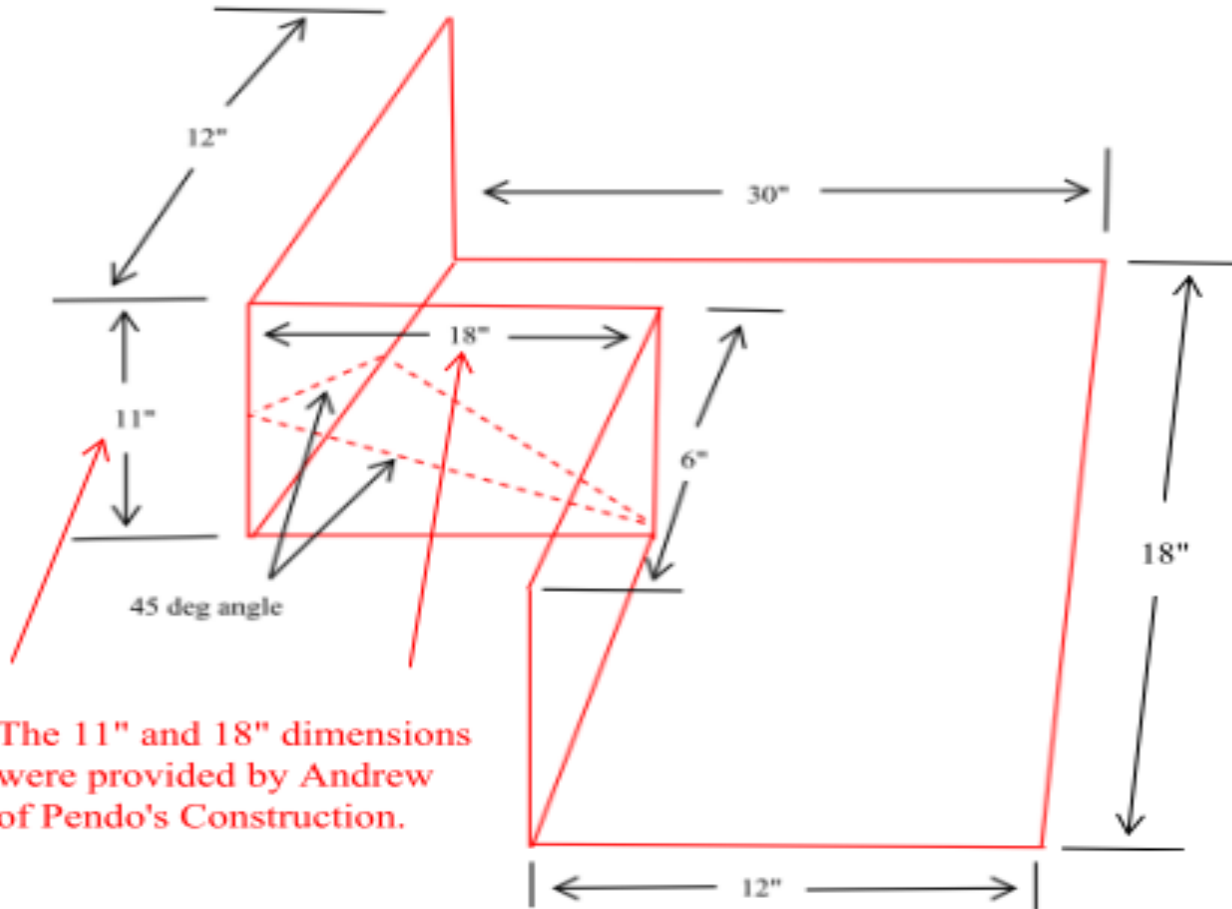
**Firehouse**

The 11" and 18" dimensions were provided by Andrew of Pendo's Construction.

This is to be .050 alum with welded corners and cricket. This is to be used at the parapet wall on the firehouse. Two will need to be made, this one and one for the other side which will be the opposite of this one.

Roof pitch will be required for vertical sections of this custom flashing.

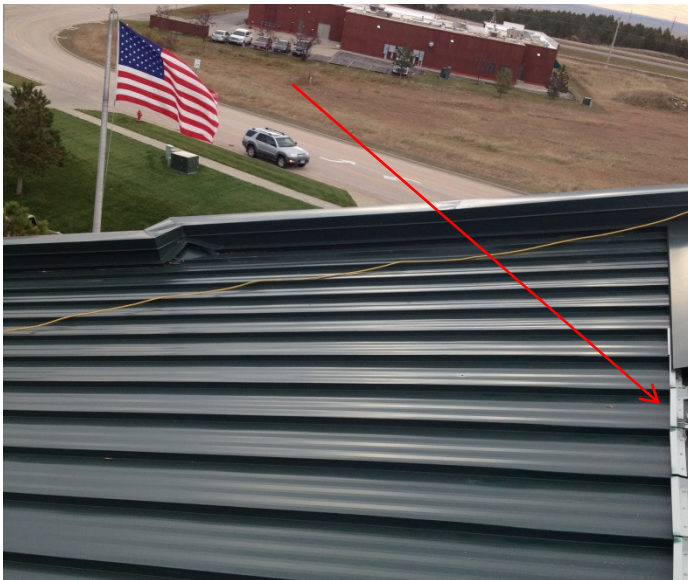
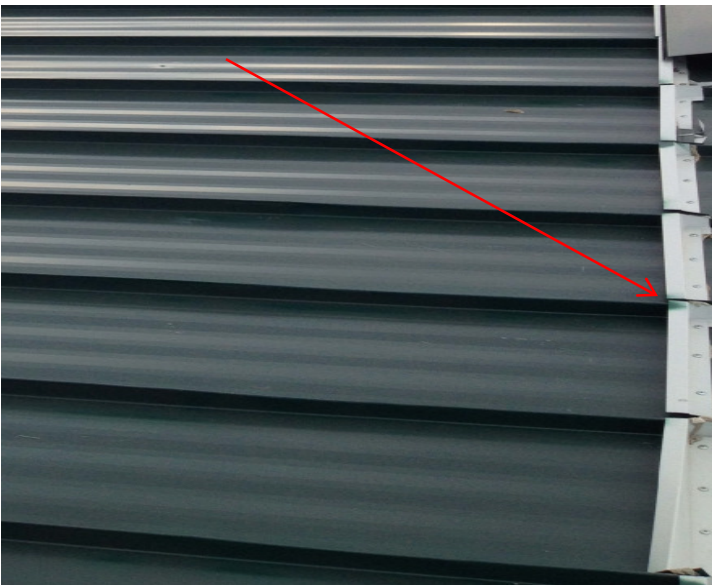
### Firehouse

In the next two pictures you can see the Z Closures at the ridge are not installed per the installation detail. Remove all existing Z Closures and install new Z Closures per the installation details. Note: Per the installation details there are 5 (five) fasteners per Z and no tab on the sides. Look very closely at the installation details to minimize future removal of components.

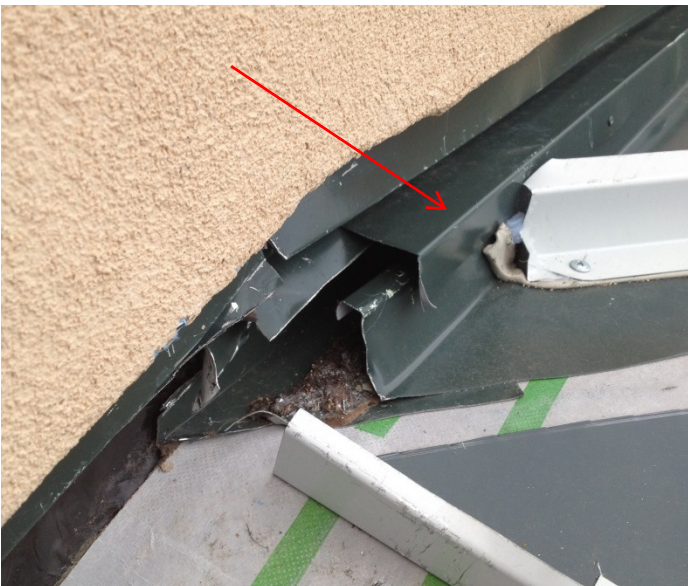
**Firehouse**

This side wall flashing is not installed to the installation detail. Remove existing flashing and install to proper side wall detail.

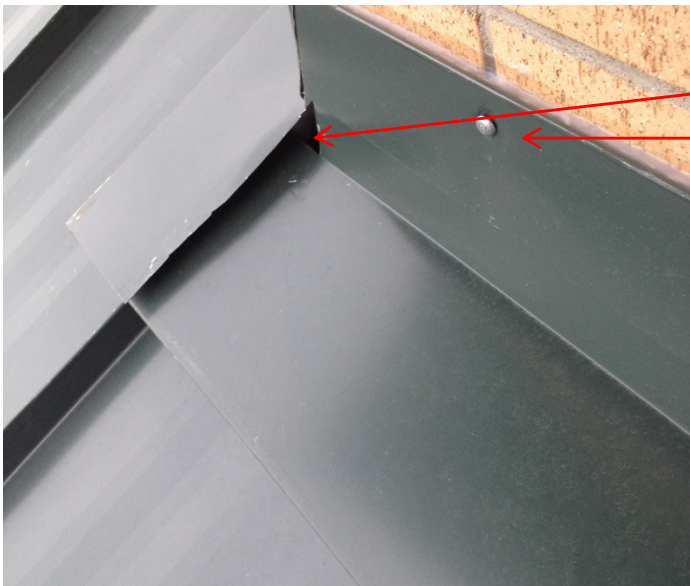
**Sue Park Buildings**

Huge hole at head wall, side wall flashing.  
No butyl tape behind head wall and counter flashing.  
Install all flashings per the installation details.

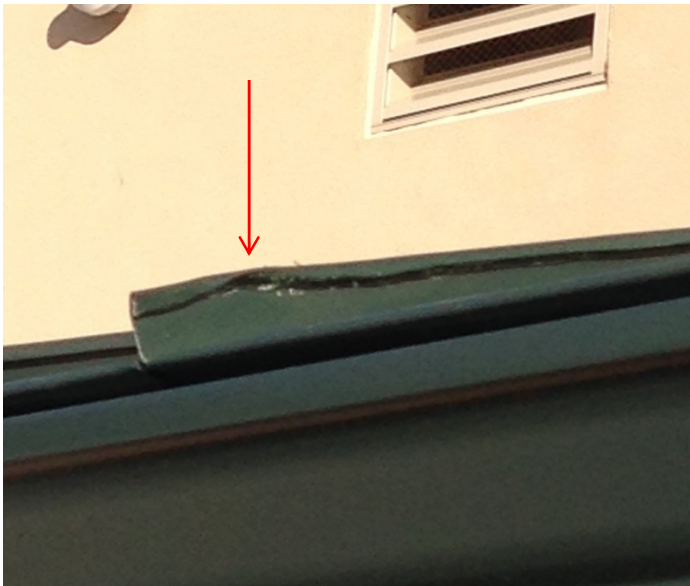
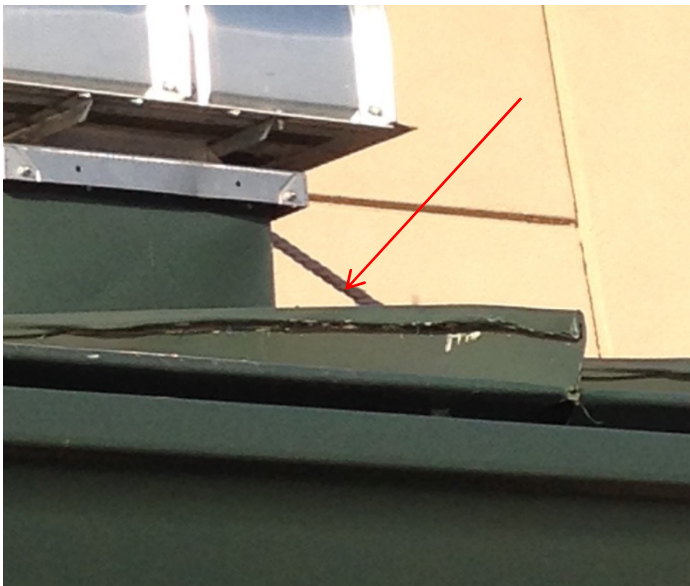
#### **Improper Seaming of panels**

In these two pictures you can see that the seams were not seamed correctly. All damaged seams must be either repaired to a proper 180 deg. seam or the panels must be replaced and seam properly.

On the next page of this report there is a picture of what a proper 180 deg. seam looks like. Use this as your reference.

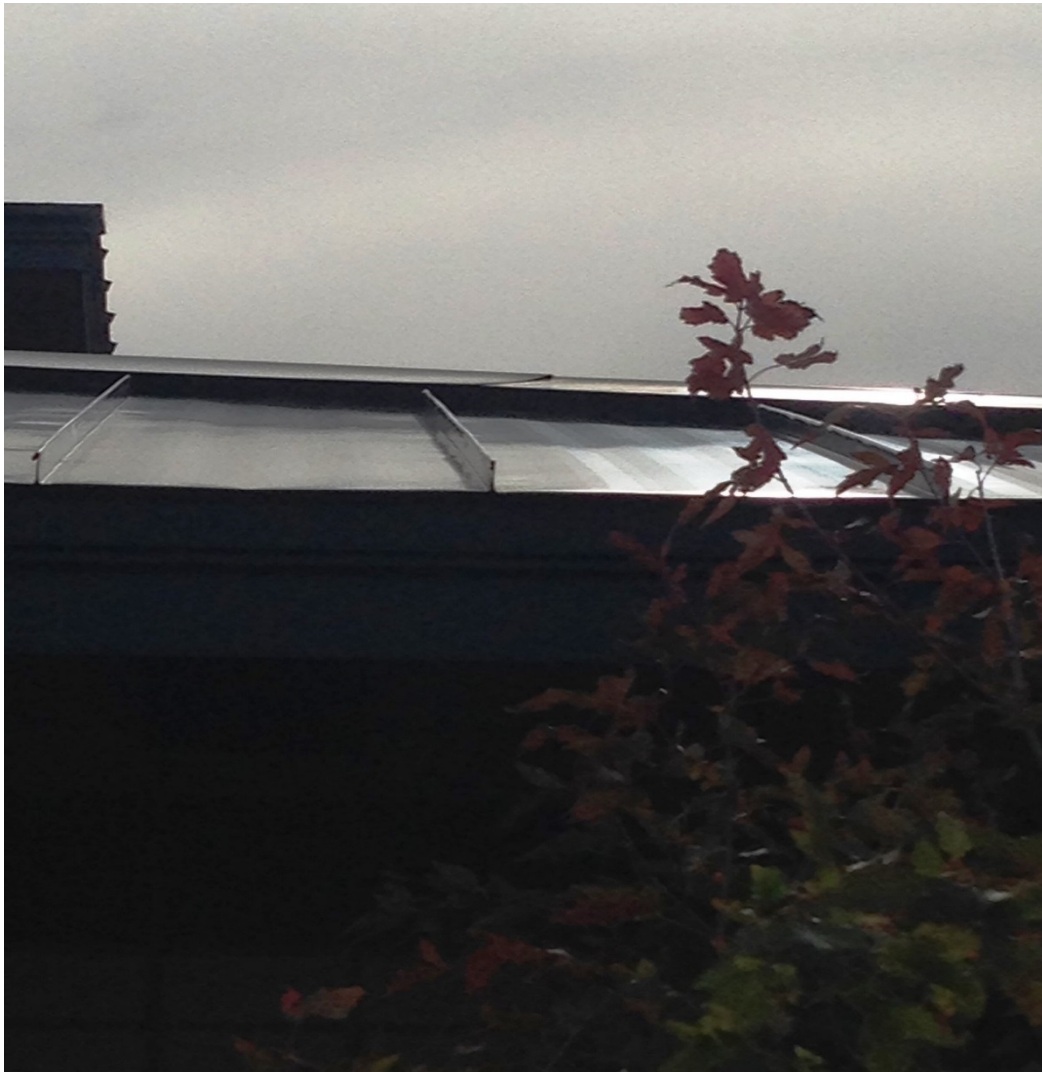
This is what a proper 180 deg. seam looks like. If the seam can not be repaired, then the panels must be replaced.
