**From:** ChrisB.Nelson@state.sd.us  
**Sent:** Monday, June 28, 2010 8:58 AM  
**To:** Bulman Karen  
**Subject:** RE: LINCOLN ACADEMY ROOF REPLACEMENT- ROOF PLAN AND PHOTOS

CONSTRUCTION DOCUMENTS  
 LINCOLN 9TH GRADE ACADEMY  
 ROOF REPLACEMENT  
 1315 QUINCY STREET  
 RAPID CITY, SD 57701

ROOF PLAN

A1

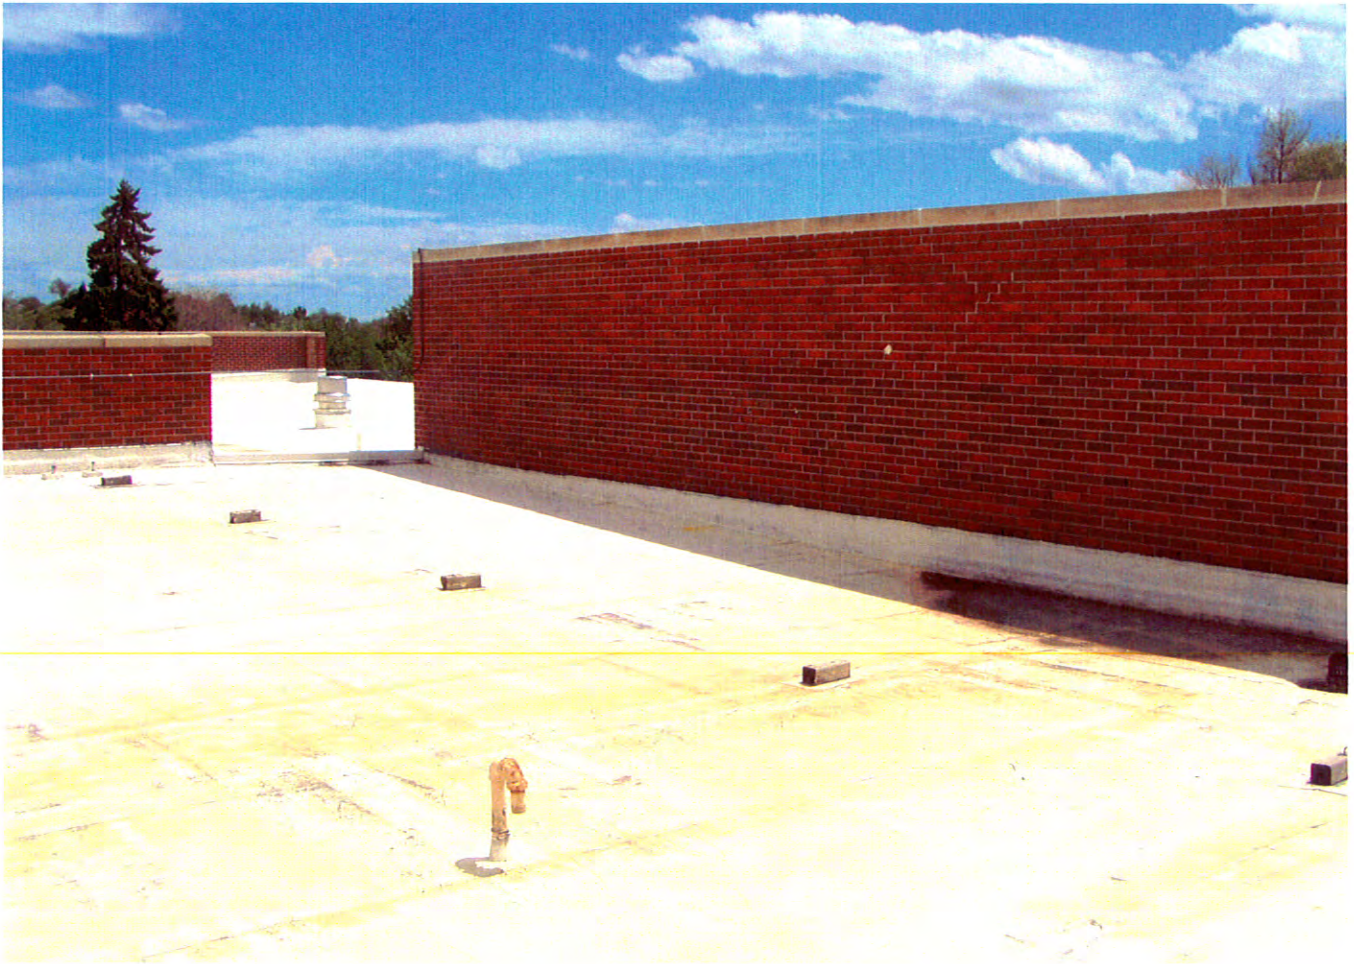
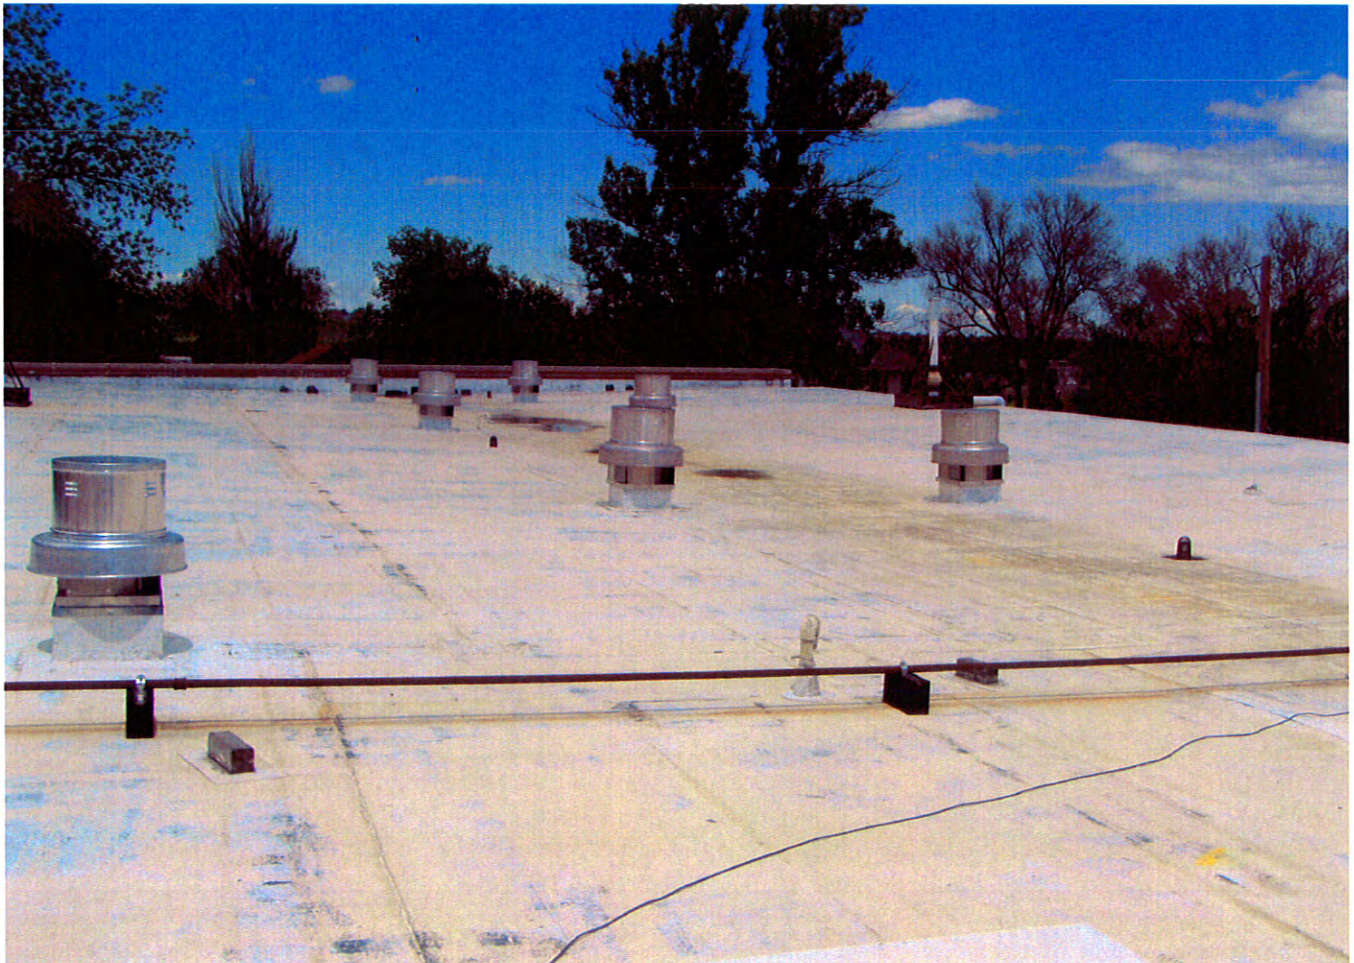
Dear Karen,  
The photos are looking northeast, one from the hillside south west of the school and one from the roof itself. The roof is a Sarnafil white membrane PVC material and will look essentially the same as it does at this time. The roof exhaust vents will be reinstalled as will the vents etc. The project is being done by the School District on an emergency basis as the roof deck is an asbestos product and needs replacement for the safety of the occupants.  
If you have any questions, feel free to ask.  
Thanks for your help with this.  
Lee Geiger, Architect
