SOUTH DAKOTA HISTORIC SITES INVENTORY

Historic Name Milton & Julia Garland House

Address/Location 1018 Fairview Street

Site Number
PN- RC -RC -WB-00296
CTY TWP CIT NBH NUM

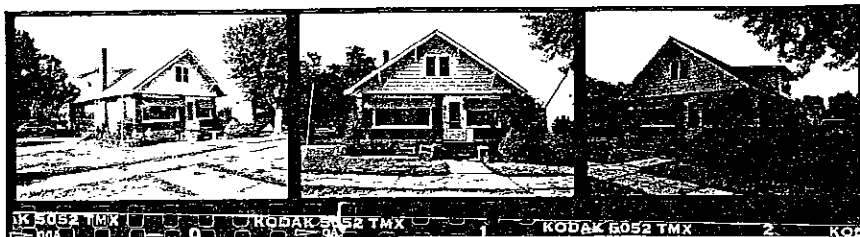
Photographer M. Hufstetler
Roll # 18/21 **Frame #'s** 0-2/33-34
(Attach Photographs Below)

Site No. PN-RC -RC-WB-00296 Date of Construction c.1917 Photos 0-2
 Function House Plan Form Rectangular Height (Stories) 1.
 Style Craftsman Bungalow Method of Construction Brick Overall Condition E

Original open, south (front) porch has been enclosed with windows and siding, and incorporated into house space: likely a modern alteration; modern metal siding on gable ends and dormers
