SOUTH DAKOTA HISTORIC SITES INVENTORY

Historic Name Frank & Marjorie Hecker

Address/Location 1602 West Boulevard

Site Number  
PN -RC -RC -WB -00507  
CTY TWP CIT NBH NUM

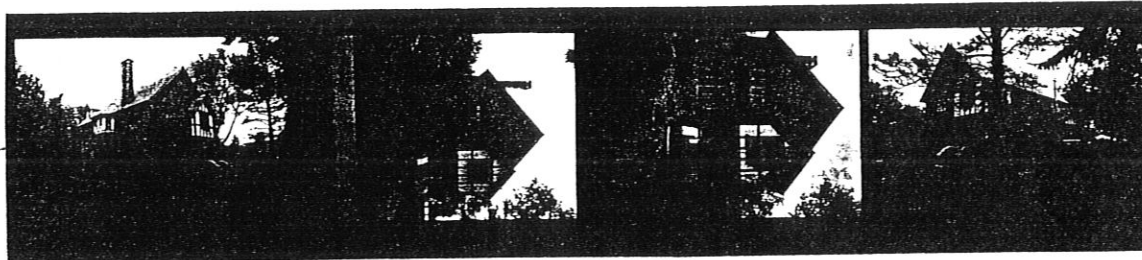
Site No. PN-RC -RC-WB-00507 Date of Construction c.1928 Photos 10-11 +  
 Function House & garage Plan Form Irregular Height (Stories) 2.5  
 Style Tudor Revival Method of Construction Tile Overall Condition E

Additions & Alterations (Types & Dates)  
 Some modern replacement windows, & skylights at south wing
