SOUTH DAKOTA HISTORIC SITES INVENTORY

Address/
Location 1021 St. Joseph Street

Site Number
PN- RC -RC -WB-00153
CTY TWP CIT NBH NUM

Significance HIST, ARCH,
LOCL

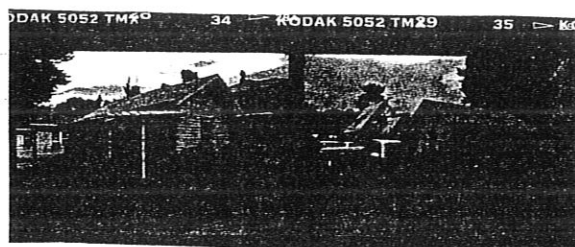
Function House	Plan Form Rectangular	Height (Stories) 1.5
	Method of Construction Wood-frame	Overall Condition E
Style Picturesque: Tudor

Foundation: Materials Concrete	Condition E
Walls: Cladding 2" Clapboard	Condition E
Windows: General/ Type	Glazing Pattern Condition Location
Unique	
G Double-hung, wood-sash	6/1 E

Roof: Form Gable; steep	Materials Asphalt shingles Condition E
Dormer: Type Shed (2)	Condition E
Location(s) East, West
