SOUTH DAKOTA HISTORIC INVENTORY

Historic Name Unknown
 Location 923 Fulton St.
 Historic Function residence

Dates of Construction and Founding
1911

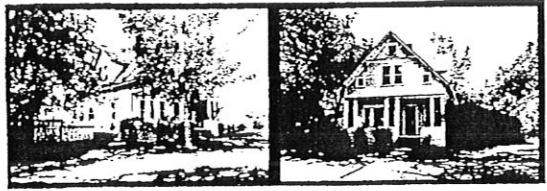
Gable-fronted dwelling with bracketed eaves and leaded glass windows. Dormers east and west, bay window east.
