original brick freight building [north side]

GRACE RESTORATIONS
2014

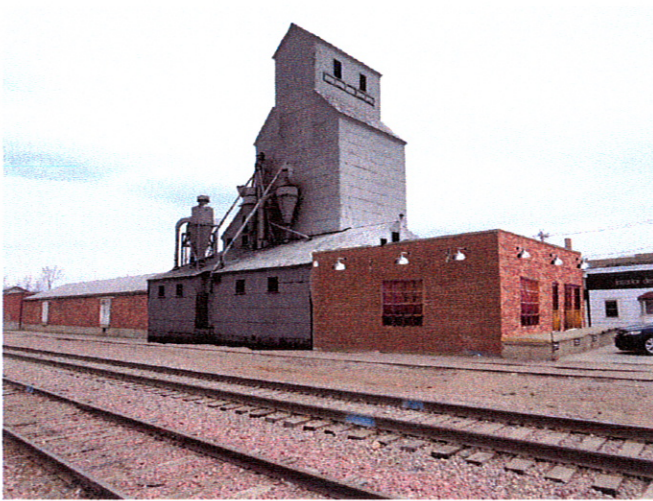
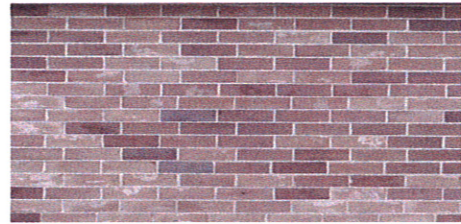
front brick [not original] adjust color

repaint front brick to match original brick

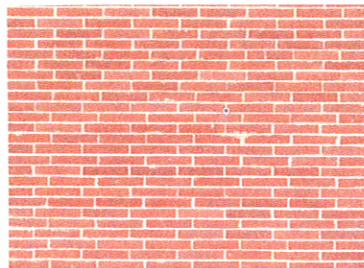
original brick on freight building

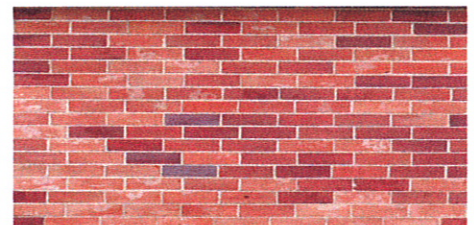
non original remodel brick wall
[front]
