SOUTH DAKOTA HISTORIC SITES INVENTORY

Address/Location 1216 Quincy Street

Photographer M. McCormick
Roll # 15 **Frame #'s** 20-23
(Attach Photographs Below)

Date 07/17/1991

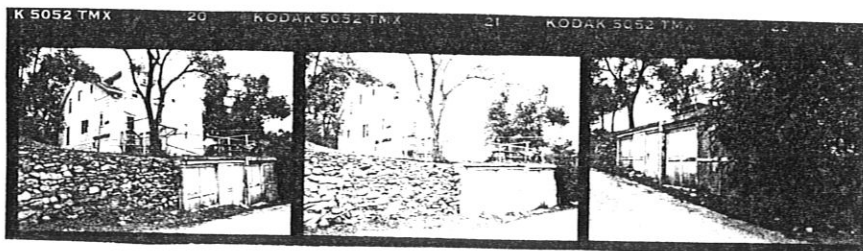
This building is located at the rear of the lot and is accessed via the alley. It appears to be composed of two houses that have been attached or a house with a large addition (pre-1923).

Foundation: Materials	Concrete	Condition	E
Walls: Cladding	4" clapboard	Condition	E
Windows: General/ Type		Glazing Pattern	Condition Location
Unique			
G	Double-hung, wood-sash	1/1	E

Roof: Form	Multi-gable	Materials	Asphalt shingles	Condition	E
Dormer: Type	Wall: gable roofed	Condition	E		
	Location(s)	East & north slopes			
Chimneys/Ventilators: Materials	Two metal vents & a brick chimney			Condition	
	Location(s) Interior: east & south slopes				
Porches: Materials	Condition	Height (Stories)	Roof Configuration	Location

Walls: plain corner & freize board trim

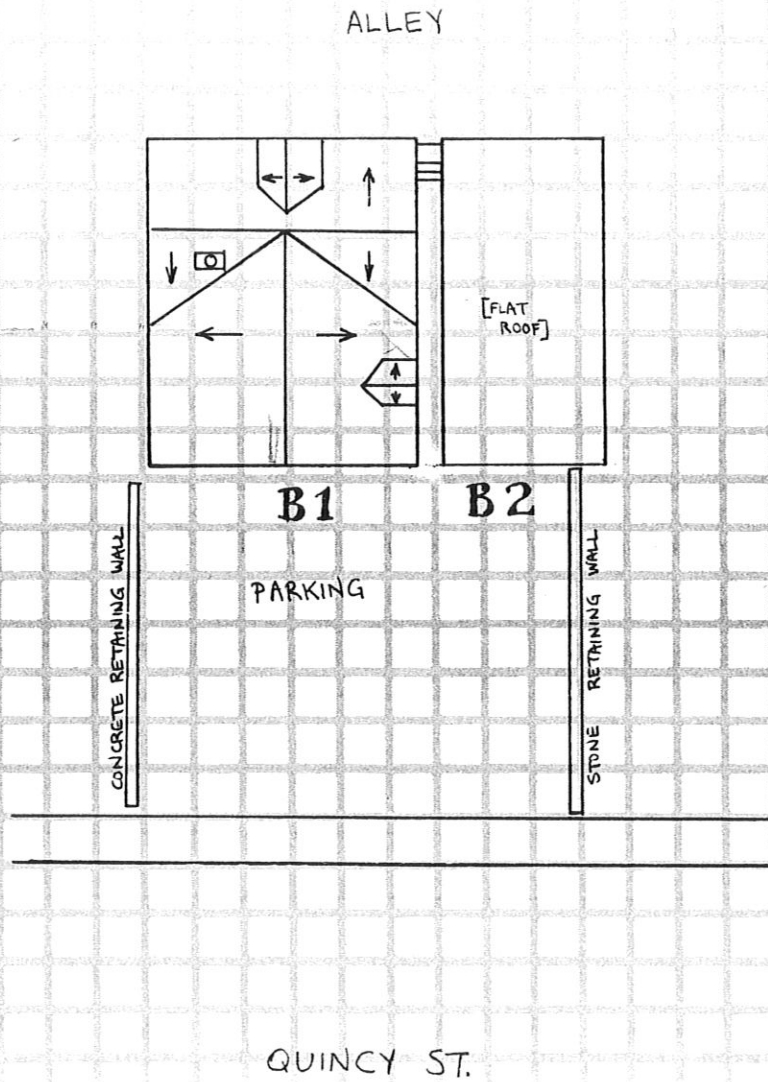
Site Plan: Indicate all door and window openings, roof shapes, and landscape features.

The garage is built into a slope so that the roof is at ground level, creating a deck off the house. It has two bays, each holding double doors. It is flanked by high, rubblestone retaining walls that buttress the slope.
