HISTORY AND CURRENT CONDITIONS
OF
BIG BEND POWER PLANT
Rapid City, SD

Building Condition

BIG BEND POWER PLANT

Cost Estimate for Stabilization & Window and Door Replacement

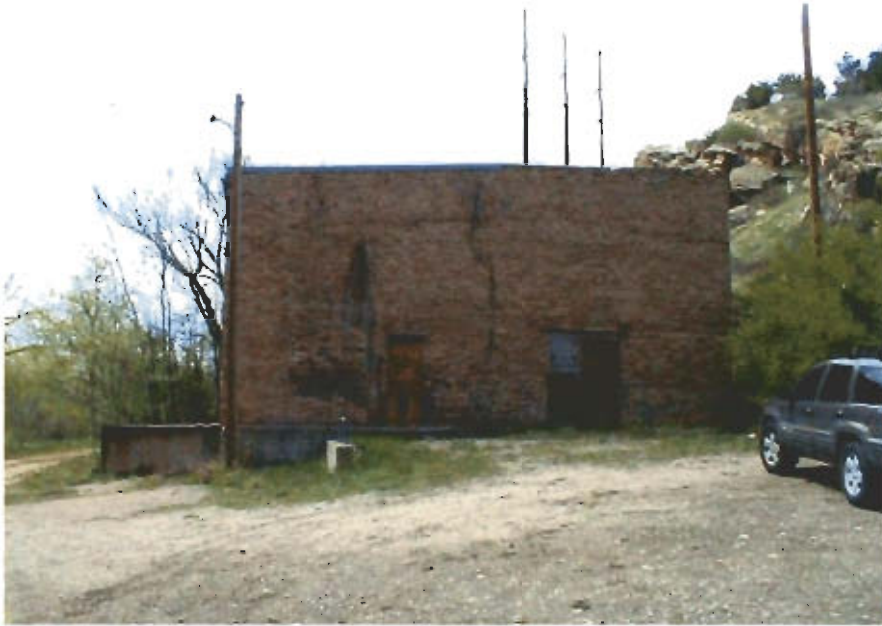
VIEW FROM EAST

The east wall has a large crack in the masonry, which runs from top to bottom in the approximate center of the wall. The wall appears to be leaning slightly inward at the top center. Previous openings have been in-filled with a variety of masonry materials. Some brick has been broken to allow access to the interior.

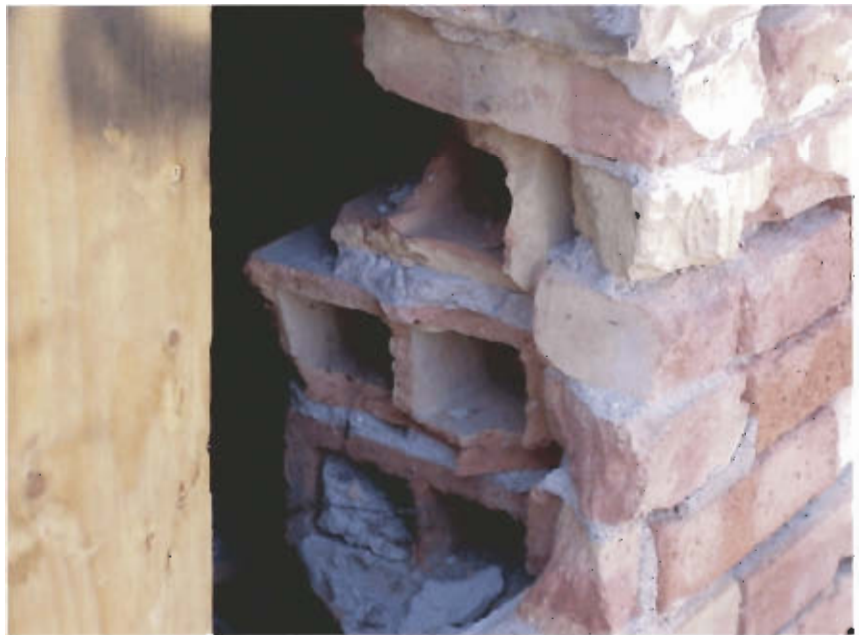
DETAIL EAST WALL

- Remove roofing and roof deck; replace roof deck and roofing, flashing and wall cap.
- Repair masonry at top of wall and parapets.
- Install gutter and downspout.
- Remove tree at the southwest corner. Underpin footing if necessary.
- Repair deteriorated masonry and mortar.
- Stabilize east wall and bring back into vertical plane.
- Repair large cracked area of east wall with either masonry, steel ties or both.

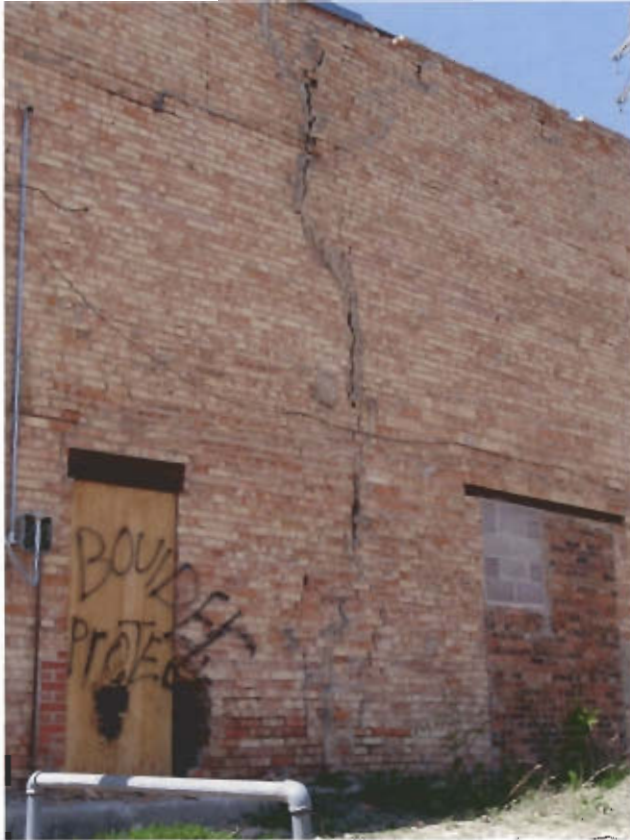
EAST WALL WITH CRACK

| 1. | Major vertical crack repair | \$ 5,000 |

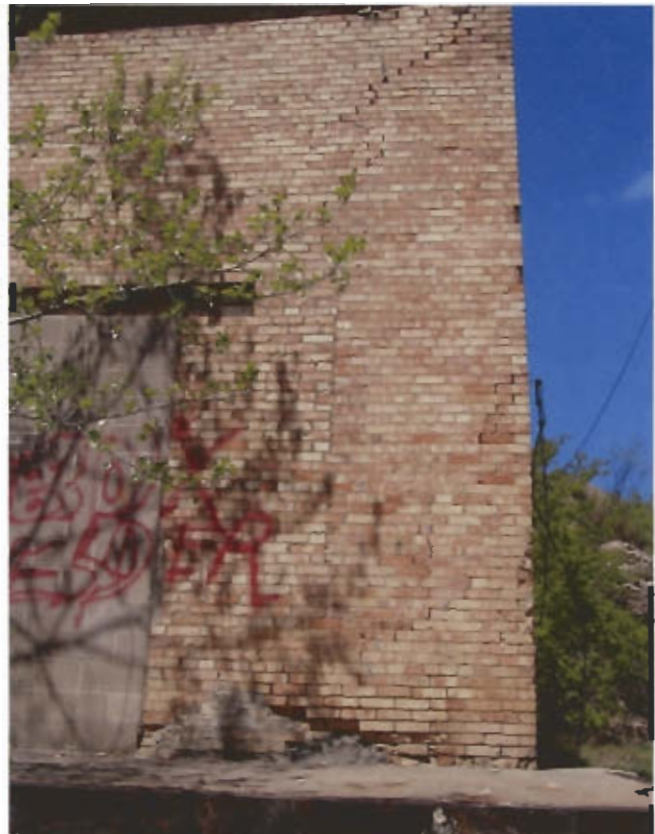
The south wall has some masonry deterioration at the bottom of the southeast corner, but is otherwise in generally good condition. The large opening has been in-filled with concrete block and a steel framed passage door.

SOUTHEAST CORNER

- 10X12 area (upper east) \$1,950
- 8X12 area (lower east) \$ 260
- 8X20 area (west, full height) \$ 2,600 | \$ 4,800 |

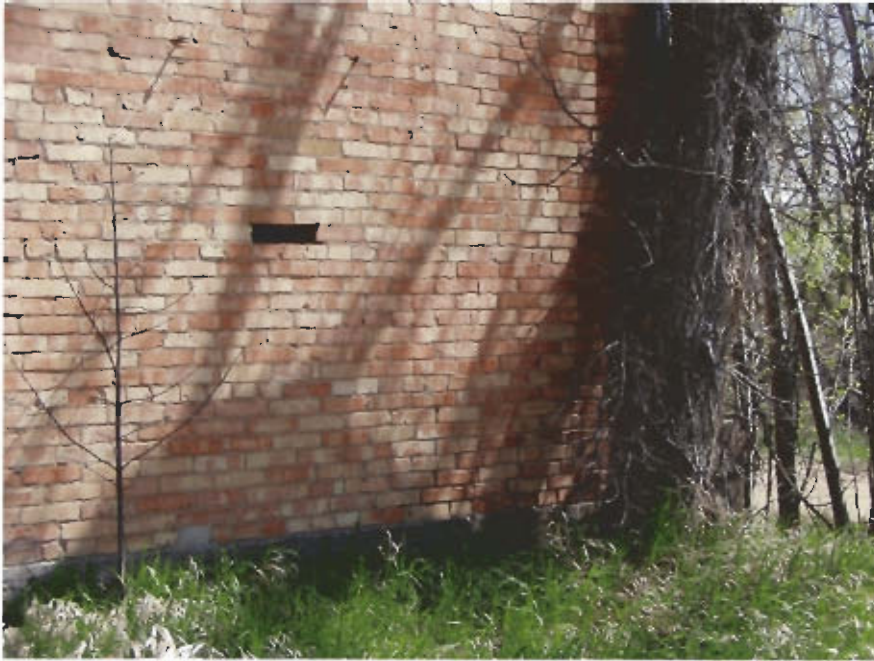
The west wall is in generally good condition with two notable exceptions. The wall top has deteriorated as a result of the absence of metal cap flashing. At the southwest corner, a tree has grown to the point where it has begun to displace vertically the concrete foundation and the masonry. Previous openings have been in-filled with concrete block and/or brick.

TREE AT SOUTHWEST CORNER

| B. | Remove tree and stump at southwest corner | \$ 1,500 |
| C. | Underpin footing at southwest corner | \$ 6,000 |

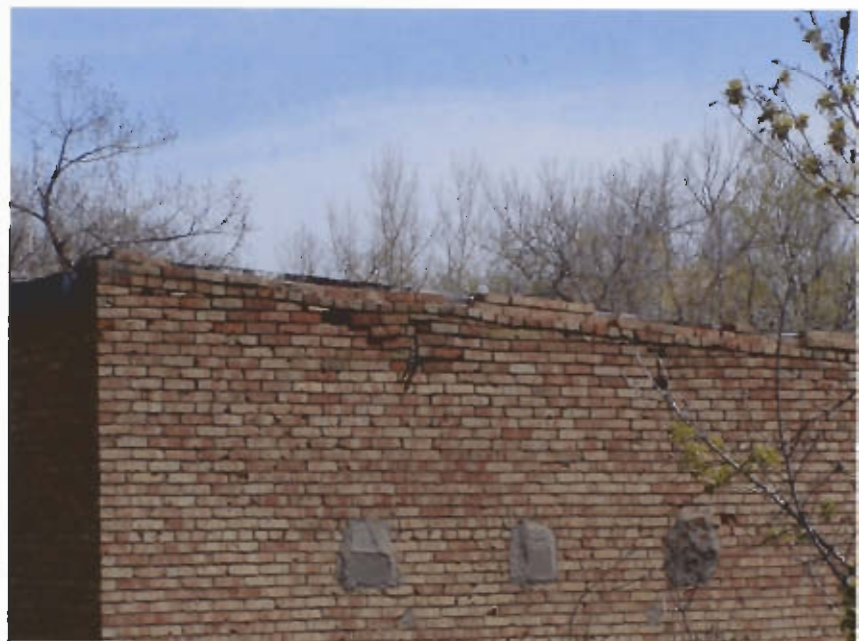
The roof appears to have leaked for some time. The wall flashing and wall cap are almost entirely gone. As a result, the brick and mortar at the top of the wall are deteriorating and separating. These first two deficiencies will cause rapid further deterioration if not repaired.

TOP OF WALL WEST SIDE

1.	Rebuild top of wall, full length	\$ 4,400
2.	Tuckpoint lower north corner	\$ 1,500
3.	Replace 3 windows	\$ 1,740
	- Demo masonry in-fill (3 X \$110)	
	- New wood windows (3 X \$470)
