Ref: Perrine Drainage Basin Design Plan  
Creek Drive Area South of Centre Street

Re: Creek Drive Water Damage

Flooding Problems Related to Hawthorne Ditch and Perrine Drainage Basin  
1220 Creek Drive, Rapid City, South Dakota

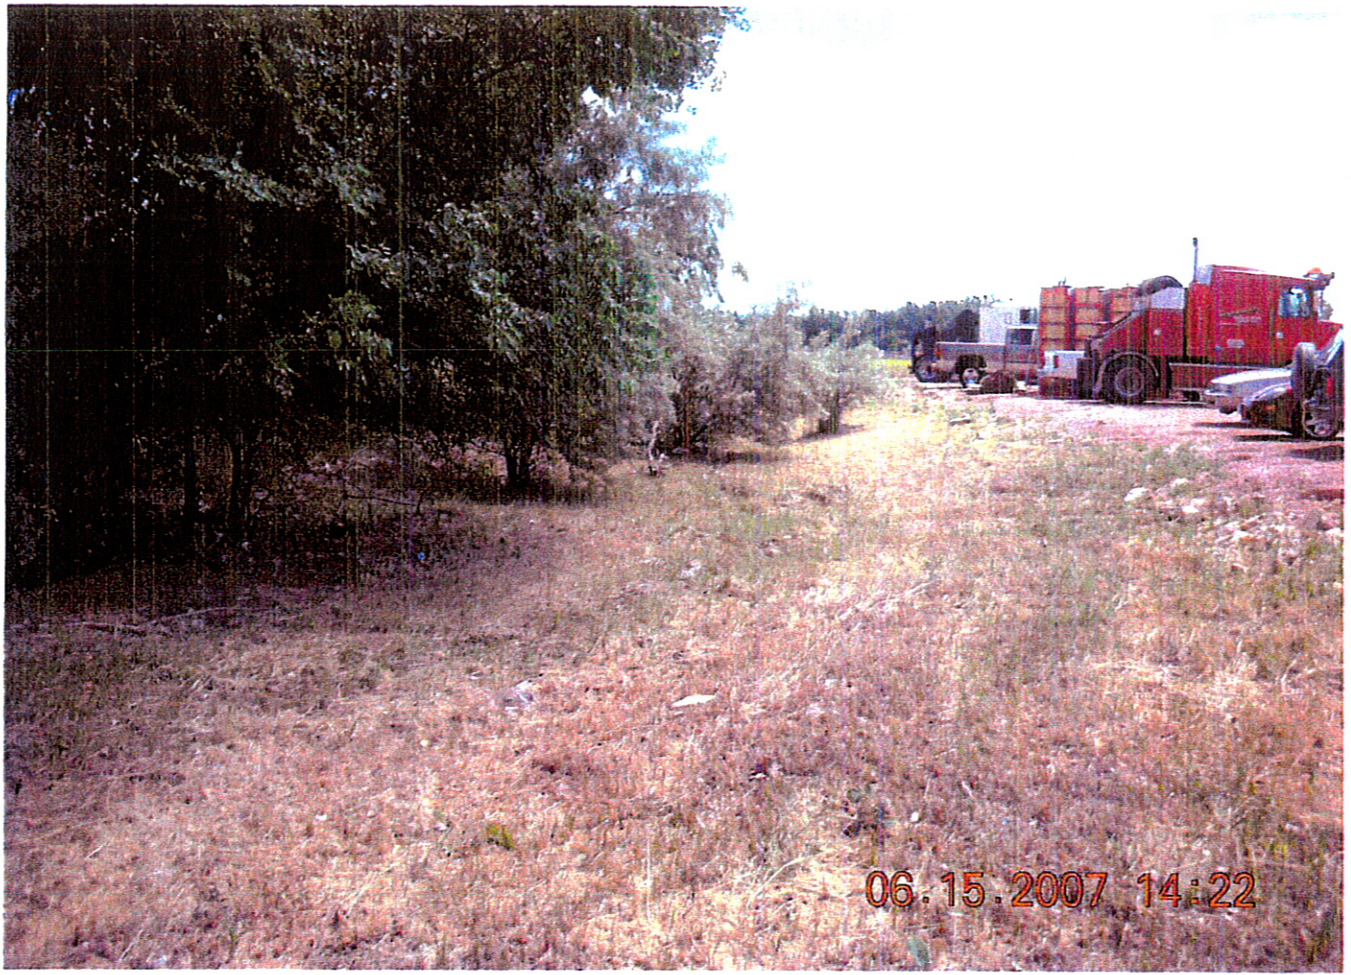
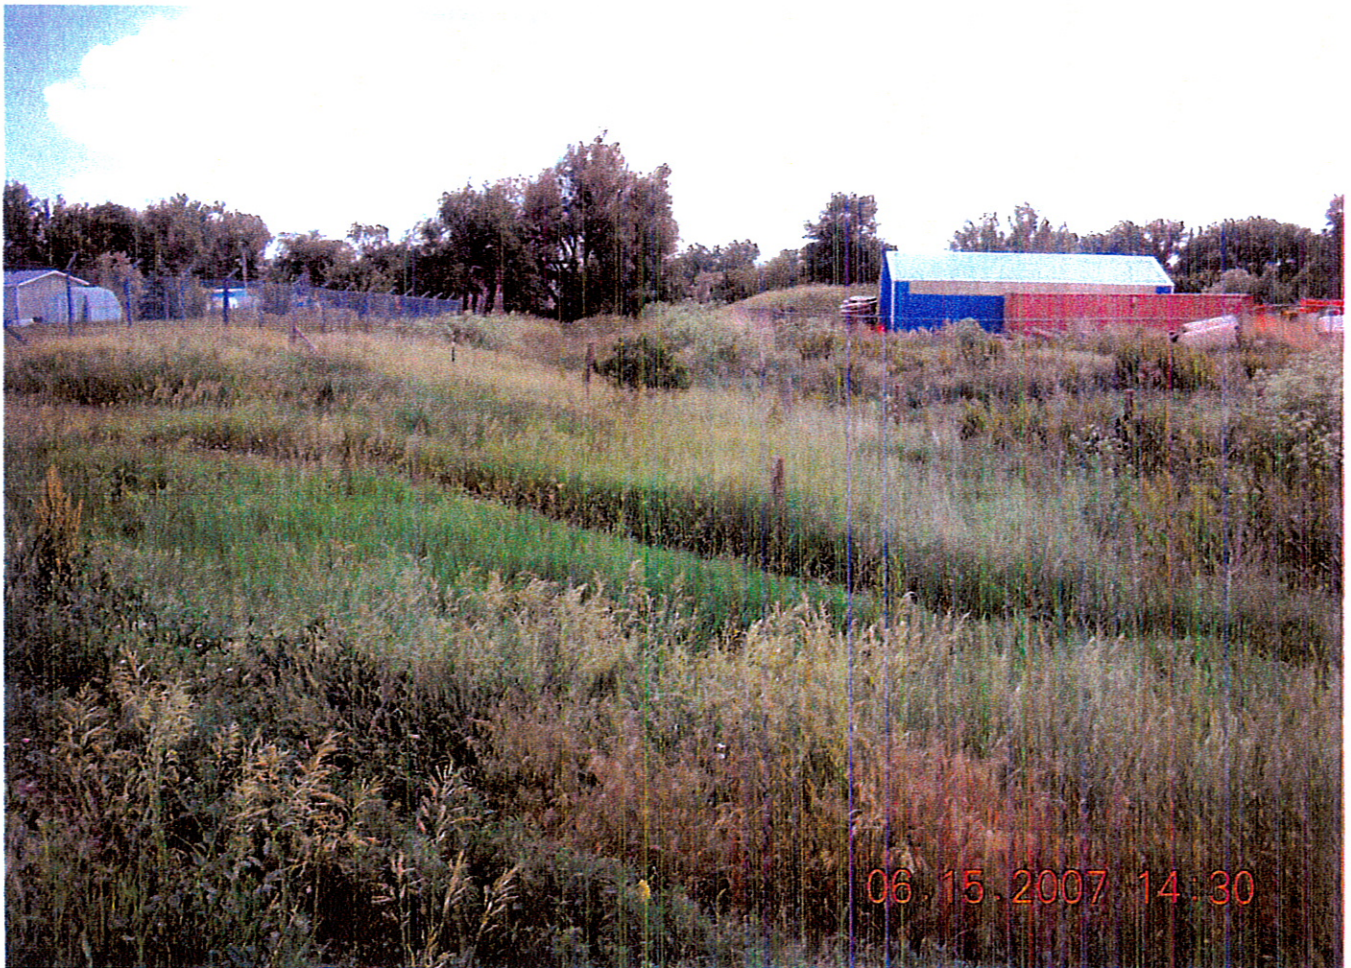
It is recommended that the existing channel between Centre Street and the abandoned rail line be regraded. The existing channel has a steep grade and is susceptible to erosion. It is recommended the channel be regraded with a 10 foot bottom, 3:1 side slopes, and an invert slope of 0.0090 ft/ft. Much of the invert slope flattening will occur as a result of grading required to install the Element 7 storm sewer. Depending upon final design drop structures may be necessary. Normal depth for the recommended channel using 365 cfs is 3.0 feet at a velocity of 6.4 fps. The Froude Number is 0.78.

The existing 48" pipes through the railroad right of way should be removed and the embankment open cut to allow for the Element 8 flows. The existing pipes are plugged with the existing downstream channel being at approximate top of pipe elevation. Under existing conditions the railroad pipes will cause a flow split with most of the flow directed to the east where Kennel Drive will be overtopped.

The channel section between the railroad and the Hawthorn Irrigation Ditch is adequate with only minor shaping required. Significant improvements are not recommended since the existing channel grade is flat and the channel is a wetland. Minor shaping as necessary can be completed with the Hawthorne Irrigation Ditch improvements discussed below.

The railroad open cut should be to the same approximate elevation as the top of pipes. Excavating the channel down to pipe flow line would lower the downstream channel such that the irrigation ditch will back into the channel. It is suggested the open cut be lined with riprap to lessen erosion. It may be possible to line the channel invert immediately upstream of the open cut to serve as a channel drop.

The channel will discharge into the Hawthorne Irrigation Ditch which does not have capacity for additional flow. It is recommended that an overflow weir system and outfall channel to Rapid Creek be constructed to carry the entire storm water discharge. The weir system would allow irrigation flows to continue in the ditch and divert the storm water to the outfall channel. It will be necessary to secure an easement or right of way for the outfall channel.
