SOUTH DAKOTA HISTORIC INVENTORY

Historic Name Hall Building

Location 623 St. Joseph Street

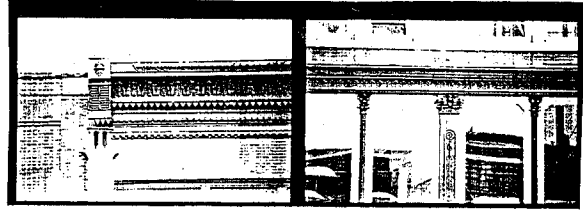
ROLL 3

This two-story Italianate building has the best preserved facade in the downtown historic district. It is distinguished by an intact cast iron front from the "Union Foundry and Pullman Car Wheel Works" of Chicago. The storefront has a transomed entrance at each corner flanking four tall, narrow windows that are divided by fluted, iron pilasters with Corinthian capitals. Dividing the first and second floors is a metal cornice with a band of acanthus leaves.

The brick second floor has two tripled windows featuring a central single pane flanked by narrow $\frac{1}{2}$ double hung sash. Each set of three windows is divided by turned wooden pilasters. A stringcourse connects these openings at the sill, while a simple metal cornice at the top spans the width of the facade. Centered on the second floor is a raised stone panel with a lion's head, pateras, and other diminutive ornamental elements in relief. Brick dentils project just below an ornate metal cornice featuring a quilloche, zigzag, scallops, rope molding, and rosettes. A rusticated stone pier from the former building to the east rises from the first floor to the cornice.
