SOUTH DAKOTA HISTORIC INVENTORY

Historic Name Lampert House

Location 914 West Boulevard St.

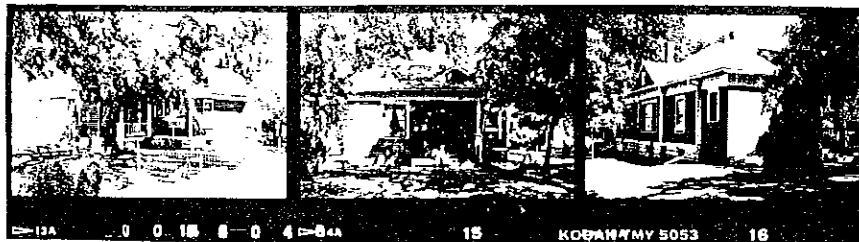
One-story vernacular dwelling with 1/2 double hung sash, side passage, and turned baluster at entry.
