# ***TRAFFIC SIGNAL WARRANT STUDY***

**E. ST. PATRICK STREET & S. VALLEY DRIVE**

**February 17, 2010**

**ENGINEERING SERVICES/PUBLIC WORKS DEPARTMENT**

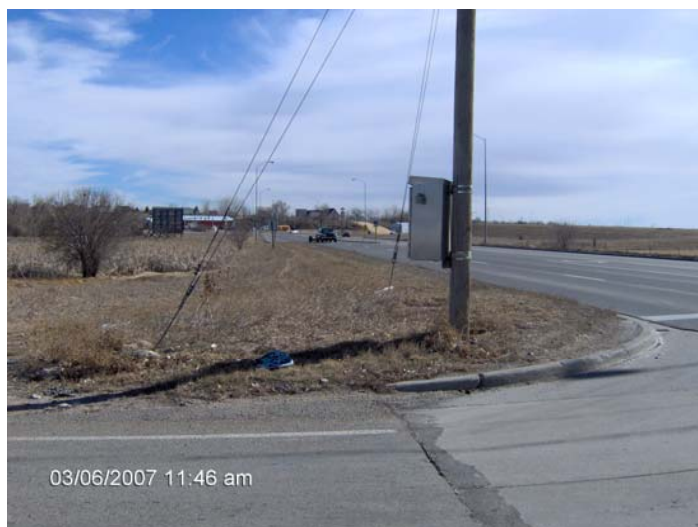
north leg of S. Valley Drive – looking east

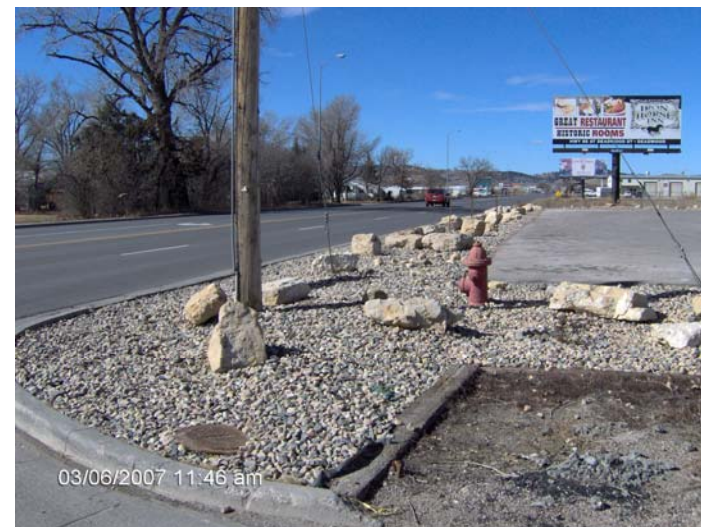
north leg of S. Valley Drive – looking west

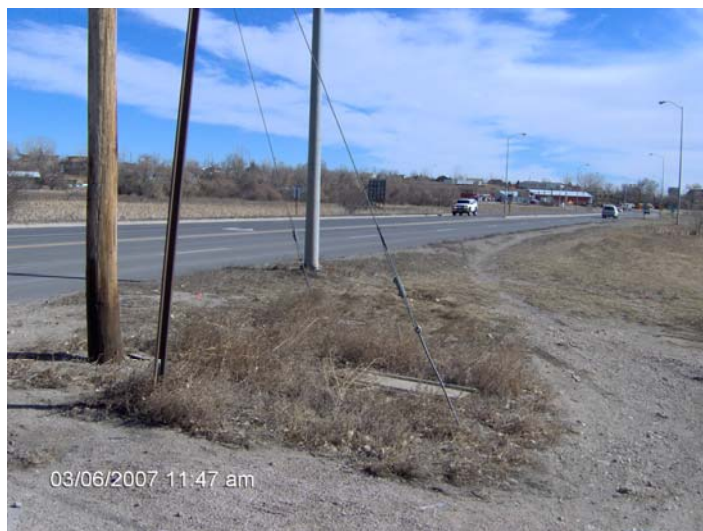
south leg of S. Valley Drive – looking east

There is adequate intersection sight distance from the north approach of S. Valley Drive for left-turn, crossing, and right-turn maneuvers. There is existing brush and vegetation on the southwest corner that restricts sight distance from the south approach.
