October 1, 2015

Re: Case # 15PD001
Major Amendment to a Planned Development @ Elks Country Estates
Petitioner: Chad Zandstra Construction
Location: 3744 Padre Drive, Rapid City, South Dakota

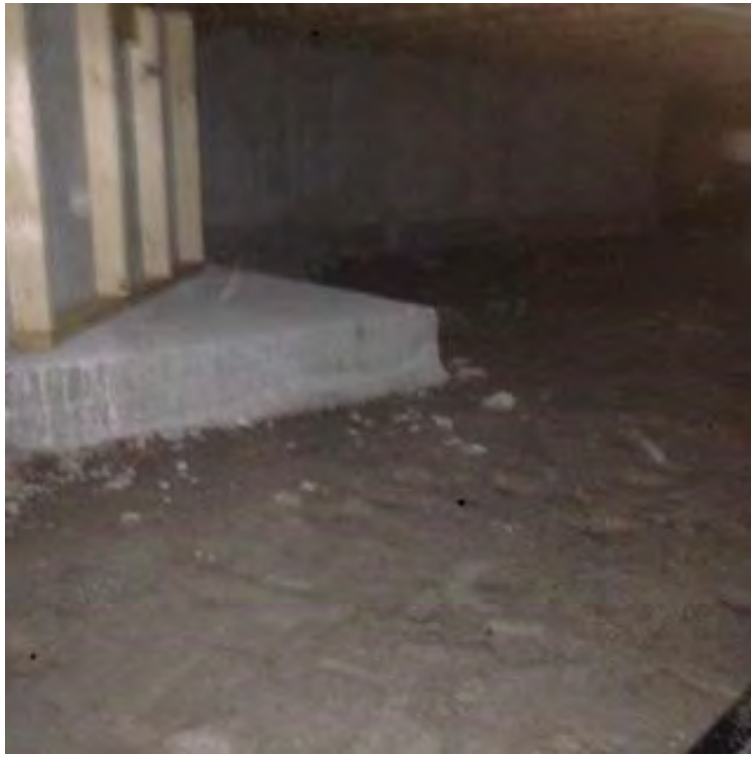
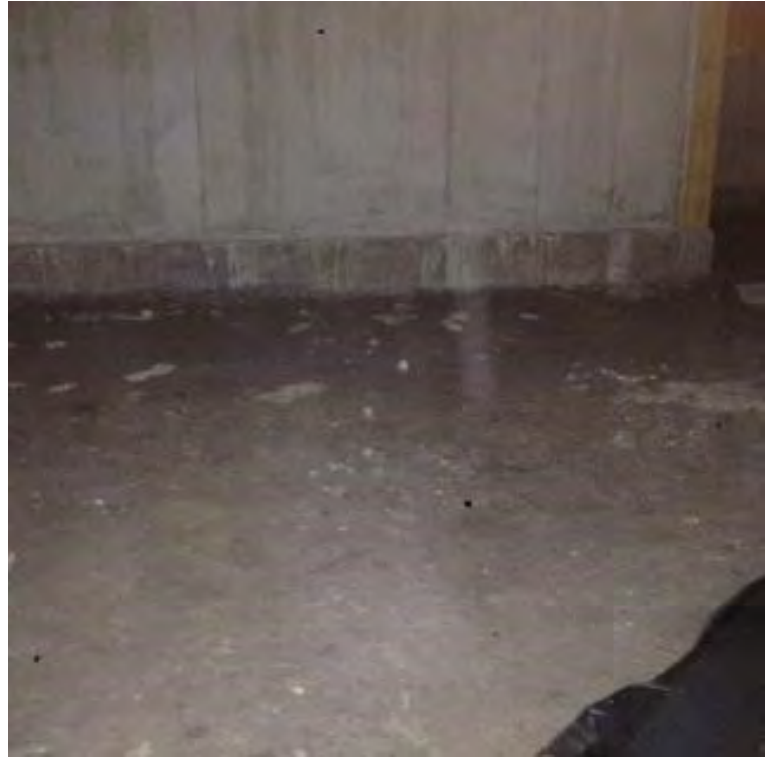
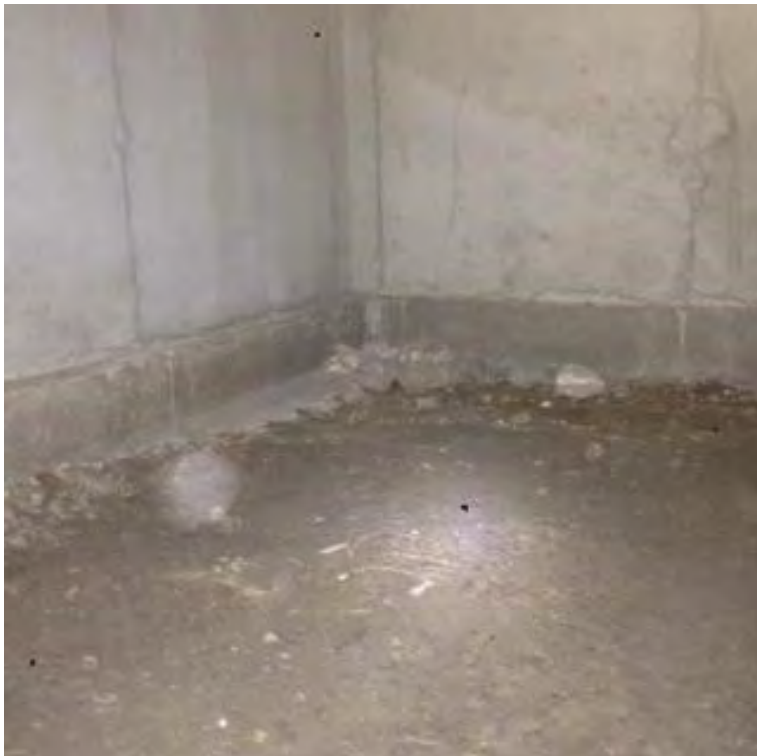
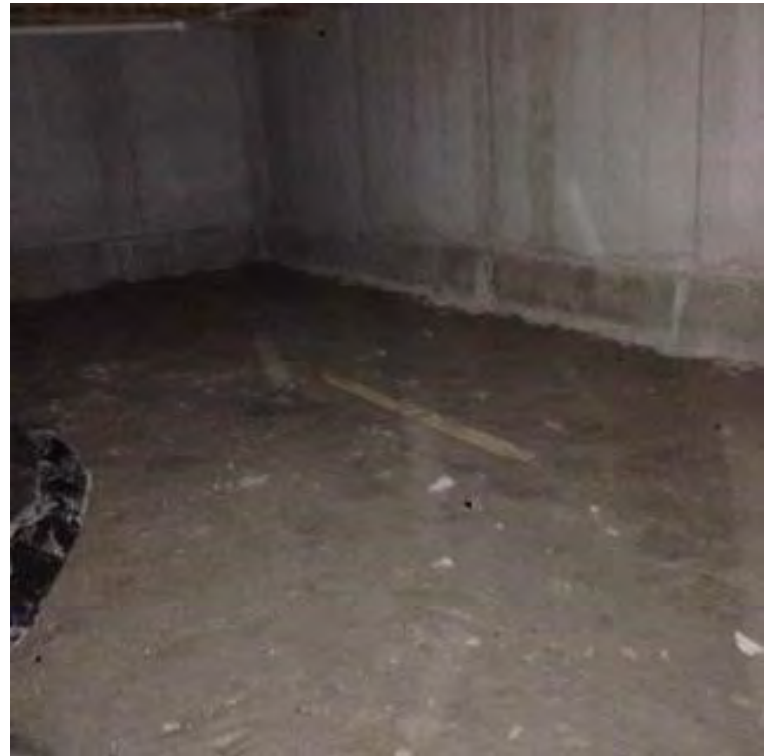
Photos Taken: 9/24/2015 @ approximately 2 pm

Images show no standing water in crawl space underneath vapor barrier

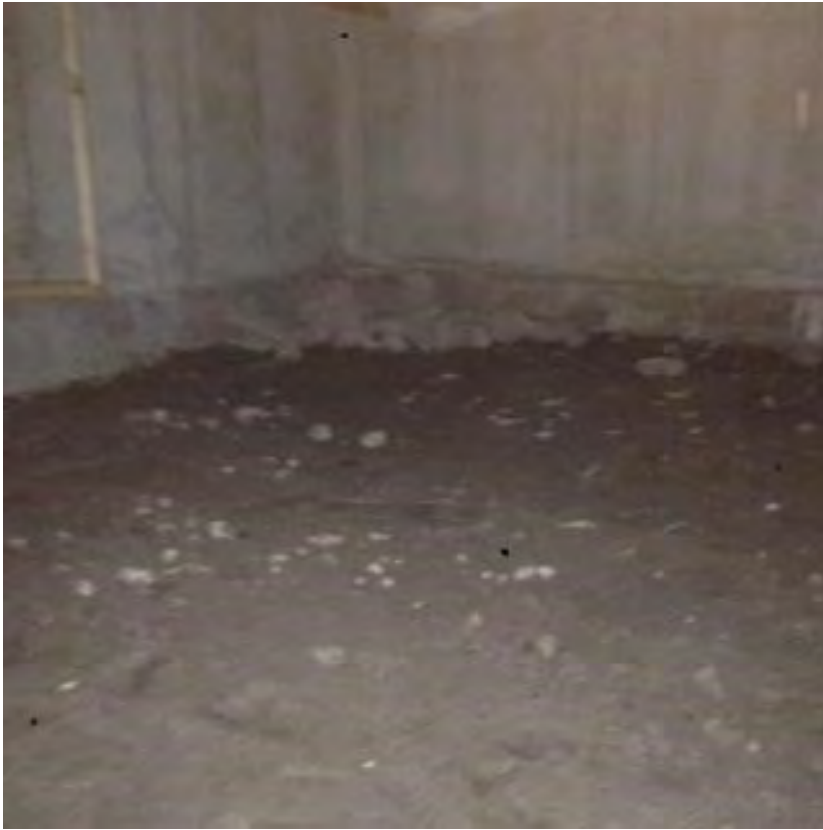
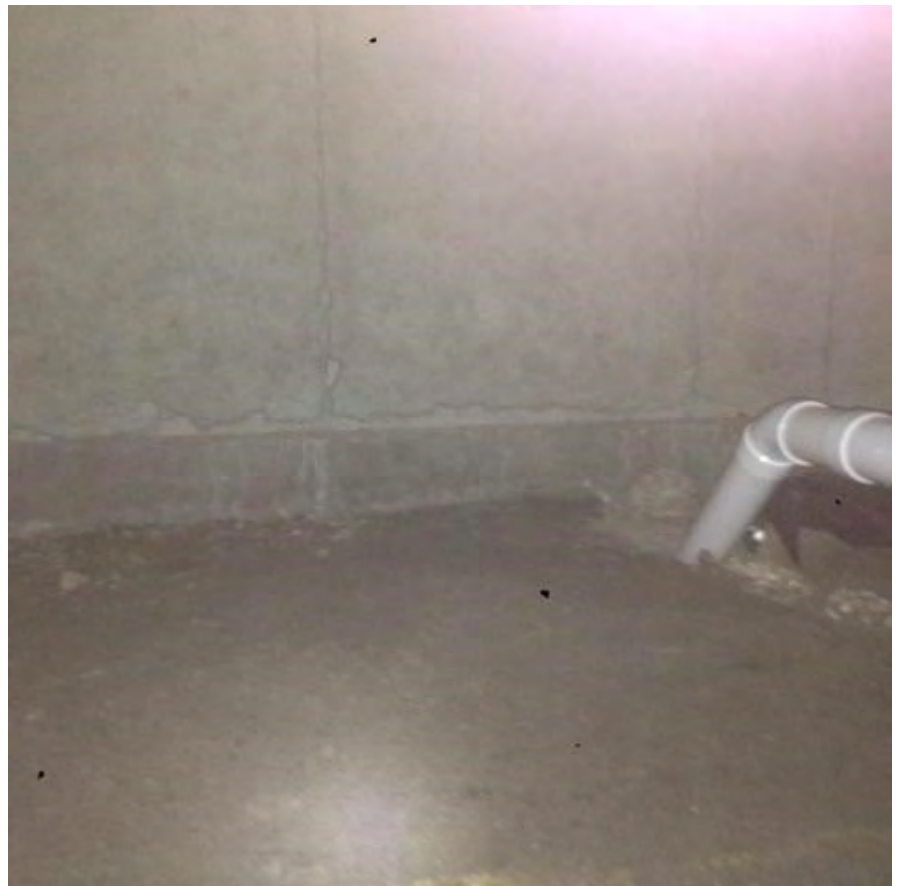
Photos Taken: 9/24/2015 @ approximately 2 pm

Images show no standing water in crawl space underneath vapor barrier

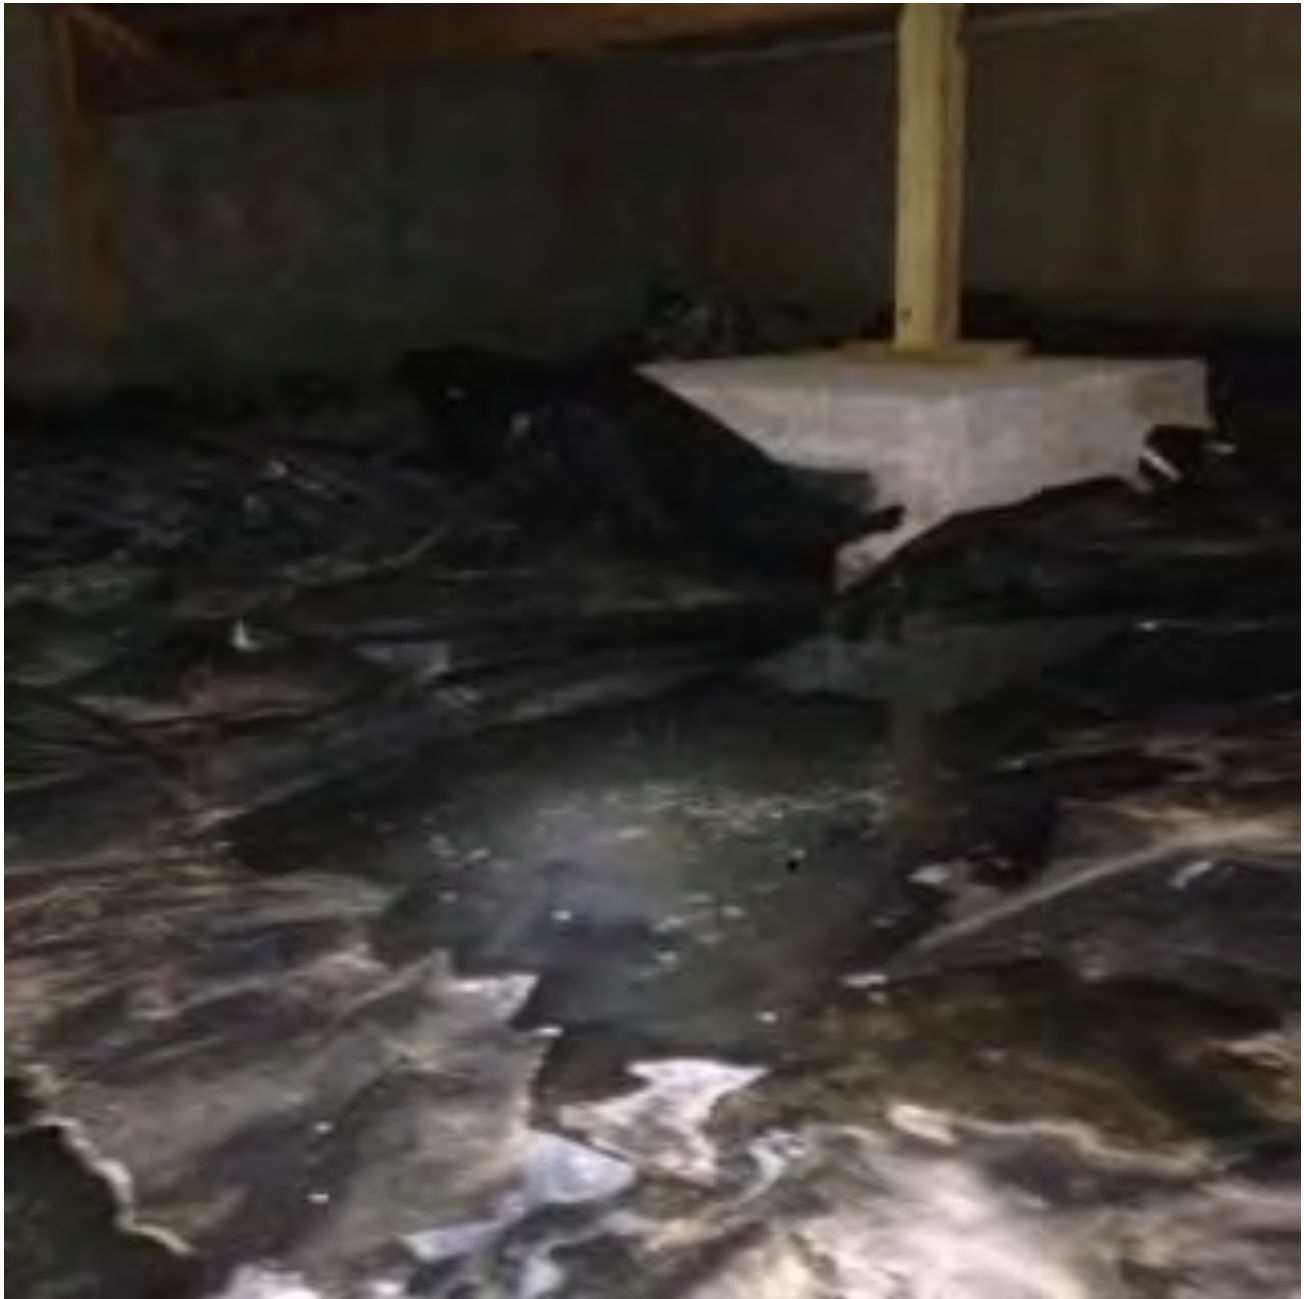
Photos Taken: 9/24/2015 @ approximately 2 pm

Image shows puddle of salt water from a broken water softener; not installed per Contractor

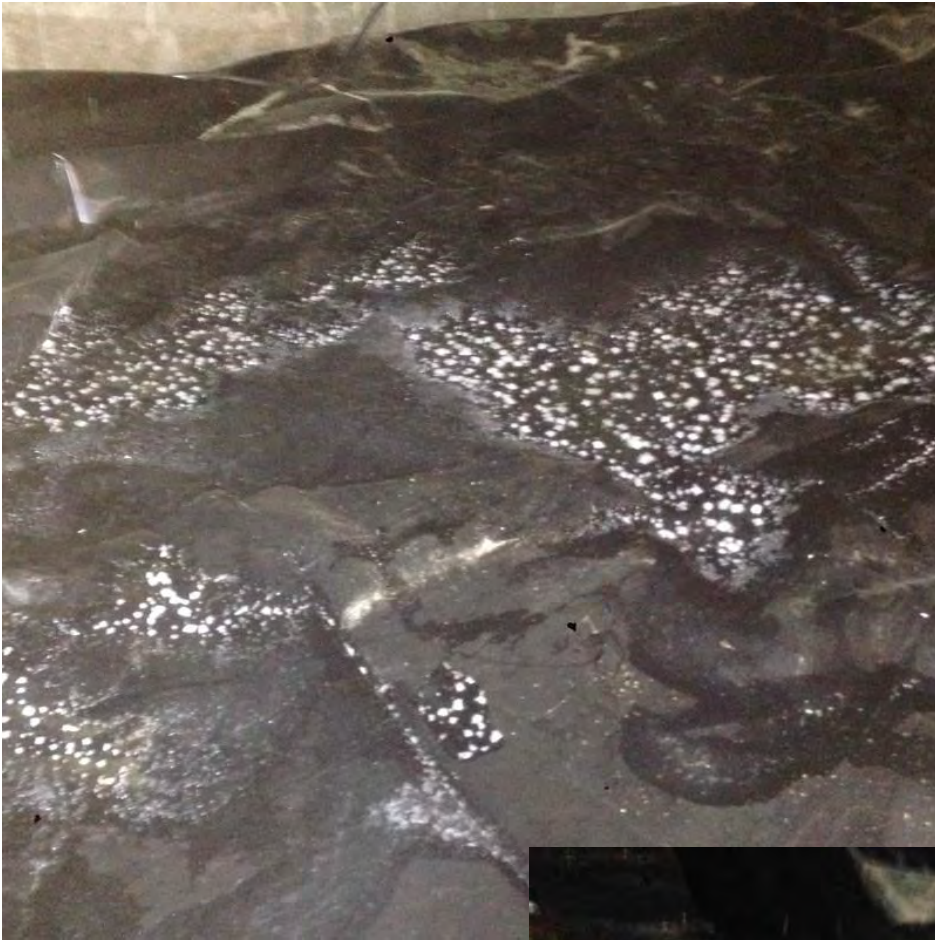
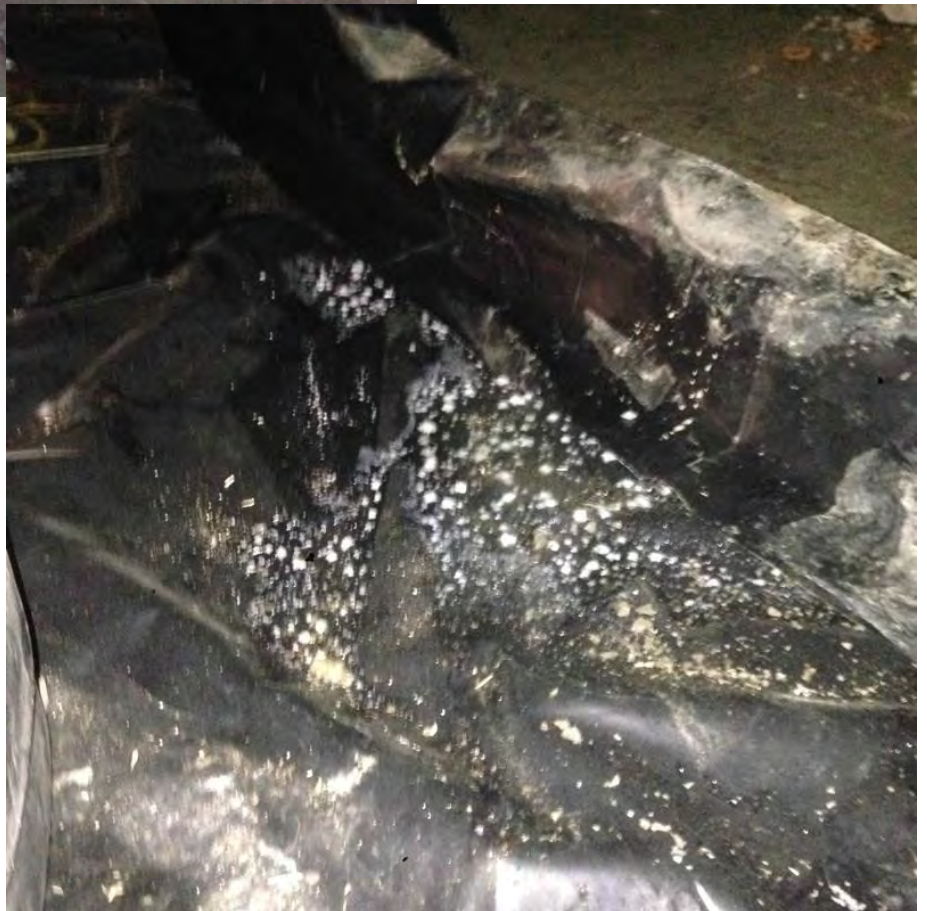
Photos Taken: 9/24/2015 @ approximately 2 pm

Images show saltwater residue on vapor barrier

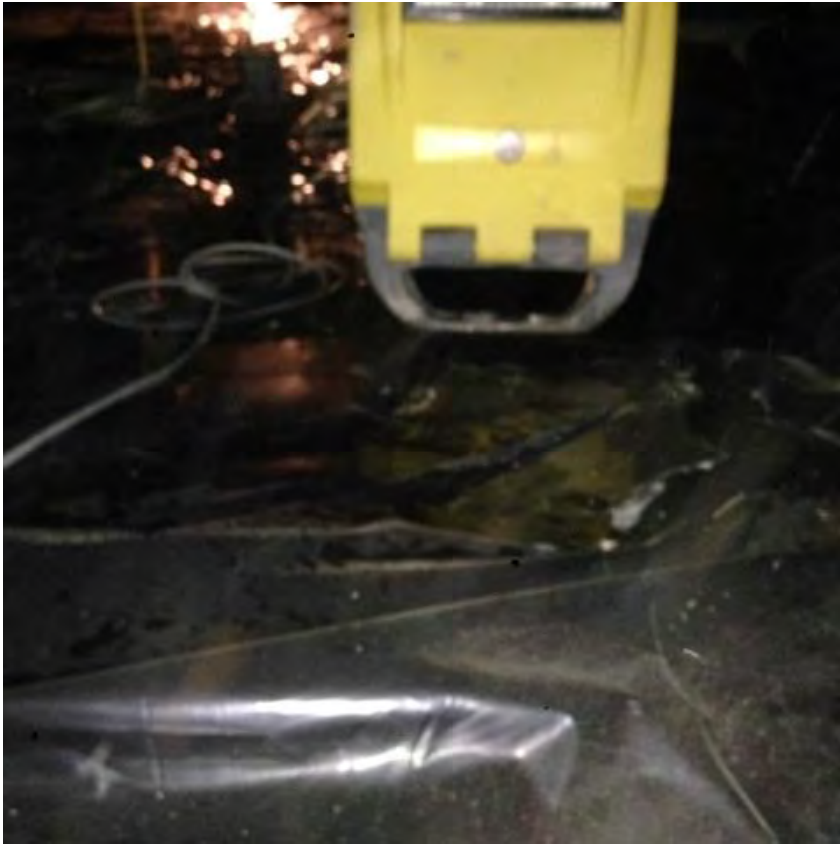
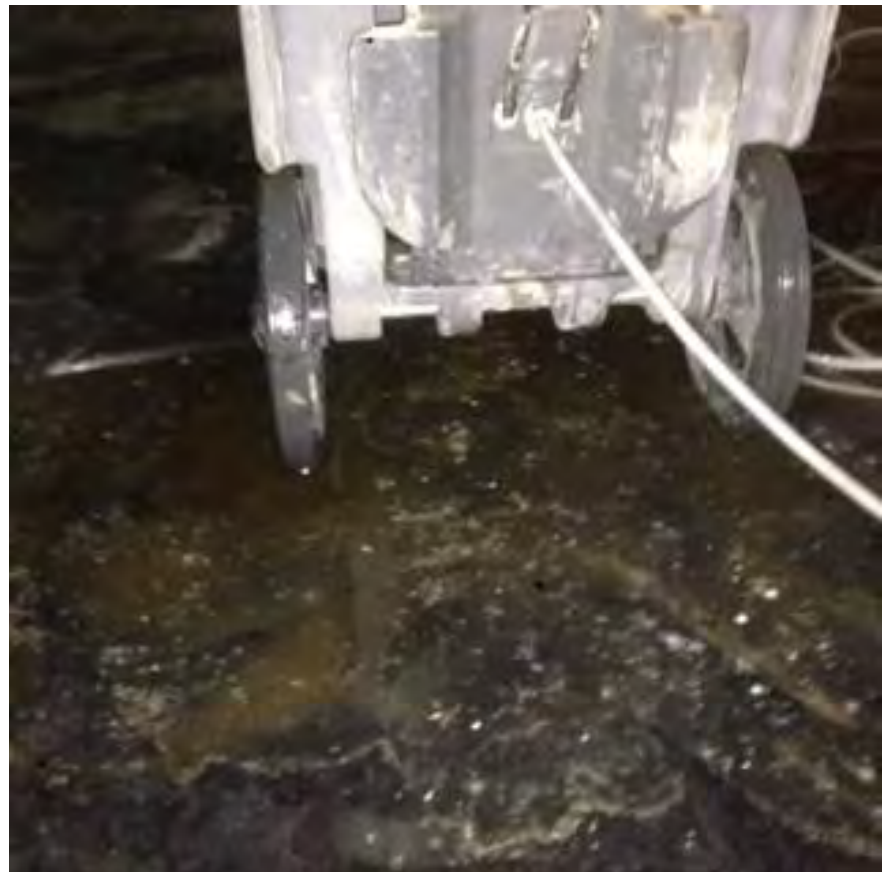
Photos Taken: 9/24/2015 @ approximately 2 pm

Images show dehumidifier placed in crawl space by Contractor; it malfunctioned due to the over exposure to the salt water in the crawl space causing it to discharge improperly.

Chad Zandstra Construction arranged a meeting with the affected homeowner at 1:00 pm on September 24, 2015 to enter the crawl space and evaluate the issues presented at the Planning Commission meeting. Pictures taken during that site inspection are attached for reference. As indicated on attached pictures, the water present in the crawl space originated from a leak in the water softener that the homeowner had installed, the pictures show the presence of salt deposits consistent with discharge from the water softener. Note that Chad Zandstra Construction did not install the water softener, yet we repaired the leak from the water softener and rectified the plumbing issues leading to the presence of water in the crawl space. Additionally, we pulled back the plastic vapor barrier to evaluate the soil conditions below the vapor barrier. The soils encountered below the vapor barrier were mostly dry with a few damp areas but no visible standing water as can be seen in the included photographs. At that time we replaced a malfunctioning dehumidifier that was damaged due to the presence of the salt. The new dehumidifier was fully functioning and operating efficiently when we left.

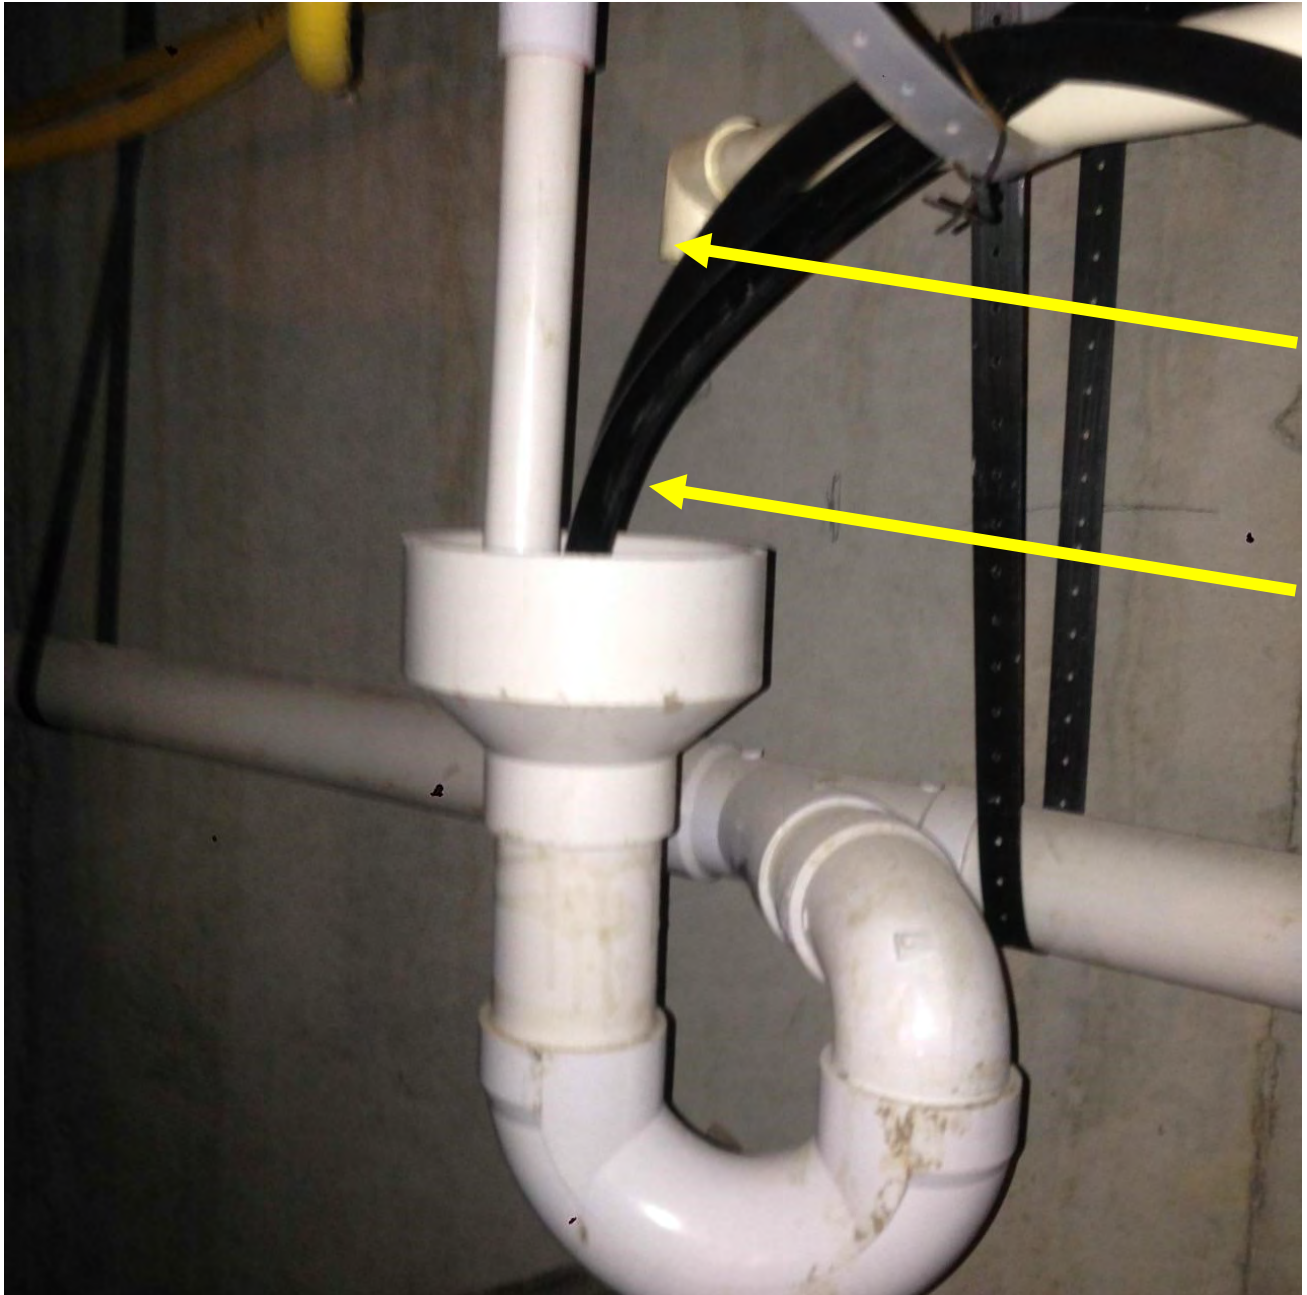
Photos Taken: 9/24/2015 @ approximately 2 pm

Image shows two pipes unaligned with the drain. Homeowner installed water softener; Contractor corrected upon finding.

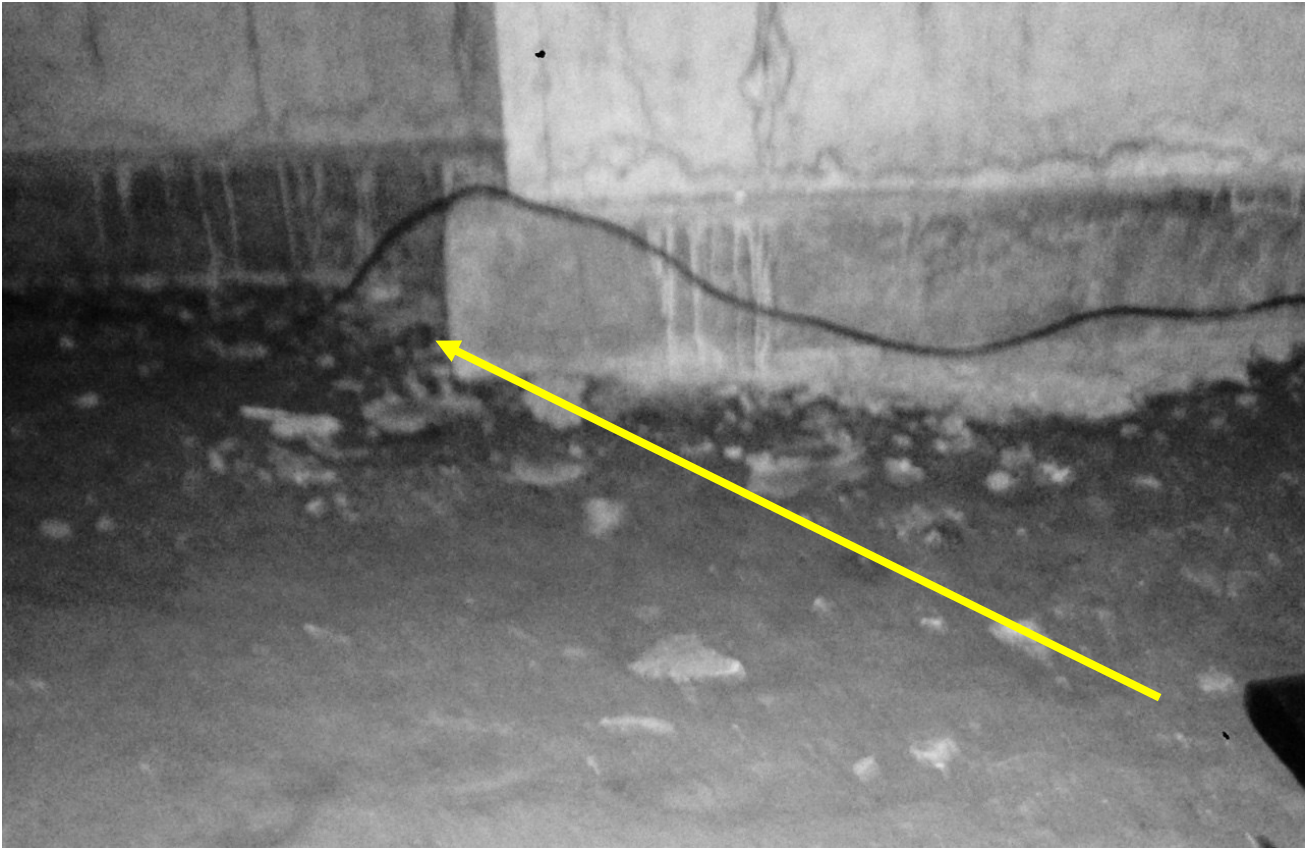
Photos Taken: 10/01/2015 @ approximately 4:30 pm

Chad Zandstra Construction arranged a follow-up meeting with the affected homeowner at approximately 4:00 pm on October 1, 2015 to re-enter the crawl space and reevaluate the conditions and confirm the new dehumidifier was operating efficiently. Upon inspection we discovered the dehumidifier had been unplugged and the salt water residue

was still present. The inspection underneath the vapor barrier showed improvements to the condition of the crawl space but we're unsure as to when and how long the dehumidifier was not operating. Before leaving the property the dehumidifier was plugged back in and functioning properly.

Image shows dehumidifier power cord unplugged lying on crawl space floor.

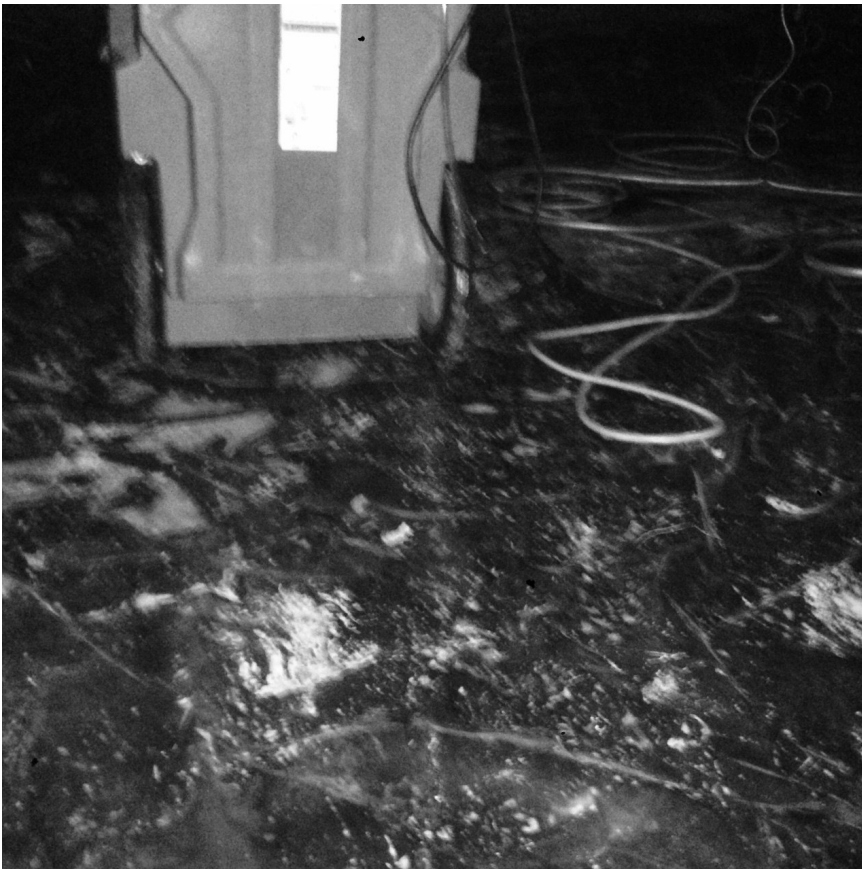
Photos Taken: 10/01/2015 @
approximately 4:30 pm

Image shows new dehumidifier.
