SOUTH DAKOTA HISTORIC SITES INVENTORY

Address/
Location 1316 West Boulevard

Date(s) of Construction circa 1914

Site Number
PN -RC -RC -WB -00379
CTY TWP CIT NBH NUM

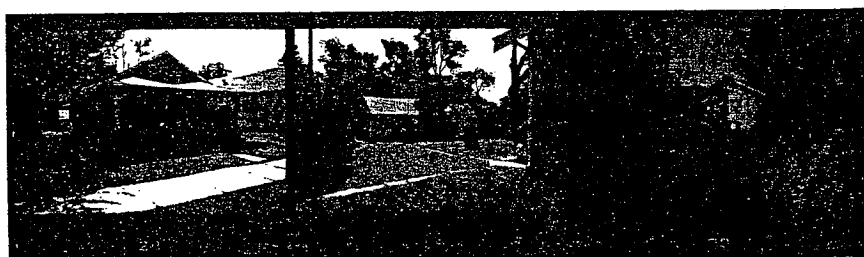
Photographer D. Martin
Roll # 1 Frame #'s 28-30
(Attach Photographs Below)

Function House	Plan Form Rectangular	Height (Stories) 1
	Method of	Overall
Style Vernacular	Construction Wood-frame	Condition E

Modern alterations: rear porch was removed and replaced by a wood deck and sliding glass door; metal-sash storm windows; and new front (west) door

Foundation: Materials Cinder block Condition E

Walls: Cladding Clapboard siding Condition E

Windows: General/	Type	Glazing	Condition	Location
Unique		Pattern		
G	Double-hung, wood-sash	1/1	E

Doors: Type	Glazing Pattern	Condition	Location
Hollow core	Single	E	West

Roof: Form Front gable Materials Asphalt shingles Condition E

Open: clapboard rails & columns E 1 Gable West

Porch: turned posts

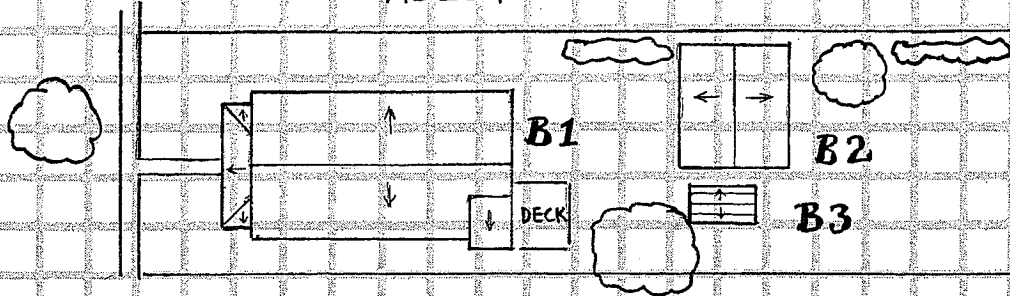
Site Plan: Indicate all door and window openings, roof shapes, and landscape features.

Appears to be garage on 1923 & 1930 Sanborns but has been turned 180 degrees towards the alley

WEST BLVD.

ALLEY
