SOUTH DAKOTA HISTORIC SITES INVENTORY

Historic Name Clarence & Marie Carpenter House

Address/Location 1501 West Boulevard

Date(s) of Construction 1939

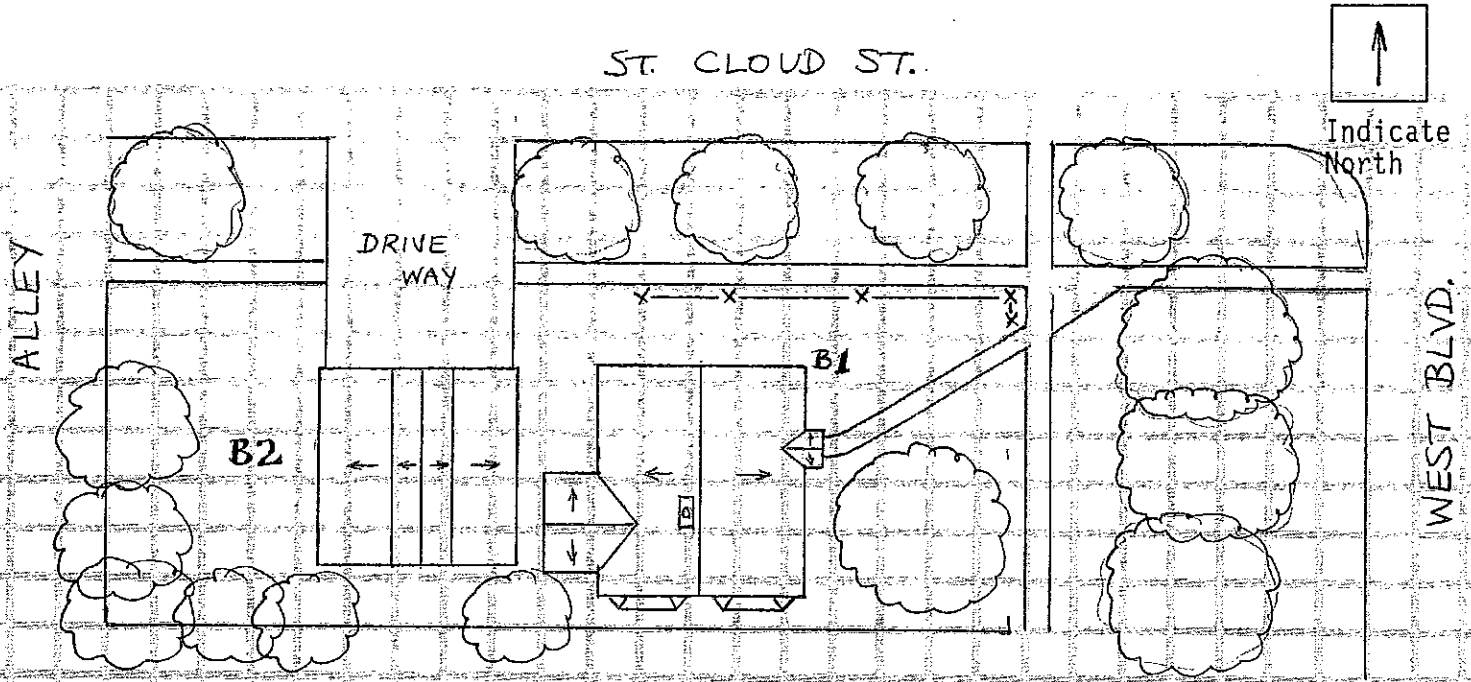
Site Plan: Indicate all door and window openings, roof shapes, and landscape features.

Site No. PN-RC -RC-WB-00466 Date of Construction 1939 Photos 20 & 23
 Function House Plan Form Rectangular + wing Height (Stories) 1.5
 Style Minimal Traditional Method of Overall
 Construction Wood-frame Condition E

Garage stalls at center and west, and carport at east
