**SOUTH DAKOTA HISTORIC SITES INVENTORY**

**Name** Charles & Elsie Sisk House

**Location** 1016 12th Street

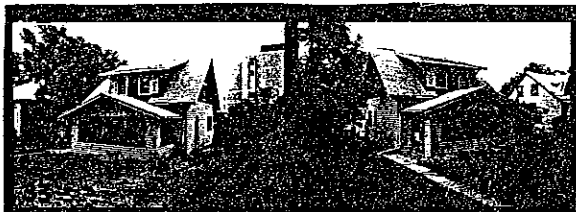
Site No. PN-RC -RC-WB-00255 Date of Construction 1923 Photos 33  
 Function House Plan Form Square Height (Stories) 1.5  
 Style Craftsman Bungalow Method of Construction Wood-frame Overall Condition E

Foundation: Materials Concrete Condition E  
 Walls: Cladding 4" Clapboard Condition E  
 Windows: General/ Type Glazing Pattern Condition Location  
 Unique  
 G Double-hung, wood-sash 1/1 E

Doors: Type Glazing Pattern Condition Location  
 Craftsman Vertical lights E West

Roof: Form Gable Materials Asphalt shingles Condition E  
 Dormer: Type Shed Condition E  
 Location(s) West

Chimneys/Ventilators: Materials Brick chimney Condition E  
 Location(s) Interior: off ridge

Enclosed: clapboard & windows E 1 Front gable West

Cladding: wood shingles on gable ends & dormers

Knee braces in gables
