SOUTH DAKOTA HISTORIC SITES INVENTORY

Address/Location 1305 W. Main Street

Historic Function House

Date(s) of Construction Circa 1925

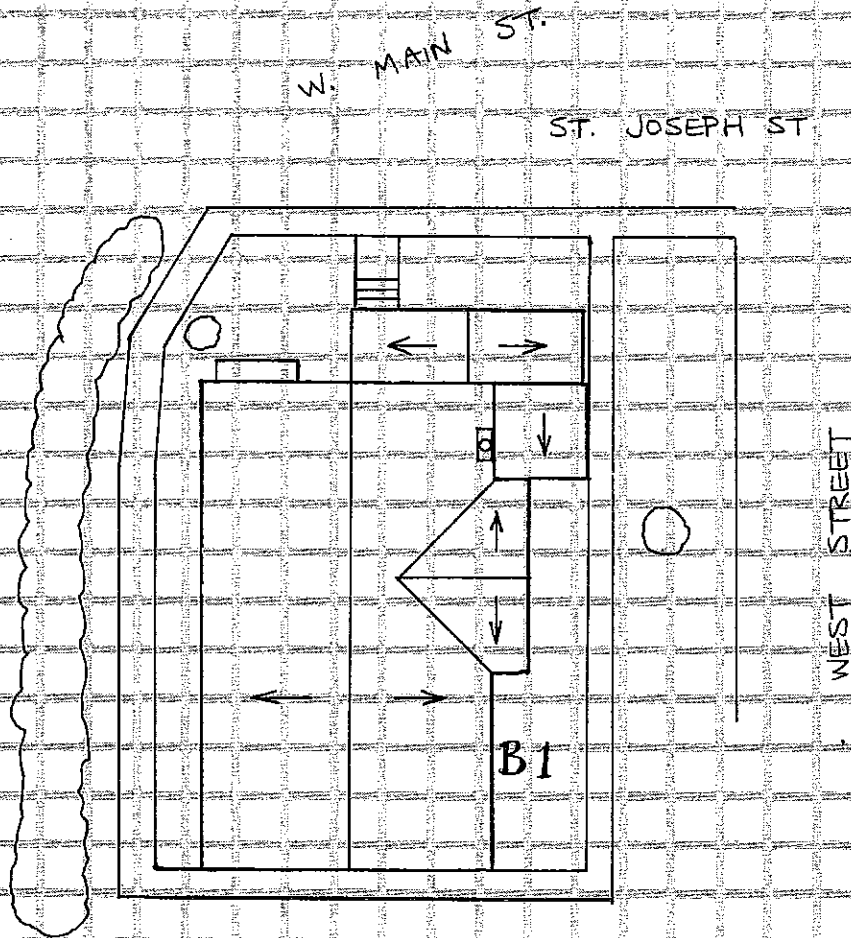
Site Plan: Indicate all door and window openings, roof shapes, and landscape features.

Function House	Plan Form Rectangular	Height (Stories) 1
	Method of	Overall
Style Craftsman Bungalow	Construction Wood-frame	Condition E

Modern vestibule on east

Bays/Towers: Form	Condition	Height(Stories)	Location(s)
Square bay	E	1	East
Square bay	E	1	North
