SOUTH DAKOTA HISTORIC SITES INVENTORY

Historic Name Edwin & Minnie Lighter House

Address/Location 1815 9th Street

Site No. PN-RC -RC-WB-00559 Date of Construction 1937 Photos 8-11
 Function House & Garage Plan Form Irregular Height (Stories) 2
 Method of Overall
 Style Colonial Revival Construction Wood-frame ? Condition E

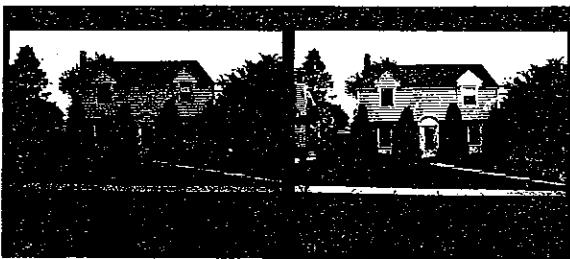
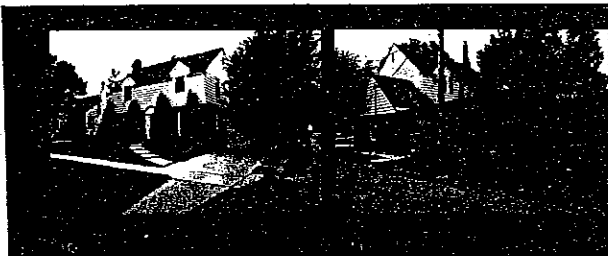
Photographer M. McCormick
Roll # 17 Frame #'s 8-11
(Attach Photographs Below)

2nd story resided, one-story rear wing (west) enlarged to west with fixed windows and panel in-fill, and two shed additions added to rear (west) of the original attached garage: modern alterations

Walls: Cladding Brick on 1st story Condition E

Windows: General/ Unique	Type	Glazing Pattern	Condition	Location
G	Double-hung, wood-sash	6sq/6sq		E 2nd story
G	Fixed, wood-sash	4x3		E 1st story
U	Casement	Single		E W. wing

Doors: Type	Glazing Pattern	Condition	Location
Wood-paneled	sm. arched lights	E	East

Roof: Form Side gable Materials Wood shingles Condition E

Dormer: Type Wall: gable roofed Condition E
 Location(s) 2 on east slope and 2 on west slope

Chimneys/Ventilators: Materials 2 brick chimneys Condition E
 Location(s) Exterior: south wall; interior: west

Porches: Materials	Condition	Height (Stories)	Roof Configuration	Location
Open: brick & concrete stoop	E	0	None	East
Open: post balustrade	E	0	None	W. wing

Cladding: horizontal steel siding on 2nd story

Windows: 1st story openings on facade (east) have a paneled wood below the window

Front door (east): wooden surround with fluted pilasters and round-topped cornice

Roof: steep pitch; and narrow, boxed eaves

West wing: one-story; brick cladding (original portion); and flat roof serving as porch balcony

Attached garage (north): original garage has a concrete foundation; brick cladding; paneled, overhead garage door; 6sq/6sq double-hung windows; and a steeply-pitched side gable roof. It has been enlarged to the west by a large ashlar-clad addition which in-turn is adjoined to the north by a vertical-siding clad addition; the additions are under a common flat roof and both apparently function as sheds
