SOUTH DAKOTA HISTORIC SITES INVENTORY

Historic Name Charles & Erma Homer

Address/Location 817 9th Street

Site Number
PN- RC -RC -WB-00140
CTY TWP CIT NBH NUM

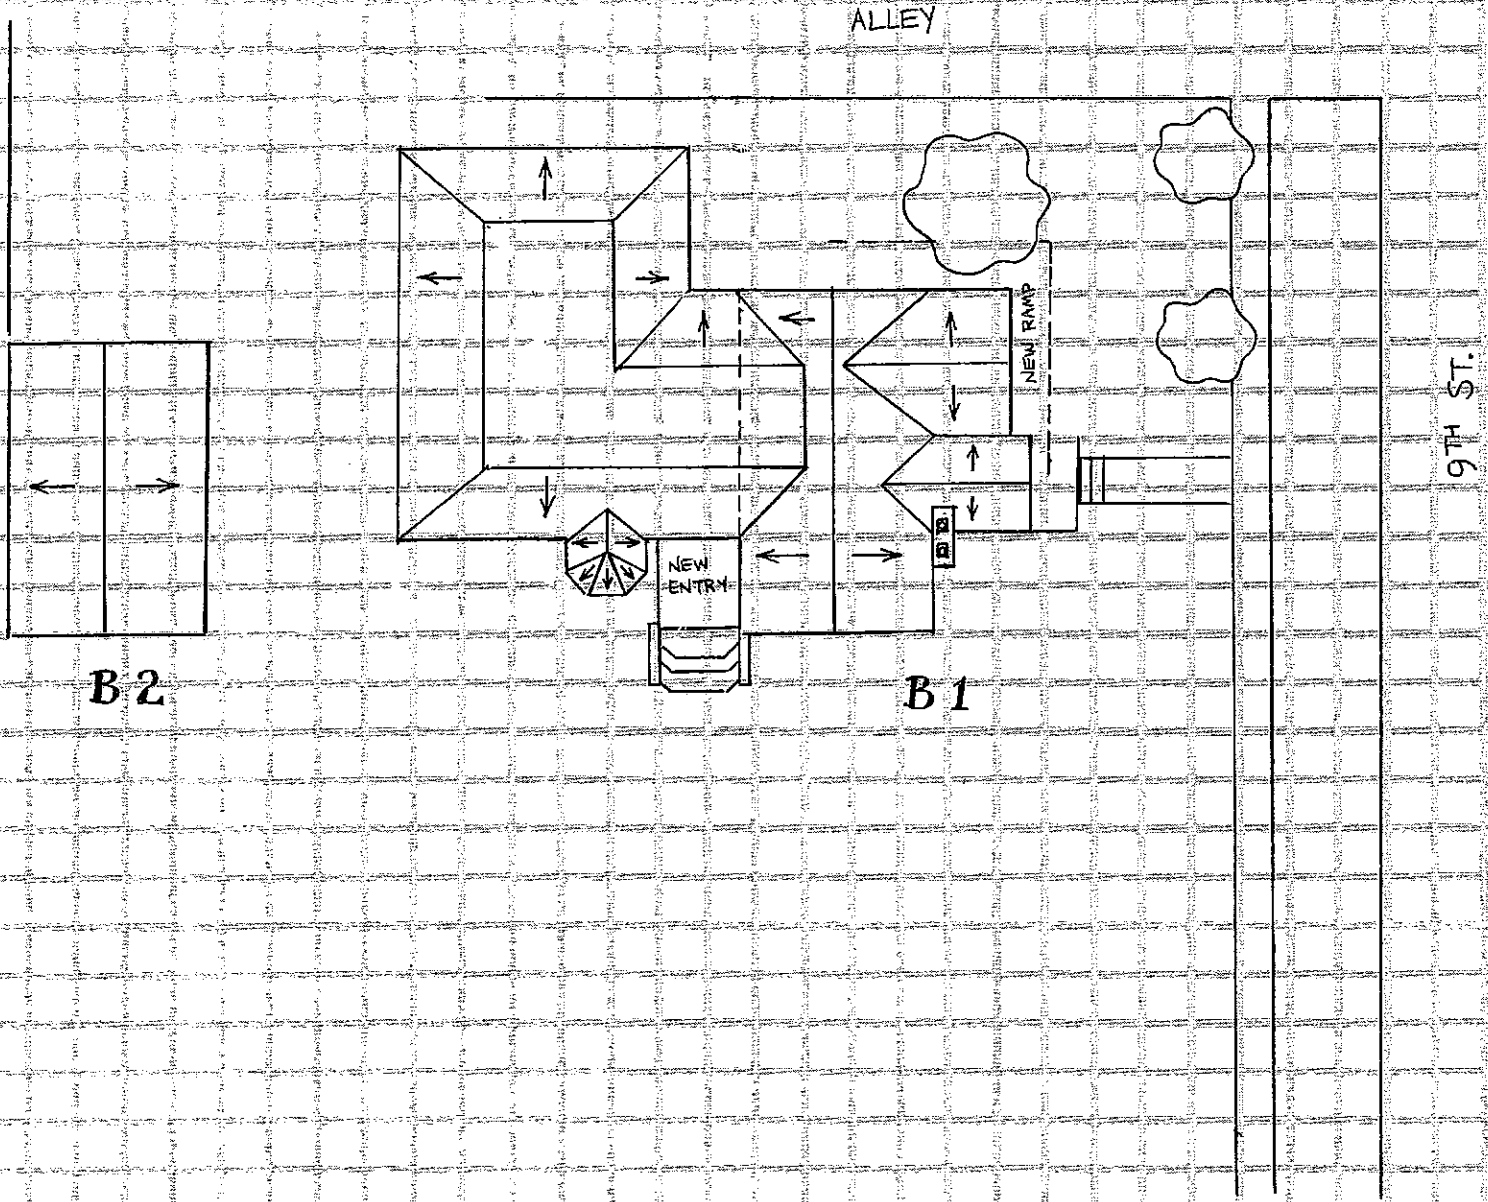
Site Plan: Indicate all door and window openings, roof shapes, and landscape features.

Function Office Plan Form Rectangular Height (Stories) 1
 Method of Overall
 Style Picturesque: Tudor Construction Unknown Condition E

New large addition on rear (west) is modern but of compatible design;
 modern ramp provides handicapped access

Bldg#	Date	C/NC	Function	Photo#	Construction Method	Height
2	c.1937	C	Garage; 2 stall	26	Wood-frame	1
