SOUTH DAKOTA HISTORIC SITES INVENTORY

Historic Name Ida Giberson House

Address/Location 1020 St. Cloud Street

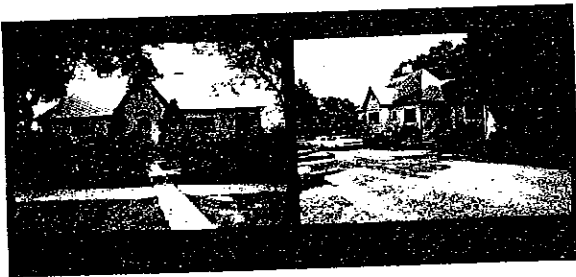
Photographer D. Martin
Roll # 2 **Frame #'s** 20A, 21A, & 34
(Attach Photographs Below)

Site No. PN-RC -RC-WB-00453 Date of Construction 1929 Photos 20-21A
 Function House & garage Plan Form Irregular Height (Stories) 1
 Style French Eclectic Method of Overall
 Construction Wood-frame Condition E

Garage: located at the basement level under northeast corner of house; access via garage opening on north

Front vestibule (south): slightly recessed entry with segmental arch lintel

Roof: narrow, boxed eaves; shingles are scalloped

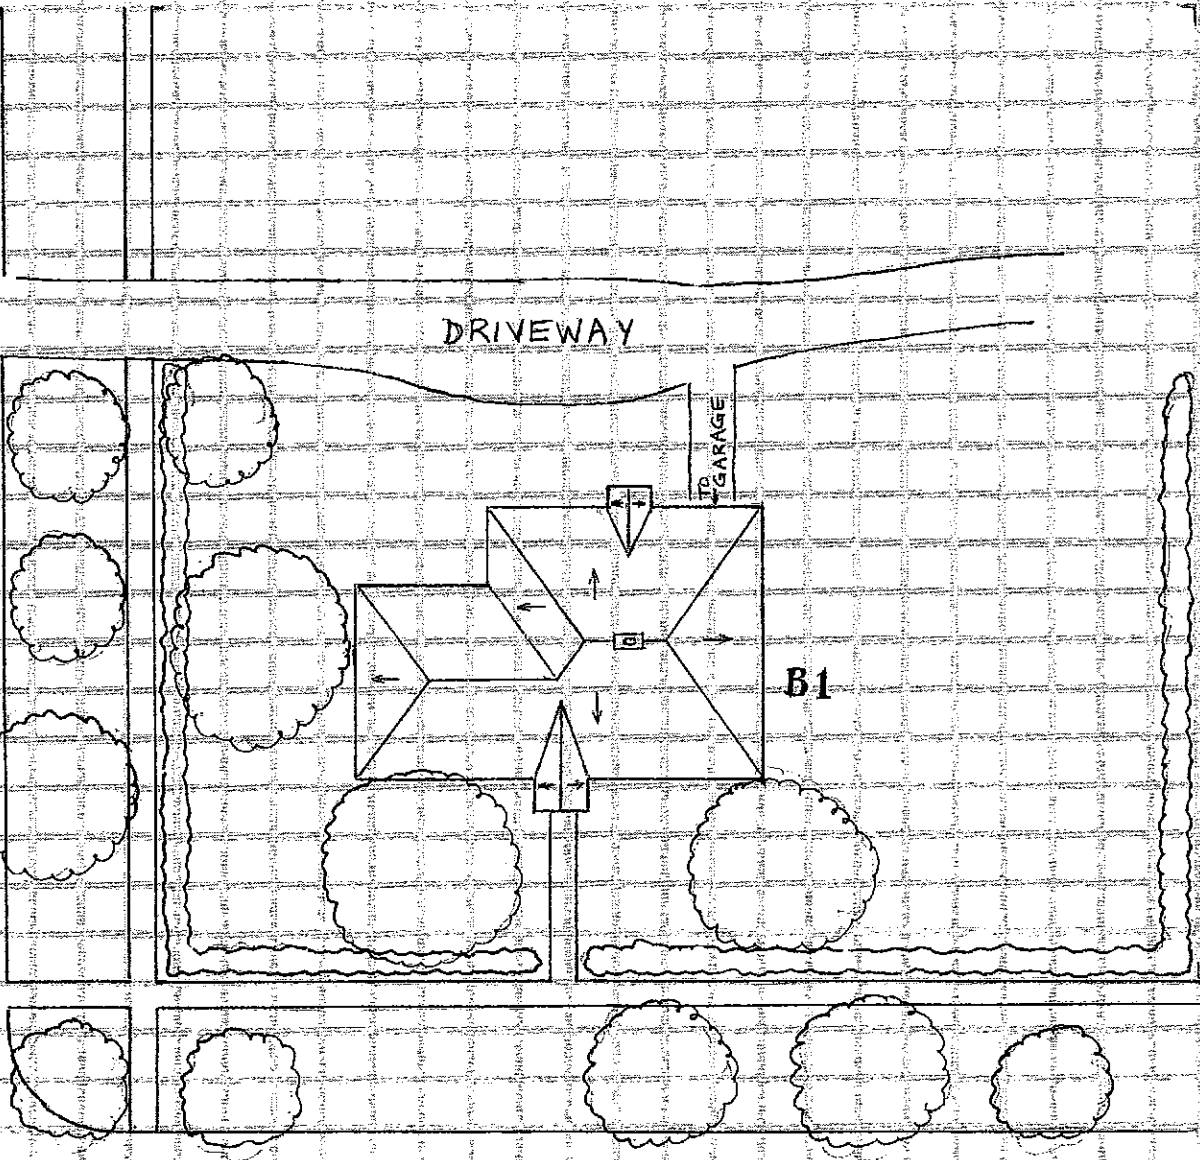
Site Plan: Indicate all door and window openings, roof shapes, and landscape features.

ALLEY

117TH ST.

DRIVEWAY

TO GARAGE

B1

ST. CLOUD ST.
