SOUTH DAKOTA HISTORIC INVENTORY

Historic Name Brown House

Location 717 South St.

Dates of Construction and Founding
1892

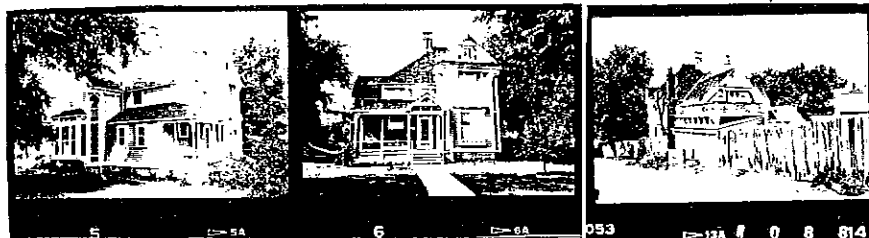
The Brown House is a two-story, gable-fronted Queen Anne building with clapboard siding. The gable front has canted corners with ornate brackets and narrow $\frac{1}{2}$ double hung windows at the top. A pair of north-facing windows, one on each floor, have bracketed hoods. Patterned shingles flank the upper window and the top of the gable. There is a gabled entry and hipped porch supported by turned posts with decorative brackets. Windows are double hung sash, some with stained glass.
