**SOUTH DAKOTA HISTORIC SITES INVENTORY**

Address/  
Location 811 St. Andrew Street

Site Number  
PN -RC -RC -WB -00536  
CTY TWP CIT NBH NUM

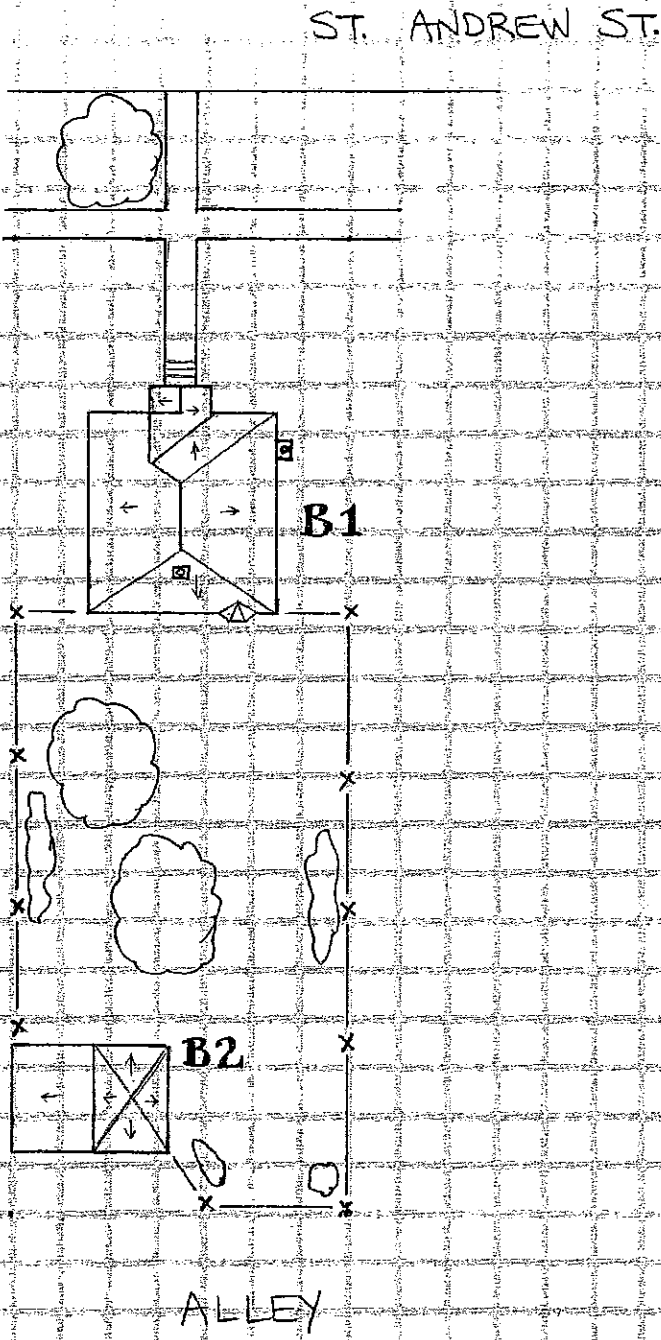
Site Plan: Indicate all door and window openings, roof shape ( ) and landscape features.

Function House	Plan Form Near square	Height (Stories) 1
	Method of Construction Wood-frame	Overall Condition E
Style Vernacular

Additions & Alterations (Types & Dates)  
 Modern exterior chimney on east wall

Bldg#	Date	C/NC	Function	Photo#	Construction Method	Height
2	c.1941	C	Garage	16	Wood-frame	1

Modern shed-roofed carport on west
