SOUTH DAKOTA HISTORIC SITES INVENTORY

Name Elsie White House

Location 1421 West Boulevard

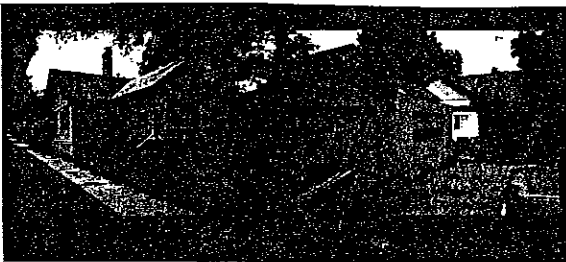
Function House	Plan Form Irregular	Height (Stories) 1
	Method of	Overall
Style Craftsman	Construction Wood-frame	Condition E

Sanborn maps indicate the main, front-gable unit was the original house. About 1930 this house was enlarged with a large gabled-addition on the west. Since then the front porch (east) has been enclosed and vestibule added on its north, and a gabled-wing added at the rear of the house at the NW corner.

Front porch (east): vestibule addition on north is under an extension of the porches' gable, creating an overall asymmetrical gable roof

Roof: open eaves with wide overhangs, exposed rafter tips, and knee braces at gables
