SOUTH DAKOTA HISTORIC SITES INVENTORY

**Address/
Location** 1301 11th Street

**Historic
Function** House

Date(s) of Construction 1922

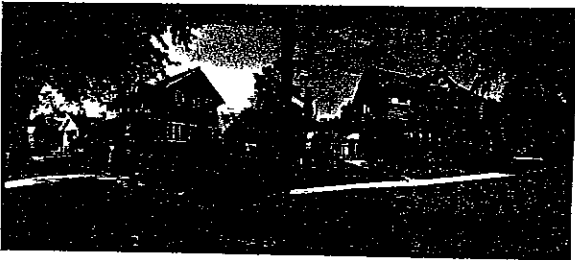
Photographer D. Martin
Roll # 1 **Frame #'s** 2-3 & 16
(Attach Photographs Below)

Site No. PN-RC -RC-WB-00401 Date of Construction 1922 Photos 2-3, 16
 Function House Plan Form Rectangular Height (Stories) 2
 Style Craftsman Method of Construction Wood-frame Overall Condition E

Some modern replacement windows (casements on north and front porch) and modern rear door (west)

Foundation: Materials Concrete Condition E

Walls: Cladding Clapboard siding - 1st story Condition E

Windows: General/Unique	Type	Glazing Pattern	Condition	Location
G	Double-hung, wood-sash	1/1 & 6/6	E	
U	Casement	Single	E	E. porch
U	Casement	Single	E	North

Doors: Type	Glazing Pattern	Condition	Location
Modern	6 lights	E	West
Wood-paneled	2 lights	E	East

Roof: Form Side gable Materials Wood shingles Condition E

Dormer: Type Roof: gable-roofed Condition E
 Location(s) East slope

Chimneys/Ventilators: Materials Stucco chimney; metal vent Condition E
 Location(s) Interior: west slope; interior: on ridge

Porches: Materials	Condition	Height (Stories)	Roof Configuration	Location
Enclosed: wood shingles	E	1	Hip	East

Walls: wood shingle cladding - 2nd story

Roof: open eaves with wide overhangs, exposed rafter tips,
and knee braces at gables

Front porch: clapboard siding, and windows
