SOUTH DAKOTA HISTORIC SITES INVENTORY

Historic Name Bert & Marguerite Flisnes House

Address/Location 1819 West Boulevard

Date(s) of Construction circa 1936

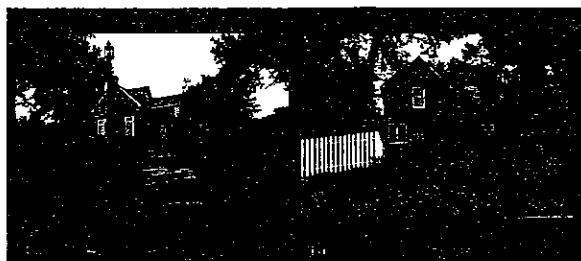
Function House Plan Form T-shaped Height (Stories) 2
 Method of Overall
 Style Picturesque Construction Wood-frame Condition E

Porch on east and wrapping around to the north has been enclosed with modern windows

Windows: General/ Unique	Type	Glazing Pattern	Condition	Location
G	Casement, wood-sash	2x4 & 3x4	E	
G	Double-hung, wood-sash	6/6	E	
U	Fixed w/ transom	2x3/3x5	E	E wing

Roof: Form Cross gable Materials Cedar shakes Condition E

Roof: steep pitch; and boxed eaves with slight overhangs

Setting: house is on a rise and setback a hundred feet or more from West Boulevard. It is surrounded by a large lawn landscaped with many mature trees and bushes. A flagstone retaining wall runs along the east side of the property along West Boulevard, and a flagstone sidewalk links the house and the avenue.

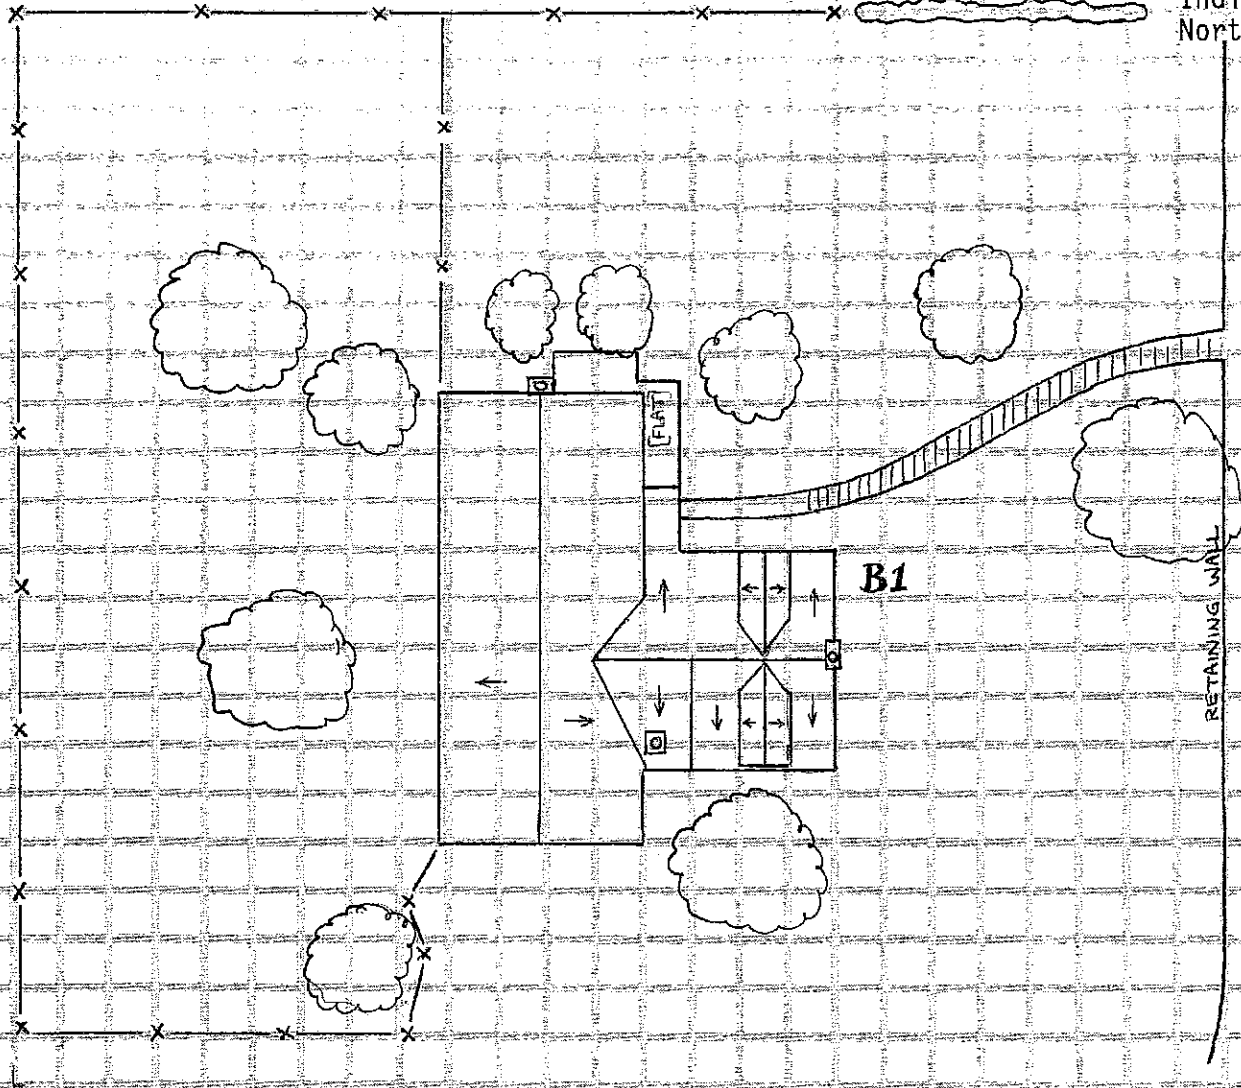
Site Plan: Indicate all door and window openings, roof shapes, and landscape features.

ALLEY

ST. PATRICK ST.

WEST BLVD.

RETAINING WALL
