**SOUTH DAKOTA HISTORIC SITES INVENTORY**

**Address/  
Location** 1518 West Boulevard

Site No. PN-RC -RC-WB-00480 Date of Construction 1924 Photos 5, 6

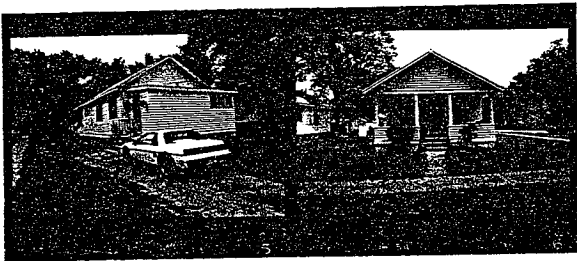
**Photographer** M. McCormick  
**Roll #** 10 **Frame #'s** 5 & 6  
(Attach Photographs Below)

Function House Plan Form Rectangular Height (Stories) 1  
 Method of Overall  
 Style Craftsman: bungalow Construction Wood-frame Condition E

Foundation: Materials Concrete Condition E

Walls: Cladding Clapboard siding Condition E

Windows: General/ Unique	Type	Glazing Pattern	Condition	Location
G	Double-hung, wood-sash	4v/1	E	
U	Fixed	4 light	E	R. porch
U	Fixed, wood-sash	6v	E	South

Roof: Form Front gable Materials Asphalt shingles Condition E

Chimneys/Ventilators: Materials Brick chimney Condition E  
 Location(s) Interior: on ridge

Porches: Materials	Condition	Height (Stories)	Roof Configuration	Location
Enclosed: clapboard siding	E	1	Shed	West
Open: clapboard rails	E	1	Inset	West

Roof: open eaves with wide overhangs, and exposed rafter tips

Front porch (west): slightly tapered square columns
