SOUTH DAKOTA HISTORIC SITES INVENTORY

Name Fred & Orene Meyer

Location 1423 9th Street

Date(s) of Construction circa 1924

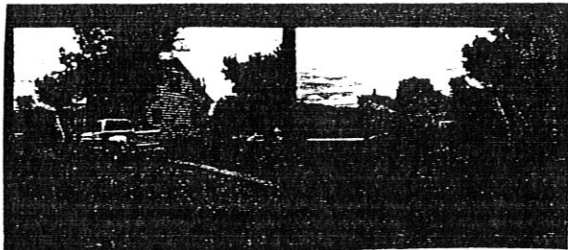
Site No. PN-RC -RC-WB-00447 Date of Construction c.1924 Photos 21-22

| Function Apartments | Plan Form Rectangular | Height (Stories) 1.5 |
| Style Vernacular | Method of Construction Wood-frame | Overall Condition E |

Original rear porch (west) was replaced by an exterior staircase and vestibule at rear dormer: these were modern alterations likely for conversion of the house into apartments
