SOUTH DAKOTA HISTORIC SITES INVENTORY

Name Fred & Orene Meyer

1423 9th Street

Date(s) of Construction circa 1924

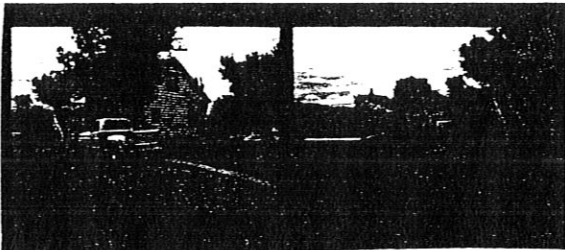
Roll # 8 Frame #'s 21-23
(Attach Photographs Below)

Function	Apartments	Plan Form	Rectangular	Height (Stories)	1.5
Style	Vernacular	Method of Construction	Wood-frame	Overall Condition	E

Original rear porch (west) was replaced by an exterior staircase and vestibule at rear dormer: these were modern alterations likely for conversion of the house into apartments

Roof: boxed eaves with partial returns

Front porch (east): lattice wall on east, and concrete stoop
