623 West Street

623 West Street (Currently vacant (Boarded-Up), (Contributing Structure): The property at 623 West Street has not been found to fit within an adaptive re-use model in the development plan for the property. The proposed development plan necessitates the removal of this structure.

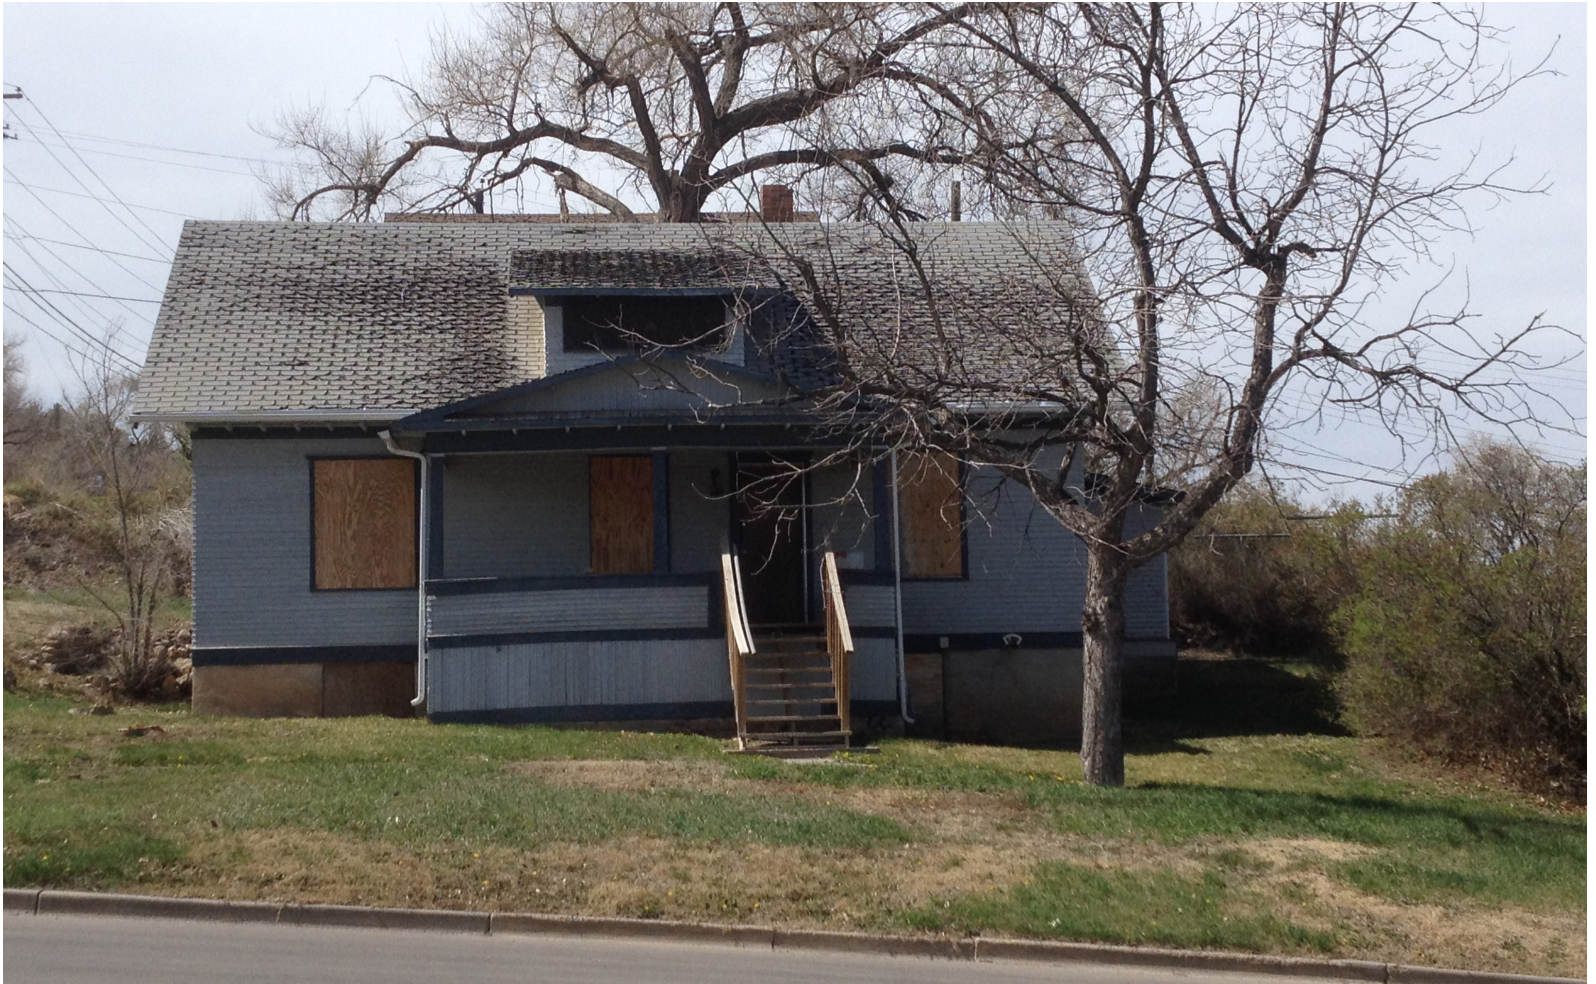
The property has been broken into, and the damage within and without has made it not feasible nor prudent to rehabilitate.

Physical Notes: The one-and-one-half-story Craftsman style house has a concrete foundation, historic wood siding and an asphalt shingle side-gable roof with open eaves and angled wood brackets. A shed-roof wing projects from the north elevation. A shed-roof dormer rises on the east slope of the roof. A brick chimney rises on the west slope of the roof. A gabled porch with wood siding-clad kneewalls and square wood columns projects from the primary (east) elevation. Four bays covered with plywood panels organize this elevation.

To mitigate harm to the residence itself, the owner has agreed to award the house to anyone wishing to relocate it. To move this house within the district has not been shown to be an available option as the current setbacks preclude a house of this size from being adaptable to any of these vacant properties. After marketing the house to the public, if no person or business can utilize the house, the request for demolition is still requested. The owners have investigated mitigation to the adverse effect if demolition is the remaining option and will contact builders and salvage operations to salvage any structurally sound and historically significant features that remain prior to demolition. Also, in the case of demolition, the house and the property will be documented for archival purposes to establish a record for historic preservation interests.
