MEMORANDUM

SUBJECT: 5th Street Pedestrian Crossing Study
Fairmont Boulevard to Oakland Street

DATE: October 5, 2009

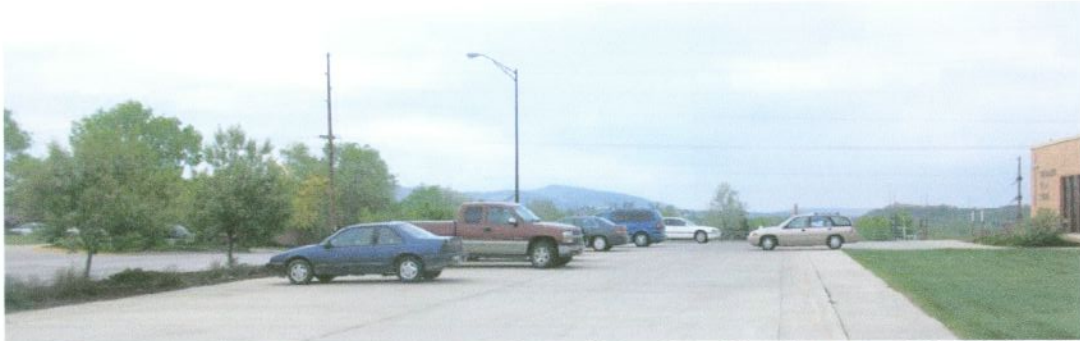
Figure 2. Cars parked in the St. Elizabeth Seton School parking lot east of the Cathedral 5/23/09.

The majority of visitors to the Cathedral are those that attend regularly scheduled weekend services and those for funerals and weddings which are scheduled individually. Figure 2 shows the cars parked on 5/23/09 for the 5:30 p.m. Saturday services.

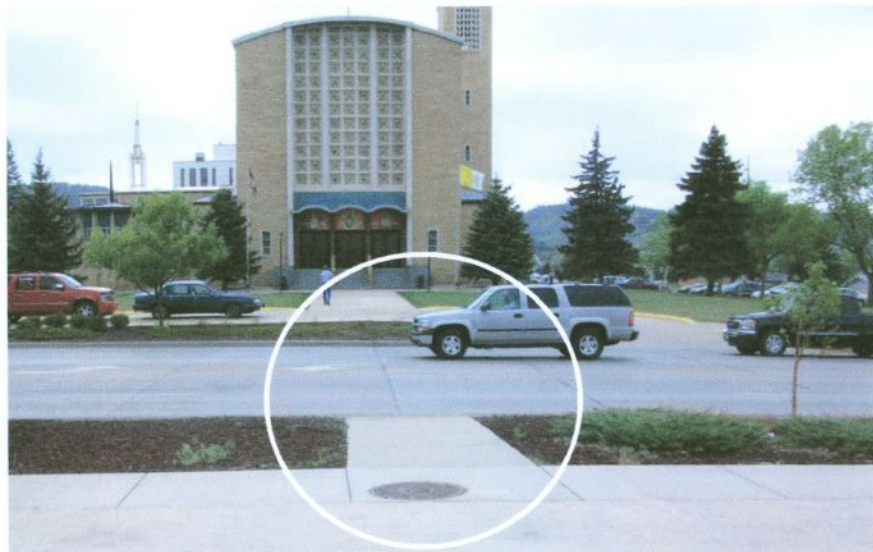
Figure 3. Inferred crossing sidewalk from the parking lot east of the Cathedral.

The majority of those who parked in the lot used an existing sidewalk running east to west on the edge of the lot. This inferred crossing area is clearly shown in Figure 3. Figure 4 shows a family dodging cars in 5th Street after using the inferred crosswalk.

- Install a user activated crosswalk at the inferred crosswalk shown in Figure 3.
- Reduce the speed limit from the current 30 mph to 25 mph (or less).
- Install automated flashing lights (reduces speed limit to 15 mph) that coincide with the start and end periods of the weekend services.

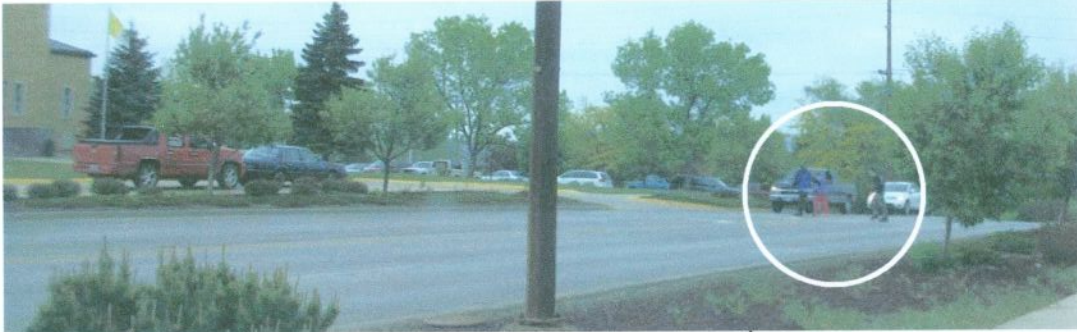
Figure 4. Family walking in front of vehicles while crossing 5th street from the inferred crossing area.

running across the Oakland/5th Street intersection to avoid on-coming vehicles. While the still shown in Figures 3 and 4 clearly indicate pedestrian traffic in jeopardy they in no way capture the running, dodging, bobbing and weaving I witnessed while observing pedestrians trying to cross this busy area on 5/23/09 and 5/24/09.

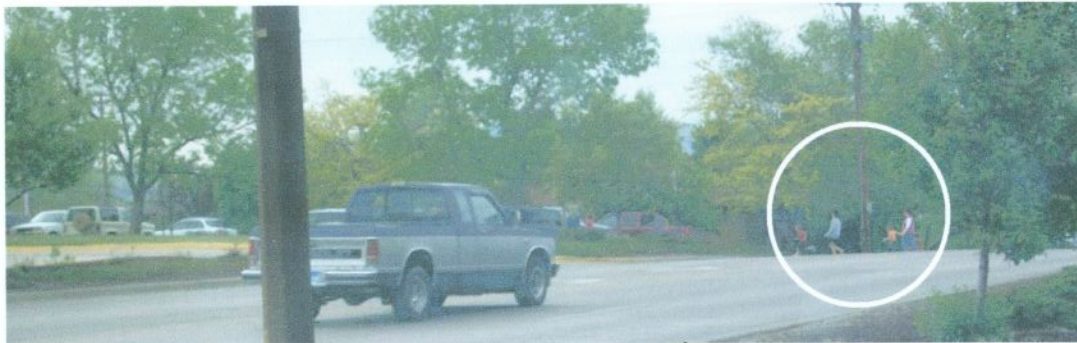
Figure 5. Family running through the Oakland Street/5th Street intersection on 5/24/2009.

In addition to those that cross in the area shown in Figure 4 some (those who live in the adjacent neighborhoods) cross directly at the Oakland/5th Street intersection. Figure 5 shows a family
