Rapid City Arterial Street Safety Study

Final Report

March 2012

FHU Reference No. 10-160-01
March 2012

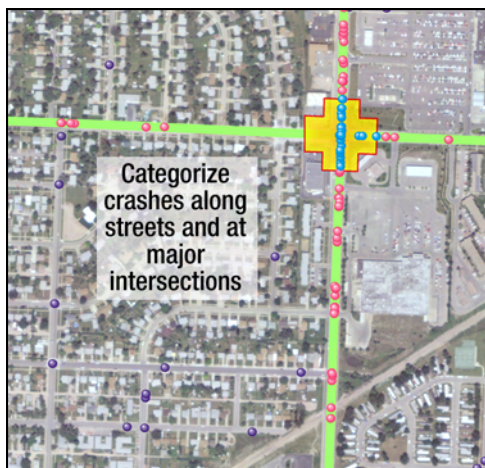
Figure 4. Classification of Crash Data Points

- Crashes were identified as occurring within a major intersection influence area or along an arterial segment, and those occurring at a major intersection were removed from further consideration. Crashes that occurred along each of the 249 arterial segments were retained for further study. **Figure 4** shows an example of arterial segment crashes as well as the intersection related crashes removed from the analysis.

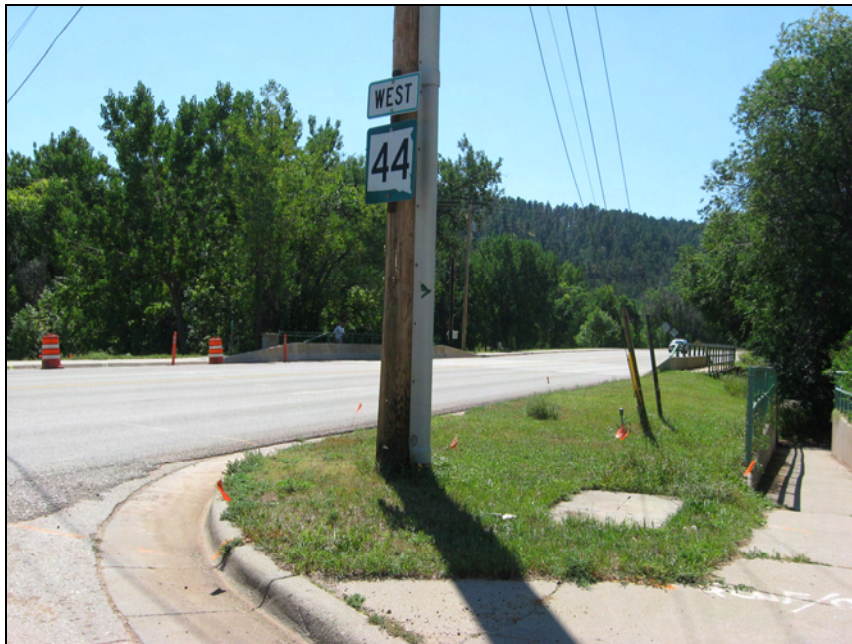
Figure 6. Jackson Boulevard and Cleghorn Canyon Road Sight Distance

In addition, consideration should be given to improving the sight distance for vehicles looking to the south from Cleghorn Canyon Road. **Figure 6** shows the current obstructions in place for vehicles at this intersection.

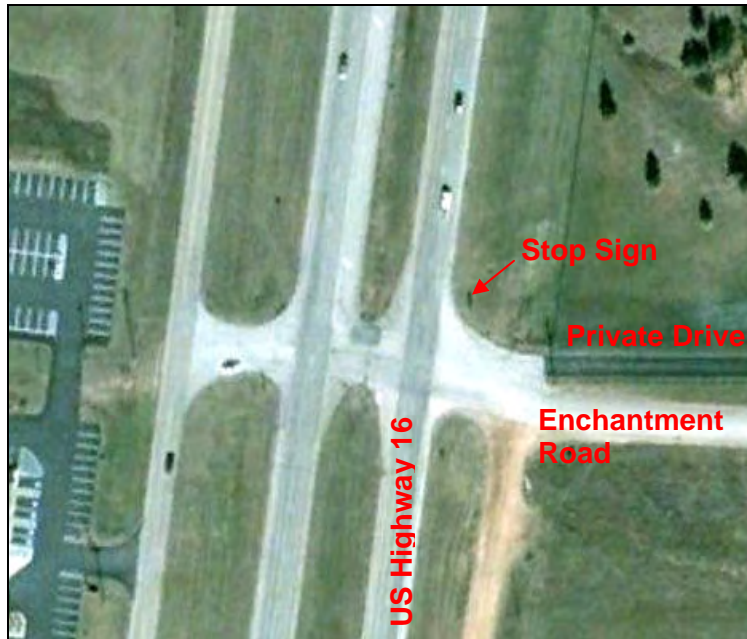
Figure 11. Intersection of US Highway 16 and Enchantment Road

There is currently a stop sign located on the right side of the westbound approach to this intersection. However, this sign is well to the right of approach due to a driveway that intersects Enchantment Road from the northeast at an angle (see **Figure 11**).

First, consideration should be given to relocating the intersection of the existing private drive further to the east so that it intersects with Enchantment Road in a more standard fashion. The width of the westbound approach can then be reduced which should help to improve the visibility of the existing stop sign. In addition, consideration should be given to installing oversized stop signs and an additional stop sign on the left side of the westbound approach of Enchantment Road. This should also help improve the visibility of the stop sign.
