CITY OF RAPID CITY

Community Planning & Development Services

Rapid City Community Walk Audit

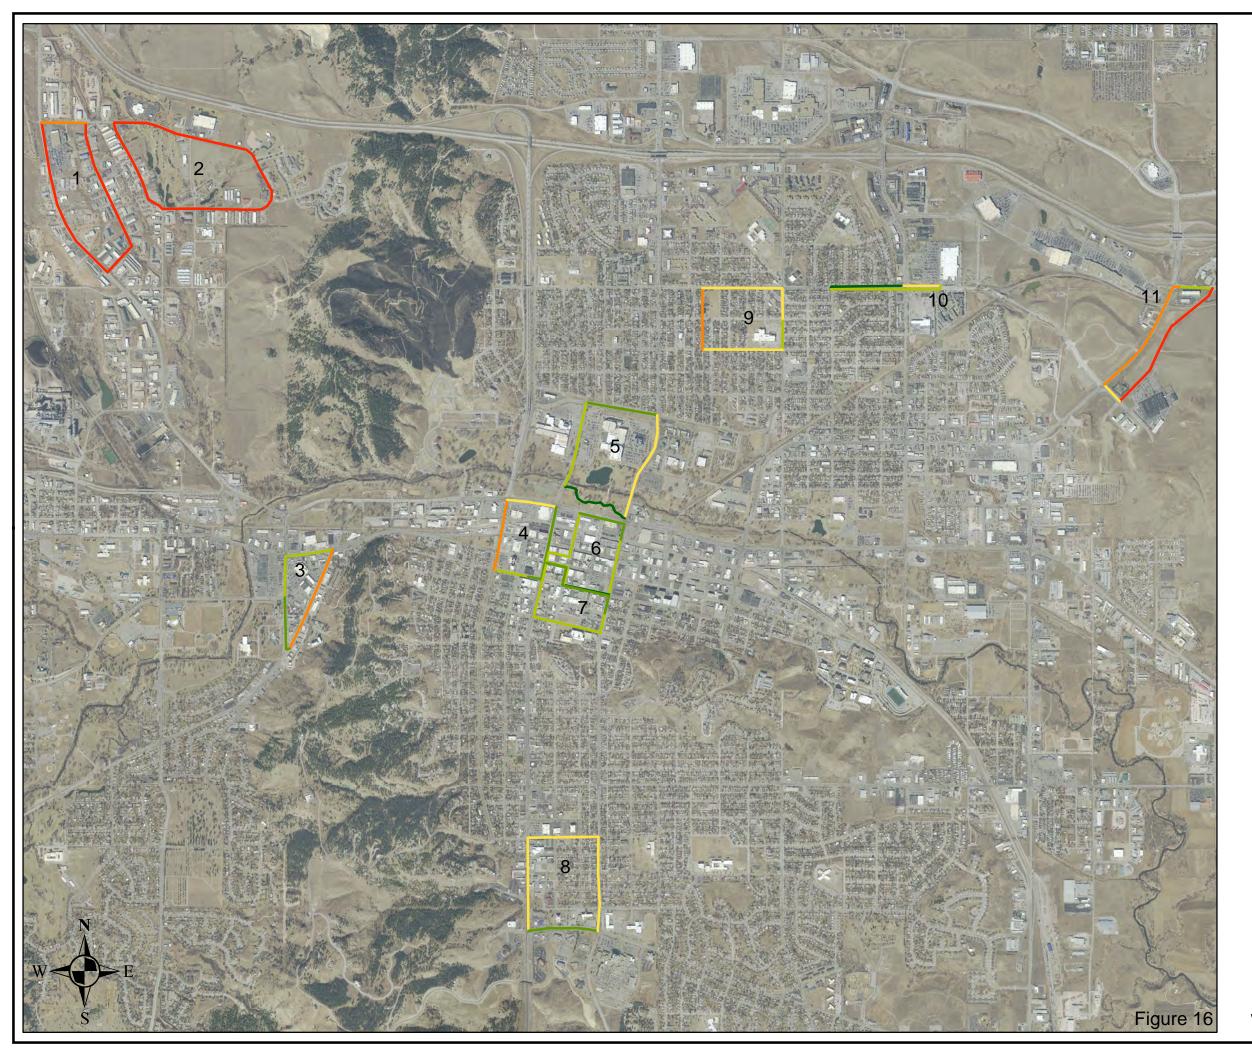
Q1: Rate the sidewalks

Routes 1 and 2 received very low scores when asked to rate the sidewalks. Much of this area does not have sidewalks, so those scoring were rating areas where most walk. Along Deadwood Avenue there is a dirt path that has been worn down from pedestrians and bicyclists. The southern portion of route 5 received one of the highest scores. This segment is through Memorial Park or along the bike path near Omaha Street. This area shows ideal conditions for walking: wide sidewalks, trees, and a sense of place has been created.

- Deadwood Avenue area (Routes 1 and 2) are in need of sidewalks
- Sidewalk connections from the bike path to the Deadwood Avenue area should be made
- Sidewalks should be installed near Feeding South Dakota, as well as sidewalk connection to the nearest bus stop
- Beautification near the downtown area creates a nicer walk and sense of place
- Countdown timers for crosswalks make walkers more comfortable
- Uneven and cracked sidewalks are dangerous and difficult, especially for the elderly and disabled
- Kansas City Street and the bike path are areas that walkers felt the most comfortable; and believed to have the best walking conditions

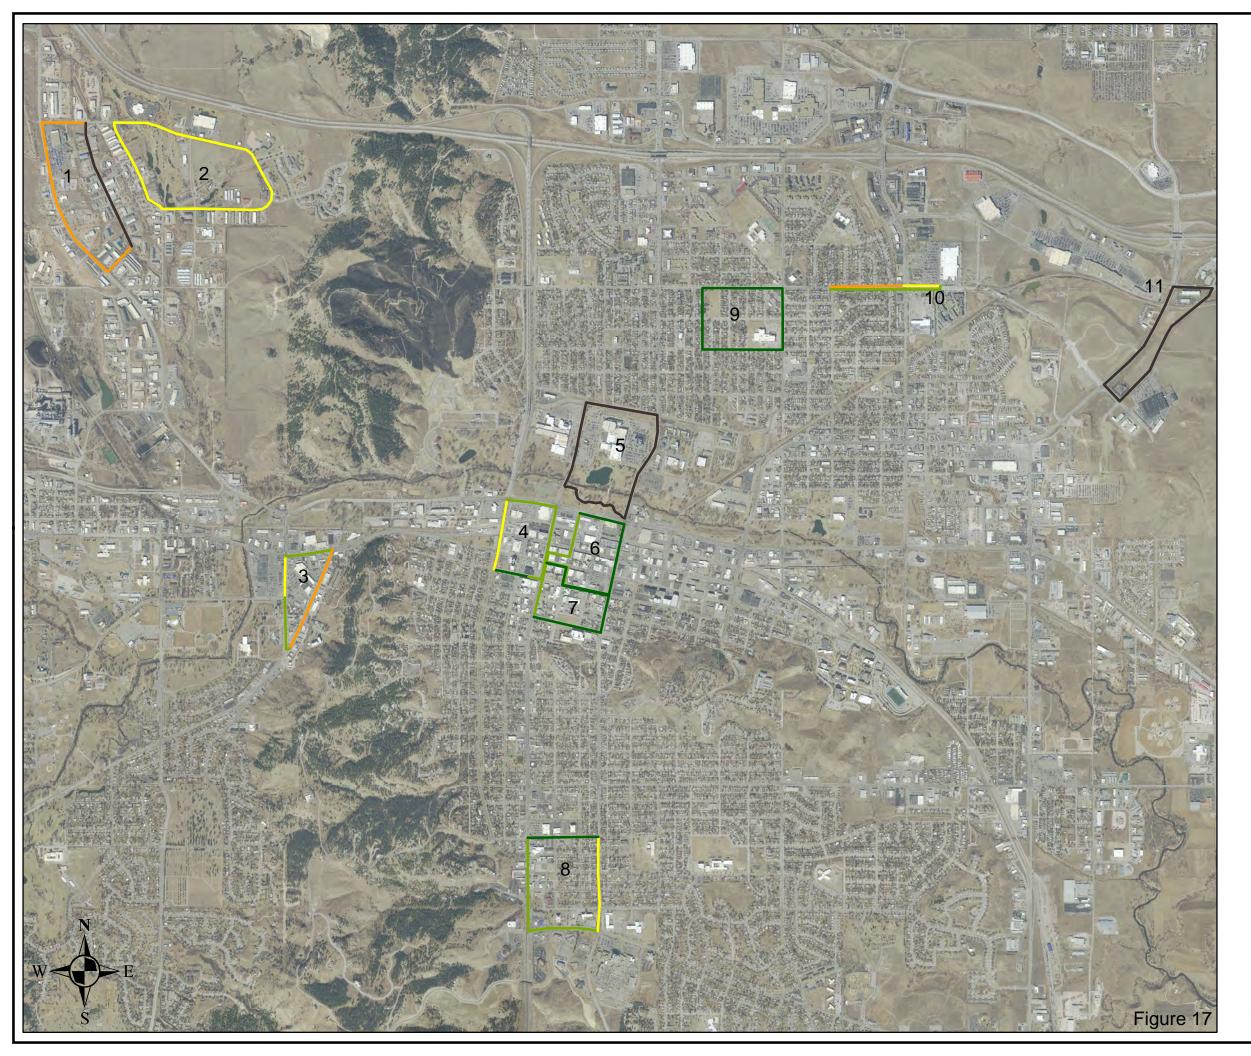
Q2: How was it to cross the street?

When asked "How was it to cross the street?", many of the downtown routes received great scores. These areas generally have crosswalks posted, whereas a crossing on route 10 received a poor score. The group walking this area was from Black Hills Works, both staff and those supported. The group began to cross when the a walk signal was received, and did not have time to finish the crossing on the walk signal. Luckily, the vehicle traffic was alert and did not proceed before the group finished crossing.

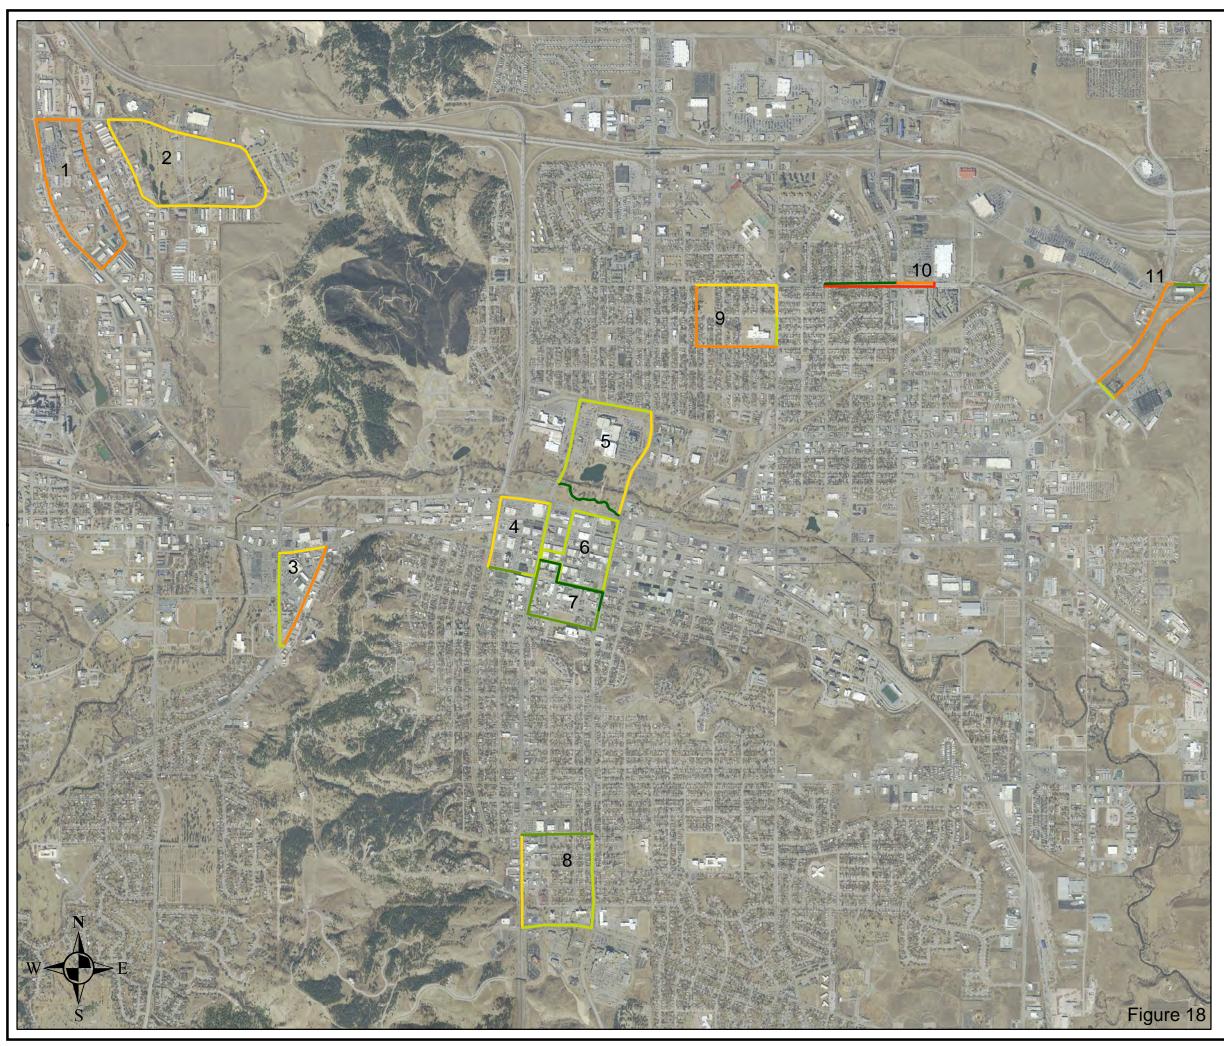
Q3: How comfortable were you walking in this area?

Figure 16 – Figure 21 show the results of the walk audits. The score sheets were returned to the City to be compiled and analyzed. The scores for each street segment were averaged and assigned a color. The best scores are represented in a green color, while the worst scores are represented in a red color on the figures. While reviewing the results, it is important to take note of a few trends that were identified through the walk audits. Some groups compared one street segment to another street segment, opposed to just scoring it based on how comfortable they felt. Some groups did not cross the street at all, as represented in black on the maps. When asking how "comfortable" an individual is walking in a certain area, it is important to note that most have a different definition on what is "comfortable". On questions that ask how "pleasant" the walk was, some stated that the company was great, which is why it received a higher score, but the walking conditions might not have been great.

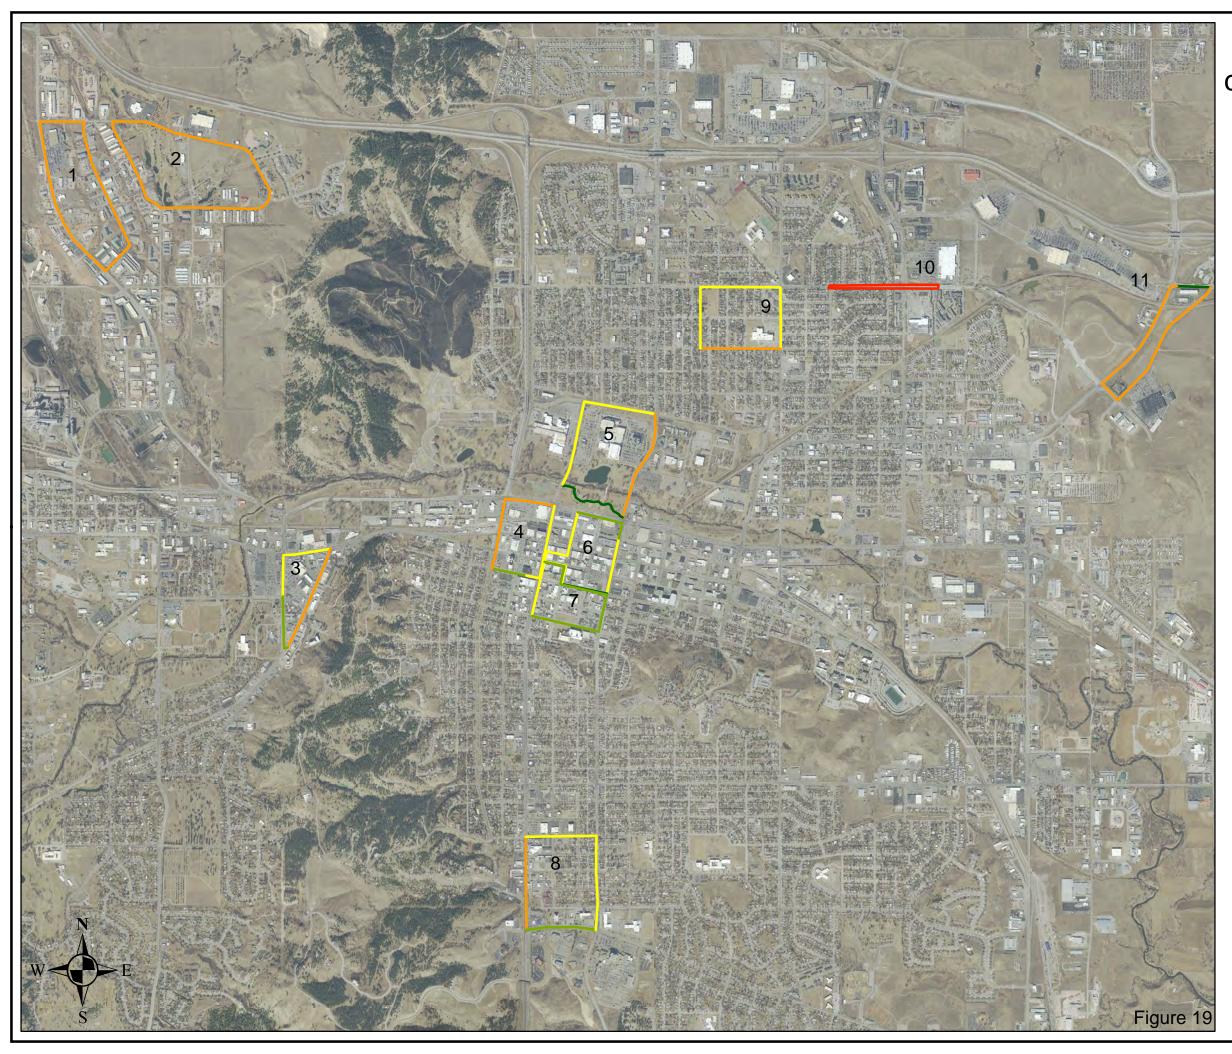
Q4: Rate this area for children, elderly, and disabled

Routes 1, 2, and most of 11 scored very poor when asked to "Rate this area for children, elderly and the disabled". These are all routes with a lack of sidewalks, as well as along busy streets.
