SOUTH DAKOTA HISTORIC SITES INVENTORY

Historic Name The James Clark House

Address/Location 1123 Fulton Street

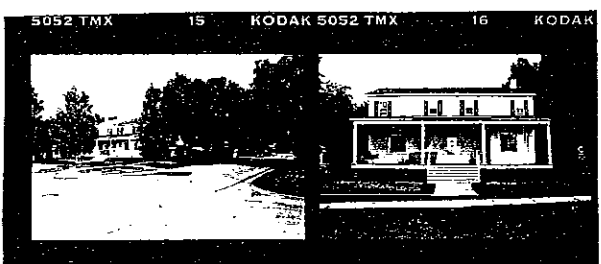
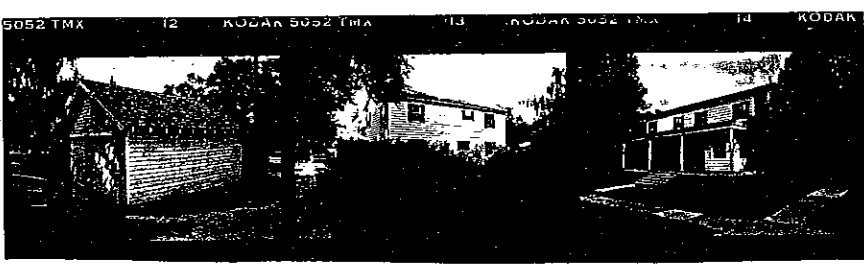
Photographer L. Johnson
Roll # 1 **Frame #'s** 12-16
(Attach Photographs Below)

Site No. PN-RC -RC-WB-00281	Date of Construction c.1909	Photos 16	Building #
Function House	Plan Form Rectangular	Height (Stories) 2	
Style Neo-Colonial Revival	Method of Construction Log	Overall Condition E

Foundation: Materials Sandstone; coursed

Walls: Cladding 8" Clapboard

Condition G	
	Condition E	
Glazing Pattern	Condition	Location
6/6	E	
4/4	G	North; Bay
Full light; storms	E	North

Foundation sandstone is ashlar-faced

Porch has lattice skirt

Window shutters have decorative arrow motif

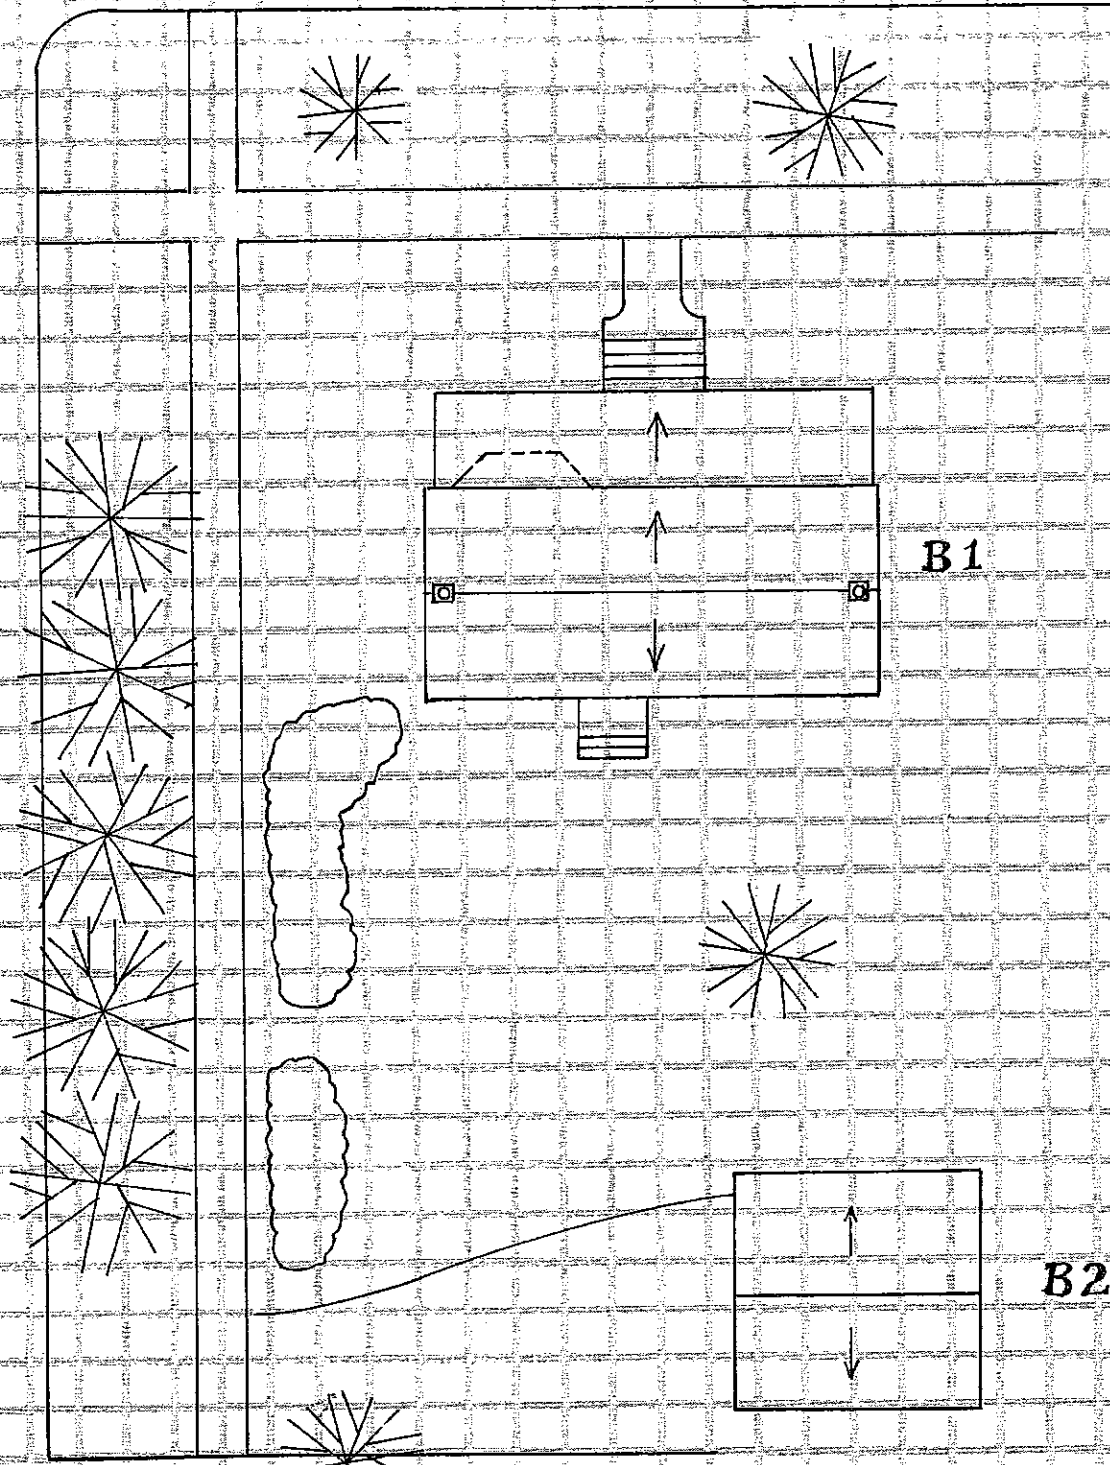
Site Plan: Indicate all door and window openings, roof shapes, and landscape features.

12TH ST.

FULTON ST.

ALLEY

B1

B2
