# ***TRAFFIC SIGNAL WARRANT STUDY***

**E. ST. PATRICK STREET & S. VALLEY DRIVE**

**February 17, 2010**

**ENGINEERING SERVICES/PUBLIC WORKS DEPARTMENT**

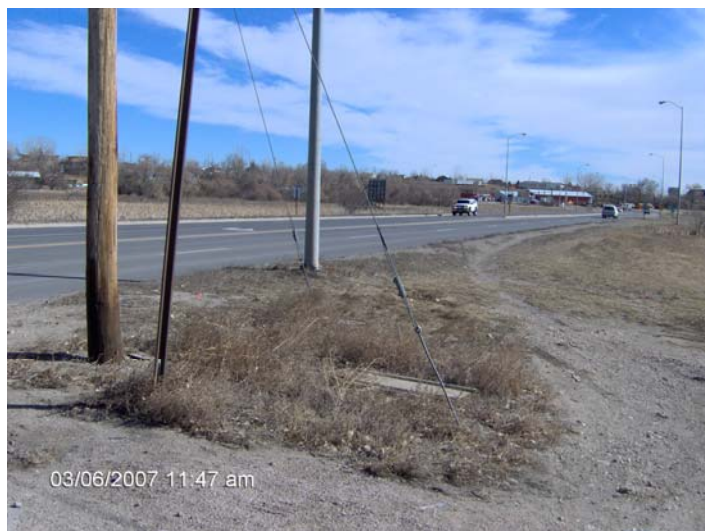
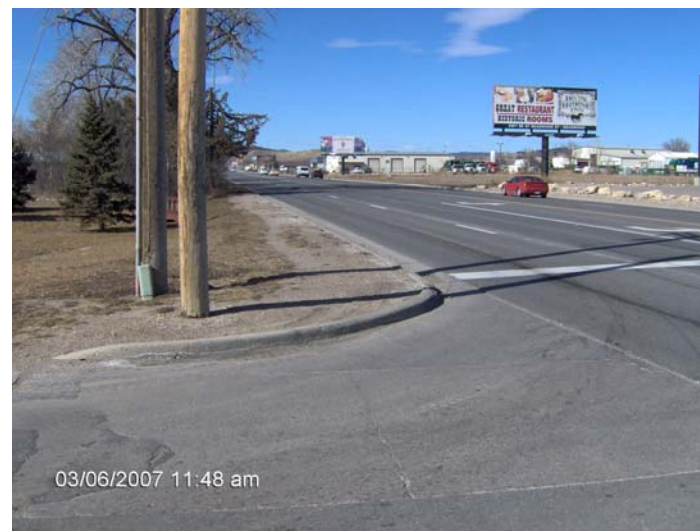
south leg of S. Valley Drive – looking east

south leg of S. Valley Drive – looking west

There is adequate intersection sight distance from the north approach of S. Valley Drive for left-turn, crossing, and right-turn maneuvers. There is existing brush and vegetation on the southwest corner that restricts sight distance from the south approach.

- 1) Brush and vegetation should be removed along E. St. Patrick Street on the southwest corner. The property owner has been contacted and has no objection to the removal.
- 2) In April 2010, crash data should be reviewed to determine what the effect on crash frequency is. If no adverse effect is seen then permanent STOP and STOP AHEAD signs should be installed on both approaches of S. Valley Drive. Rapid City staff should install the necessary signing and should coordinate that work with Pennington County Highway staff.
- 3) The remaining traffic signal poles should be removed by Rapid City staff and/or a City-hired contractor.

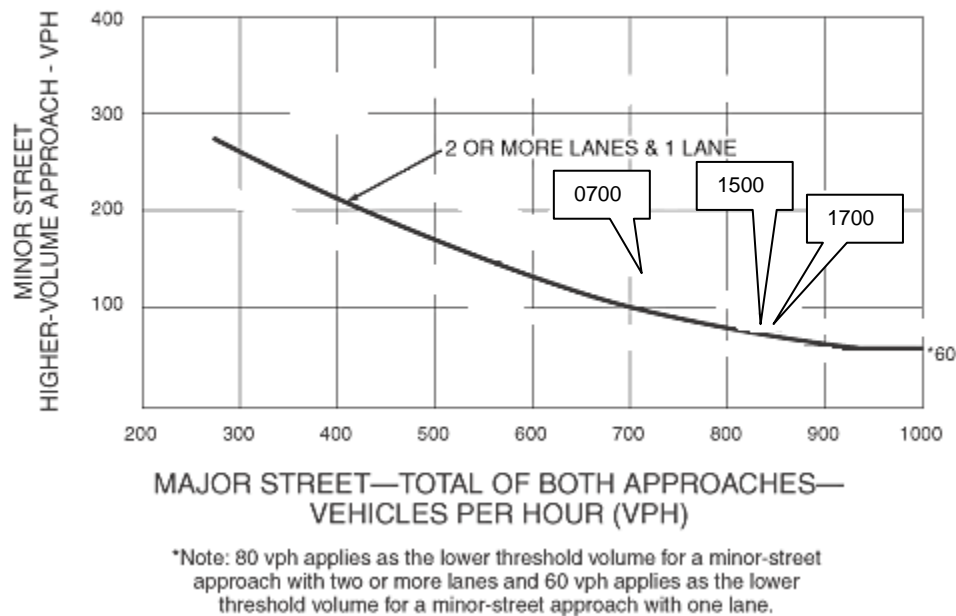
**Figure 4C-2. Warrant 2, Four-Hour Vehicular Volume (70% Factor)**  
 (COMMUNITY LESS THAN 10,000 POPULATION OR ABOVE 70 km/h OR ABOVE 40 mph ON MAJOR STREET)

The Four-Hour Vehicular Volume signal warrant is applied where the volume of intersecting traffic is the principal reason to consider installing a traffic signal. This warrant is satisfied when, for any four hours of the day, the plotted points representing the total vehicles per hour on both the approaches of major road and the corresponding vehicles per hour on the higher-volume approach of minor road (one direction only) fall above the appropriate curve of Figure 4C-2 of the 2009 MUTCD. Only three of the hourly volumes are above the appropriate curve, therefore, Warrant 2 is not satisfied.

Source: [Figure 4C-2, MUTCD, Federal Highway Administration, 2009]
