Final Report

Construction and Maintenance Assessment of Pervious Concrete Pavements

Stormwater Management Academy
University of Central Florida
Orlando, FL 32816

January, 2007

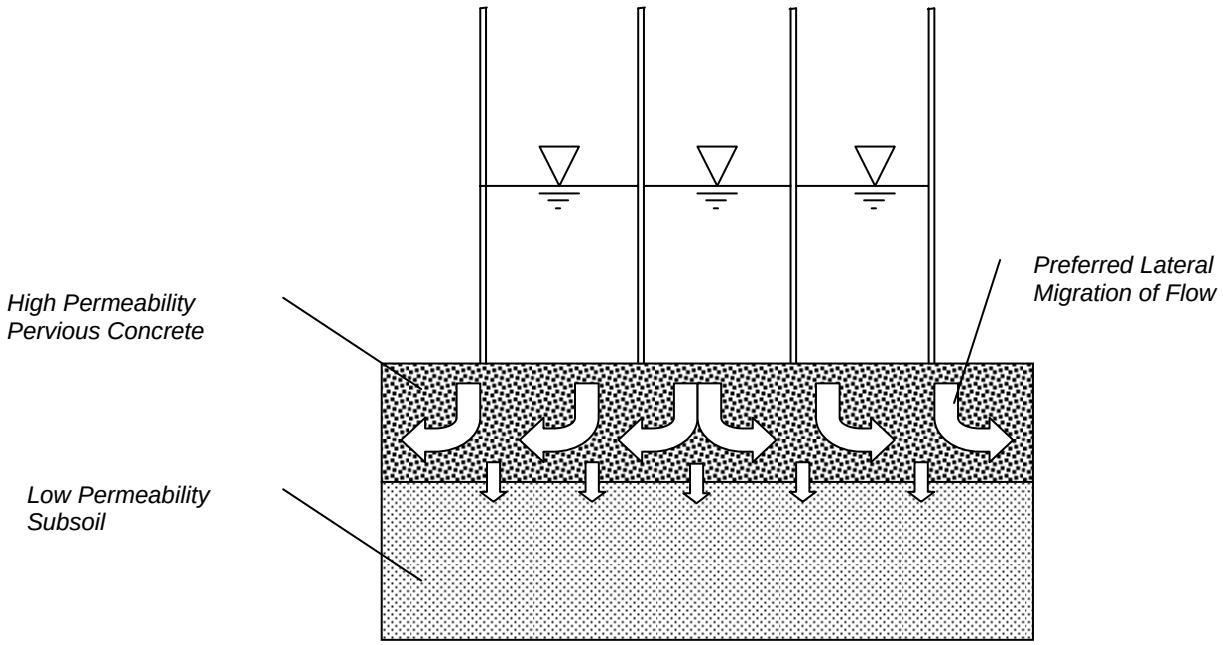
Figure 5: Double Ring Test on Pervious Concrete

Water is placed in both the inner and outer rings, but the measurement is made only of the water flow to the inner ring. The rate at which water must be added to maintain the water level at the height of the infiltrometer is measured. This rate defines the infiltration rate at the water depth of the test. The standard test method for the infiltration rate of soils in the field using double-ring infiltrometer, ASTM D3385-03(ASTM, 2003), states that this test method is difficult to use or the resultant data may be unreliable, or both, in very pervious soils. Since Portland cement pervious concrete is both very pervious and does not allow the double-ring infiltrometer to be inserted into the material, it allows preferential lateral flow as shown in Figure 5.

Infiltration tests performed on the surface of the concrete using the double-ring infiltrometer produced highly unrealistic results due to the lateral flow in the pervious concrete, which limited the ability of the water to infiltrate into the subsoil. It was determined a modified

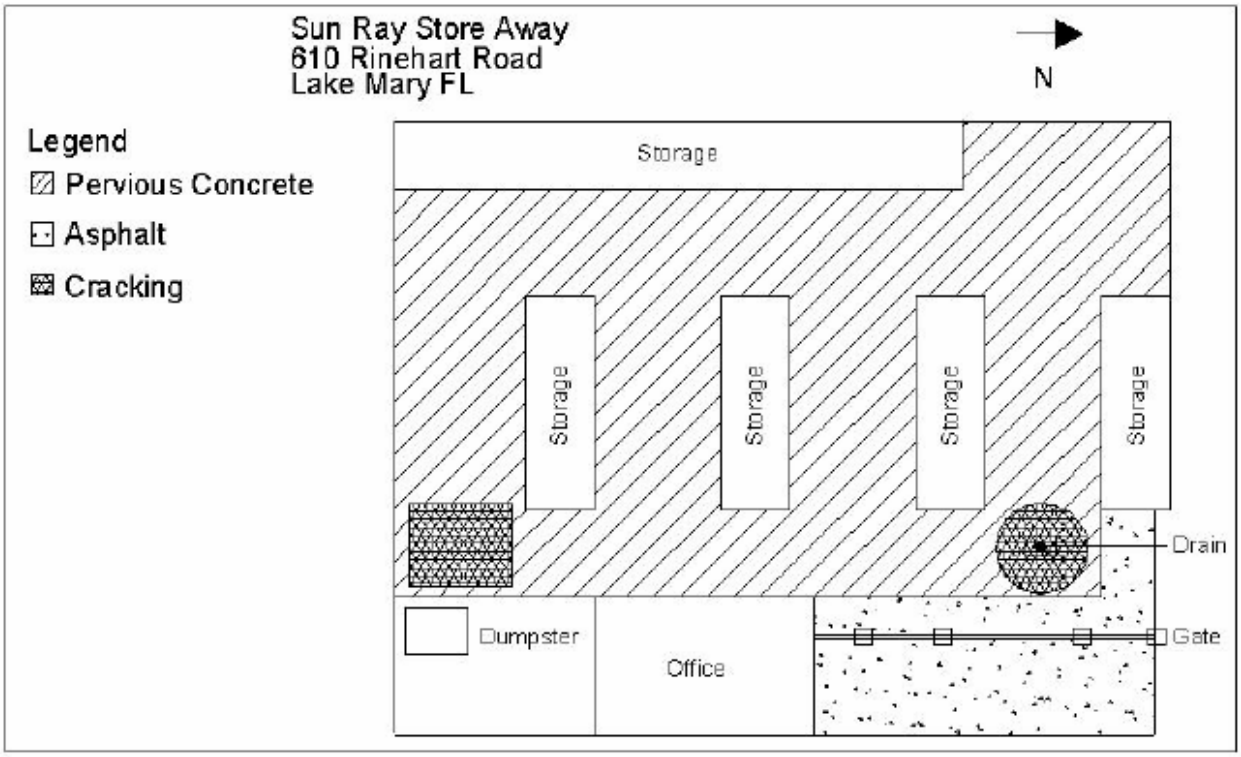
Figure 15: Sun Ray Store-Away Storage Parking Lot Schematic (Not to scale) (Mulligan, 2005)

the roadway system around the 823 storage units and in the 62 parking spaces available for large vehicle storage. Pervious concrete thickness across this site ranged from 5.1 to 6.9 inches. Damage to this pervious concrete system is limited to the area in the vicinity of the front gate and in the area of the garbage dumpster. The cracking encountered at the front gate can be attributed to the fact that all traffic entering into the facility passes over the area causing additional loading. The cracking encountered in the dumpster area can be attributed to the extreme impact-type loads caused by the garbage truck when emptying the dumpster. Figure 15 is an approximate schematic drawing for this site.

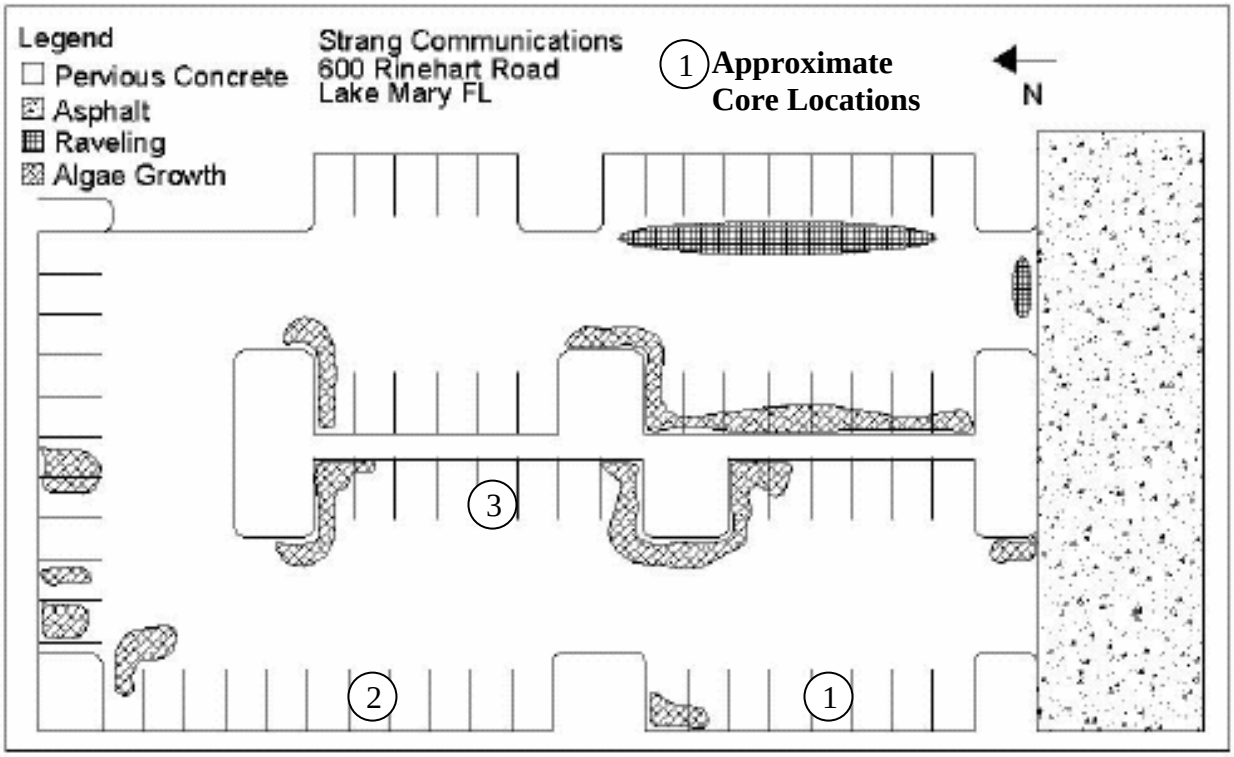
Figure 18: Strang Communication Office Parking Lot

This pervious parking lot exhibited minimal damage to the surface, although, significant raveling has taken place in one location on the site. Raveling is the deterioration of the concrete due to repeated loads over time on an area. The nine spaces located in the northwest area of the pervious concrete are raveling at the entrance to each stall. Also, a small amount of raveling at the entrance to the parking row on the west was also noted. Algae and leaf debris staining are also present over a majority of the pervious concrete parking lot. Figure 17 shows the location of the raveling and algae in this parking area. Depicted in Figure 18 is a picture of this site.

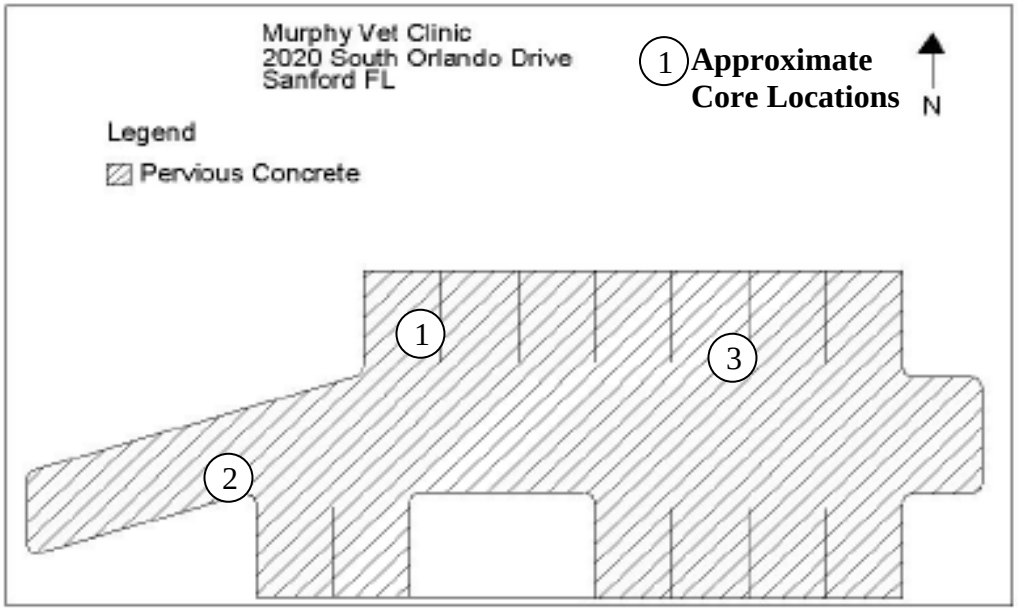
Figure 19: Murphy Veterinarian Clinic Parking Lot Schematic (Not to scale) (Mulligan, 2005)

Located in Sanford, Florida the Murphy Veterinarian Clinic is a 13 stall pervious concrete parking lot that was constructed in 1987. Located on the west end of the parking lot is a dumpster that is connected to the roadway by an asphalt drive to limit the heavy loads caused by garbage trucks. In addition a 15-foot strip of conventional concrete has been placed along the east edge of the pervious pavement that connects to the roadway to limit the impact of entering and exiting traffic. Pervious concrete thickness across this site ranged from 5.9 to 6.1 inches. The pervious concrete is in good condition with minimal structural damage to the surface of the pavement. Figure 19 depicts a general schematic layout of the site.

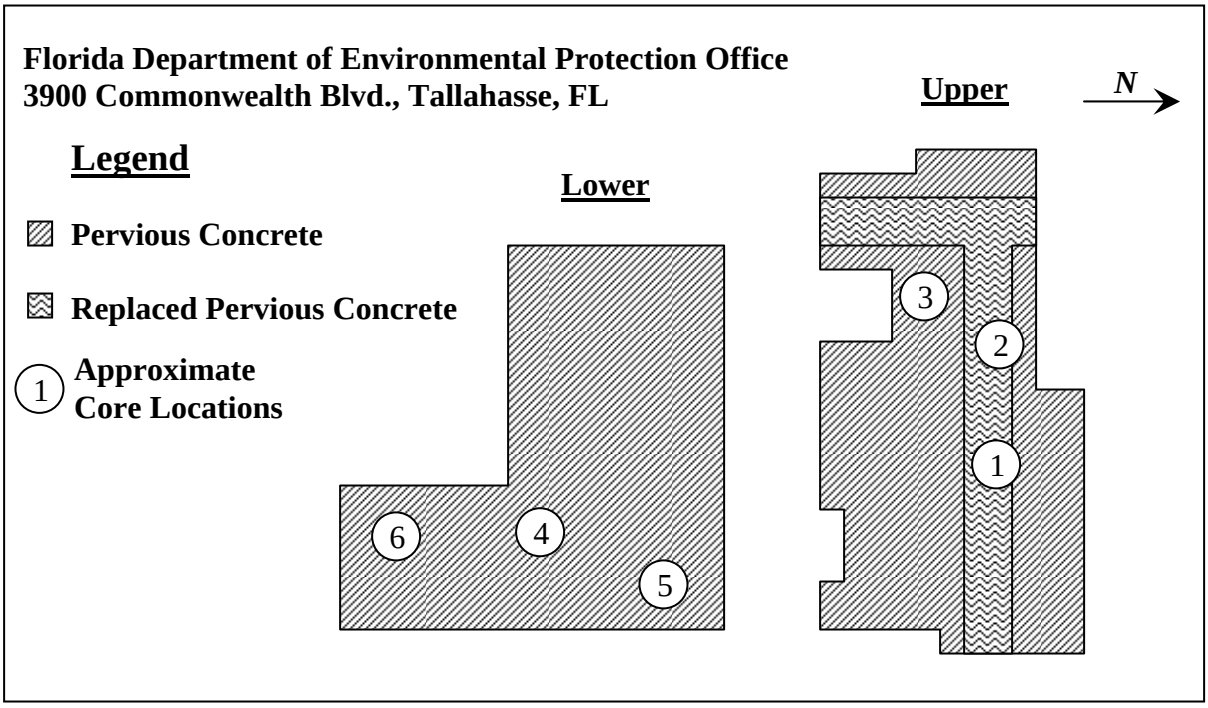
Figure 21: Florida Department of Environmental Protection Parking Lot Schematic (Not to Scale)

sealed concrete. Site infiltration tests were also done on these suspected concrete areas to further document the impervious nature of the concrete. These areas of concrete have no pores, possibly due to an excess of water used in the initial construction. This sealed state is primarily found in the area of pervious concrete that was replaced.

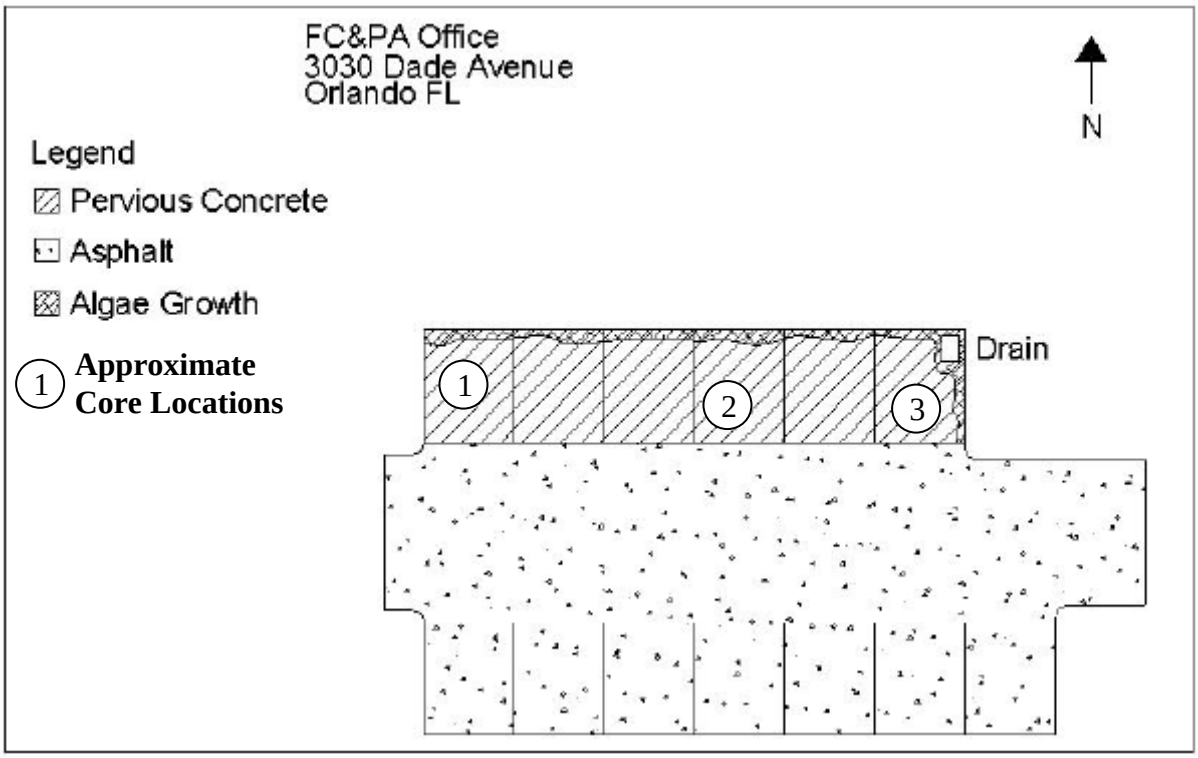
Figure 23: Florida Concrete & Products Association Parking Lot Schematic (Not to Scale) (Mulligan, 2005)

Located in Orlando, Florida, the Florida Concrete and Products Association Office, constructed in 1999, includes 13 parking stalls. The driveway and seven parking stalls located on the south side of the parking lot are constructed of asphalt, which drains onto the remaining six pervious concrete parking stalls. Pervious concrete thickness across this site ranged from 6.8 to 7.6 inches. The site is in good condition with minimal structural damage, including minor cracks throughout the area. However, a significant amount of algae was noted along the north edge of the parking spaces and also along the eastern edge. Figure 23 depicts a general schematic of the parking area.

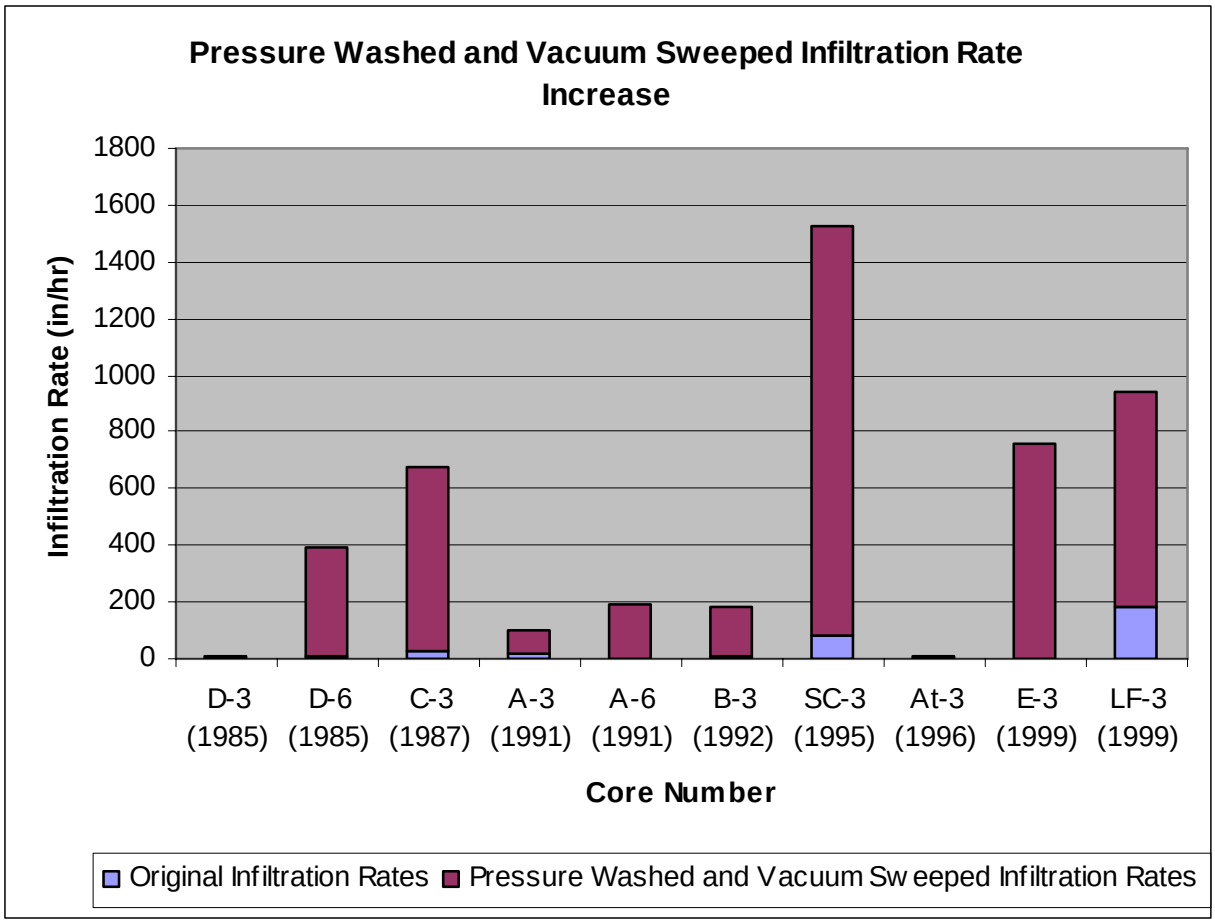
Figure 37: Comparison of Original and Pressure Washed and Vacuum Swept Infiltration Rates

When the pervious concrete was installed properly (infiltration was evident), the three methods of maintenance investigated in this study typically caused at least a 200% increase over the original infiltration rates of the pervious concrete cores. A comparison of the effectiveness of the three methods investigated in this study is shown in Figure 40 below. Based on these results it is concluded that pressure washing and vacuum sweeping typically resulted in an equivalent increase in infiltration rates and the use of both methods of maintenance resulted in the greatest

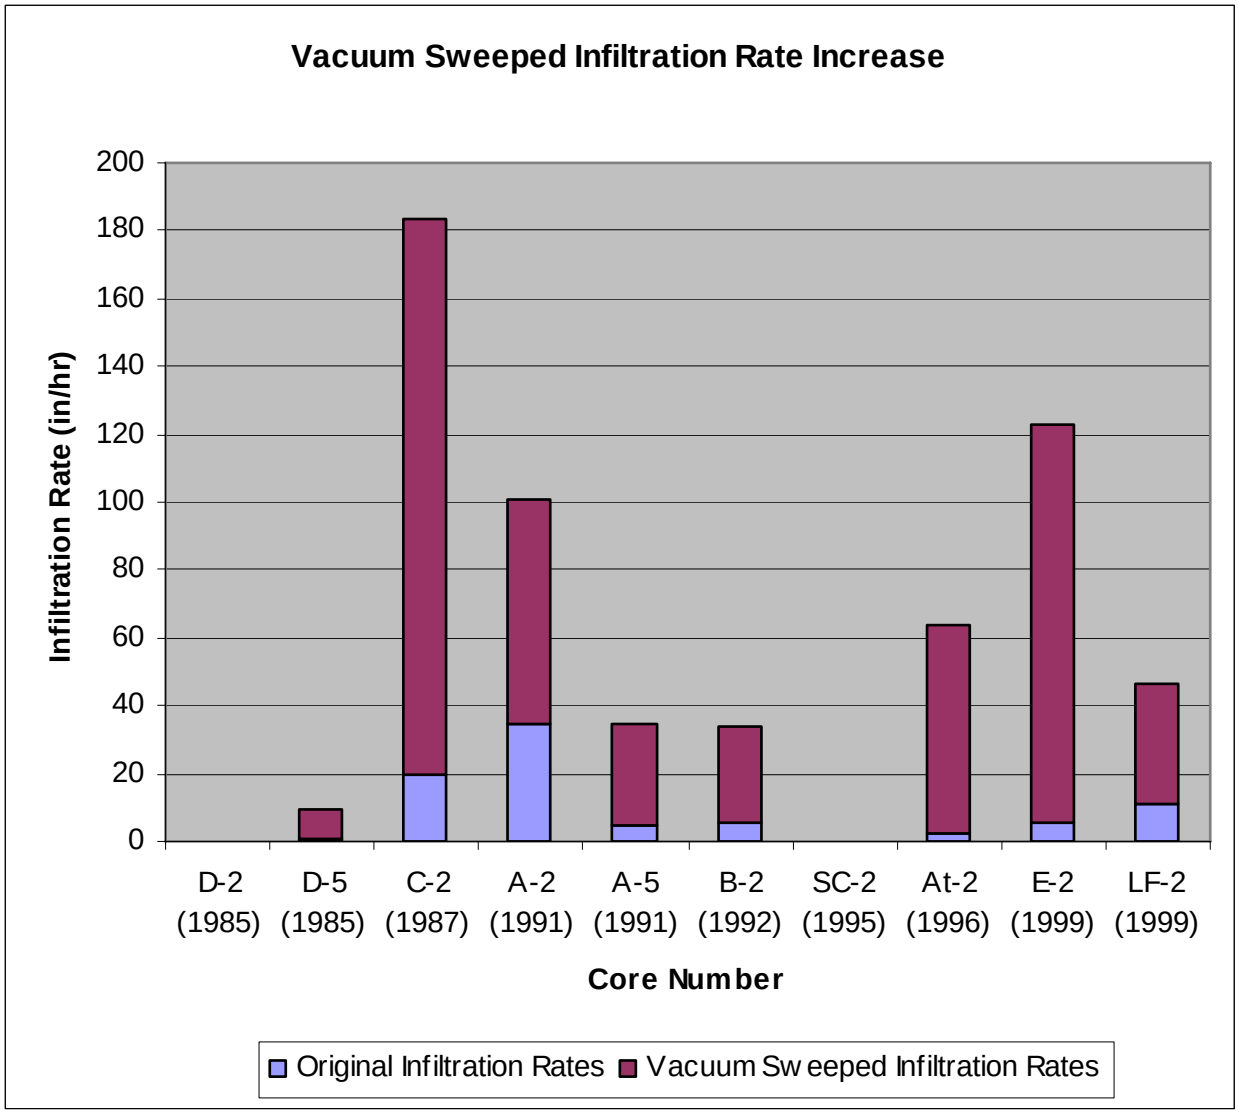
Figure 38: Comparison of original and Vacuum Swept Infiltration Rates

The pervious pavement at sites D2 and SC2 were not installed properly and exhibited the density and zero infiltration characteristics common to regular concrete.

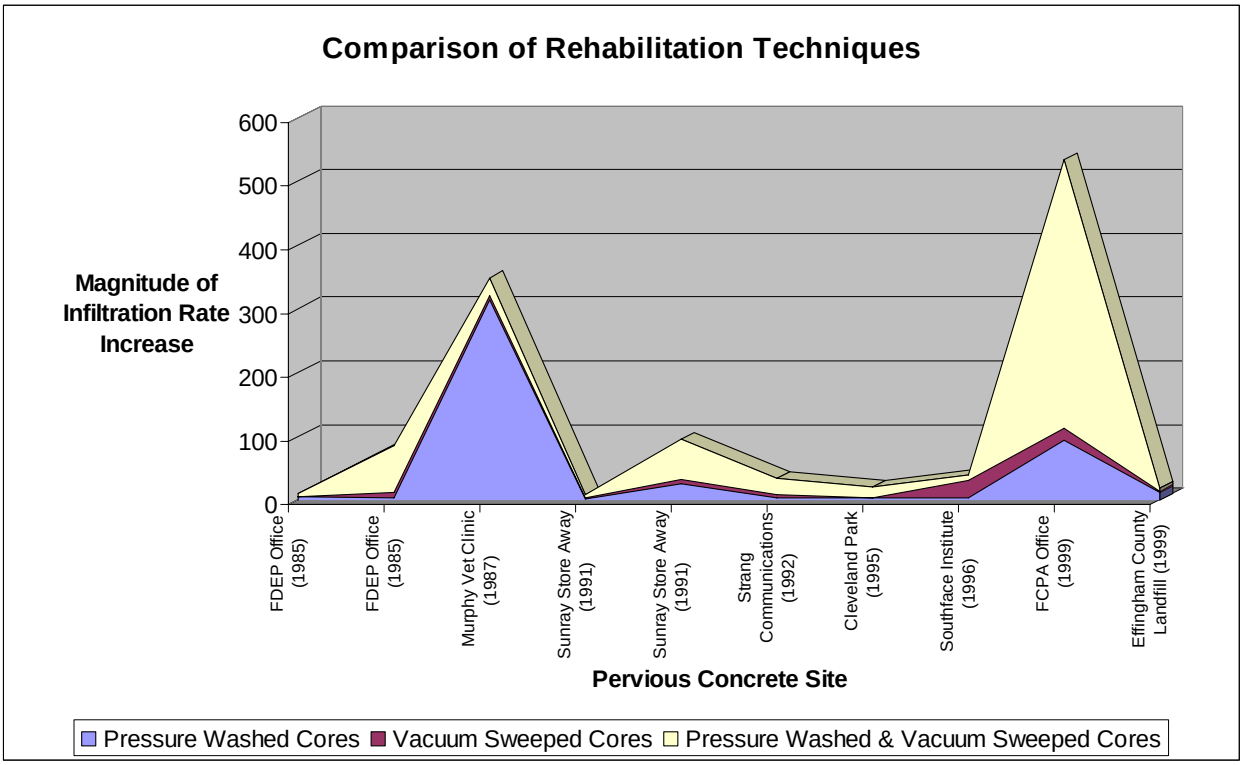
Figure 40: Comparison of Effectiveness of Rehabilitation Techniques

increase in infiltration rates. Pressure washing however did result in the release of sediment and in some cases the pervious aggregate. A site should be tested for release of particulates before pressure cleaning is done. The reason for the significant increase at the FPCA site could have been because the particles blocking the pores were released with added maintenance or the continued maintenance associated with both methods.
