Portland Cement Pervious Concrete Pavement:

Field Performance Investigation on Parking Lot and Roadway Pavements

Final Report

December 1, 2007

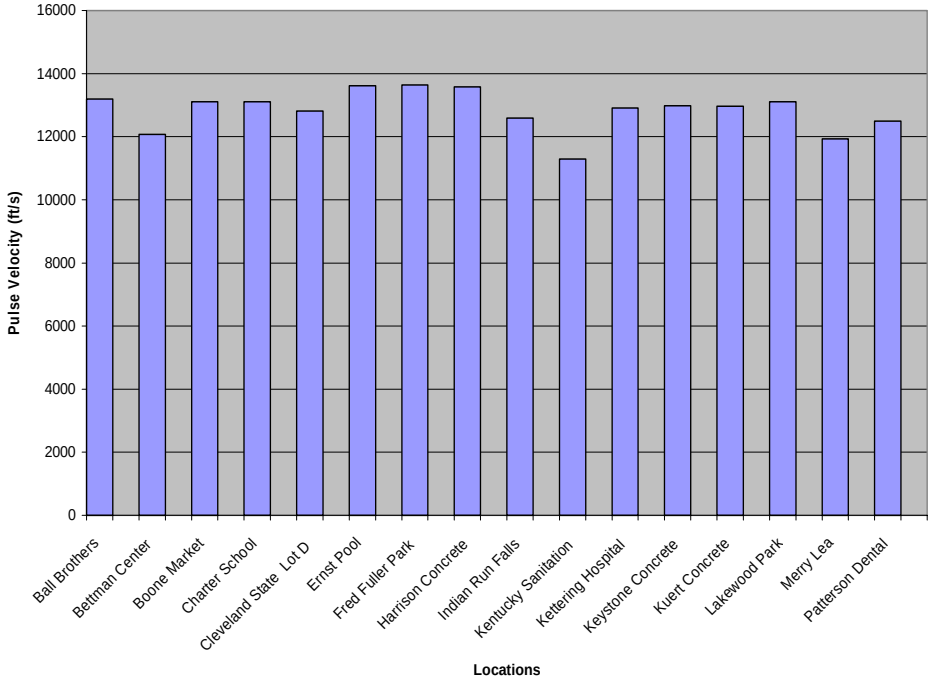
Figure 34: Average Ultrasonic Pulse Velocity in the field

LOCATION	UPV (ft/s)				Drain time (sec.)			
	Average	S.D.	Max	Min	Average	S.D.	Max	Min
Ball Brothers	13,200	1,400	15,800	8,012	70	23	117	23
Bettman Center	12,000	1,300	16,800	8,500	57	30	125	14
Boone Market	13,100	975	15,100	10,250	56	20	85	15
Charter School	13,100	450	14,100	11,600	44	27	149	10
Cleveland State Lot D	12,800	550	13,700	11,100	66	20	112	23
Ernst Pool	13,600	740	14,900	12,400	33	14	80	14
Fred Fuller Park	13,600	925	14,700	11,600	136	24	180	93
Harrison Concrete	13,600	1,850	15,800	9,500	21	10	52	8
Indian Run Falls	12,600	800	14,500	9,600	29	11	65	11
Kentucky Sanitation	11,300	1,600	13,600	8,300	45.5	12	69	19
Kettering Hospital	12,900	475	14,100	12,200	68	15	90	39
Keystone Concrete	13,000	560	13,700	11,800	103	12	125	85
Kuert Concrete	12,970	465	13,700	11,100	31	18	90	9
Lakewood Park	13,100	465	14,100	11,700	36	13	73	19
Merry Lea	11,900	380	13,100	11,300	77	21	141	44
Patterson Dental	12,500	850	14,100	11,300	42	13	67	21

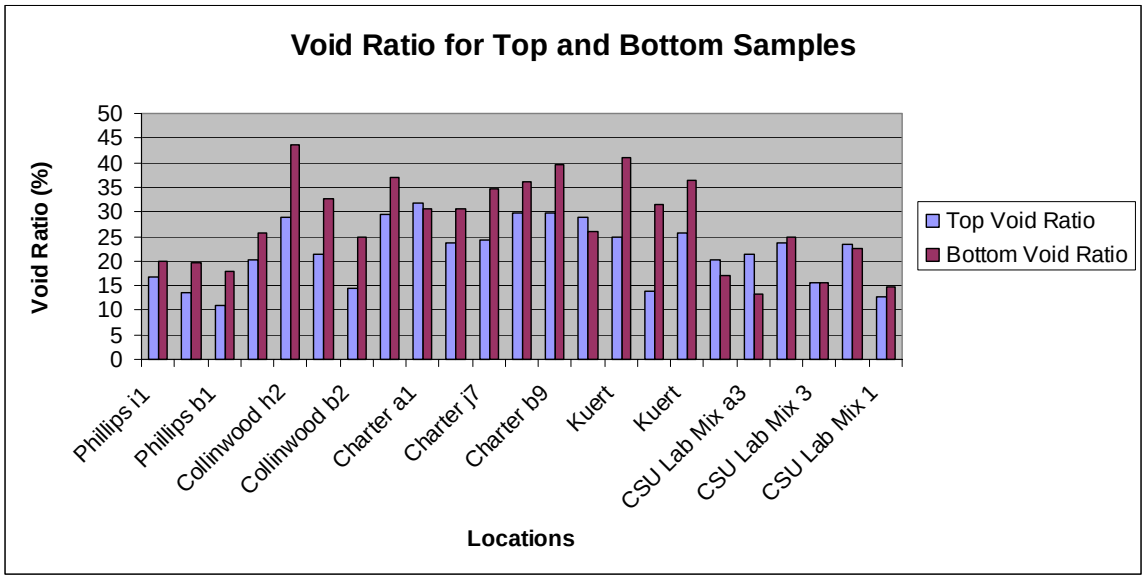
Figure 37: Void Ratios for Top and Bottom Samples

Haselbach and Freeman (2006) found that the void ratio at the top of a pervious concrete pavement was much lower than that at the bottom. The tests results reported in this section confirmed that finding.

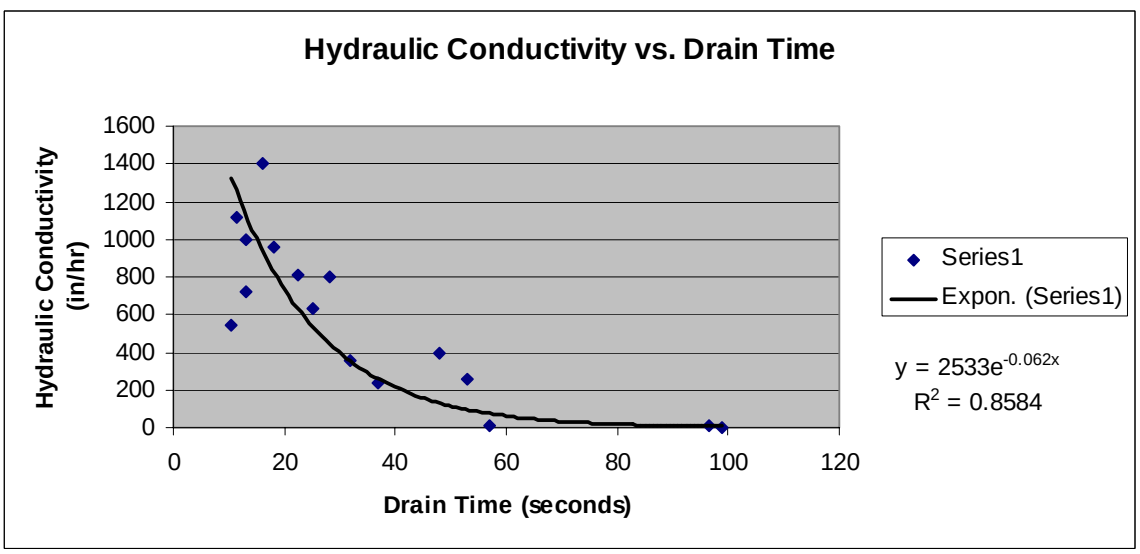
Figure 39: Comparison between Hydraulic Conductivity and Drain Time Values

The field infiltration/ drain time test developed as part of this research will be more useful if it can be correlated to hydraulic conductivity. Laboratory and field values are shown in Table 23. The bold numbers represent drain time values that were measured in close proximity to the coring locations. At six locations, the drain time was measured prior to coring. The hydraulic conductivity and drain time values are plotted in Figure 39.

The laboratory hydraulic conductivity k, in inches per hour, may be estimated from the field infiltration time t:

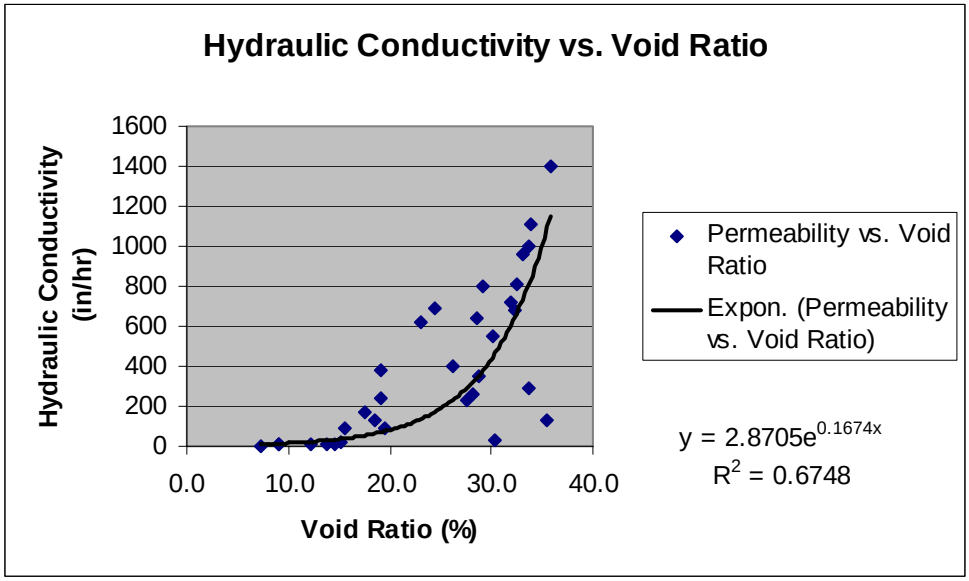
Figure 40: Relationship between Hydraulic conductivity and Void Ratio

As expected, hydraulic conductivity and void ratio are closely related, but there are some discrepancies. This is because the hydraulic conductivity depends on the interconnectivity of the voids, as well as the void ratio.

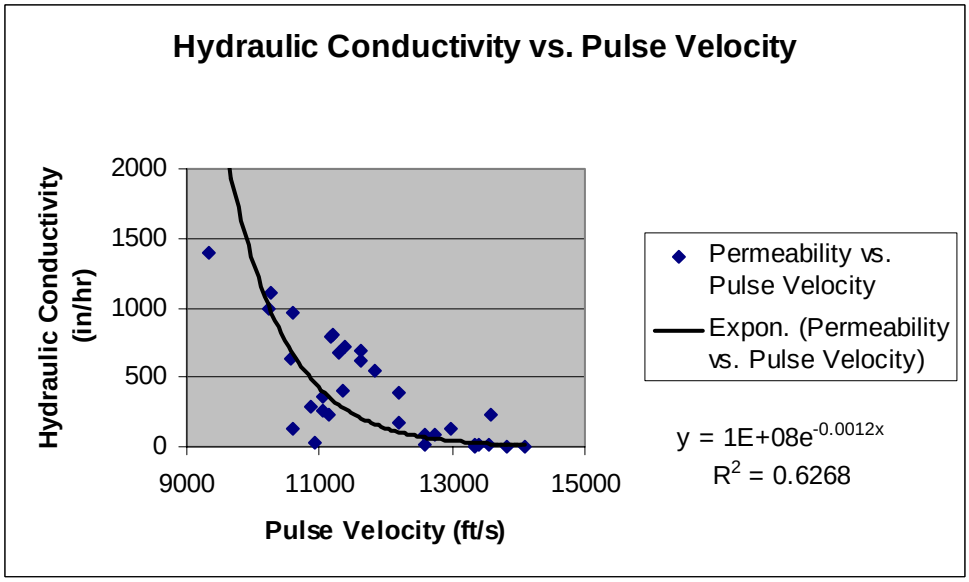
Figure 41: Relationship between Hydraulic conductivity and Pulse Velocity

The relationship between hydraulic conductivity and pulse velocity is the weakest of the six relationships developed. Pulse velocity is a more reliable indicator of strength and modulus of elasticity than of hydraulic conductivity. It can, however, provide a rough prediction.

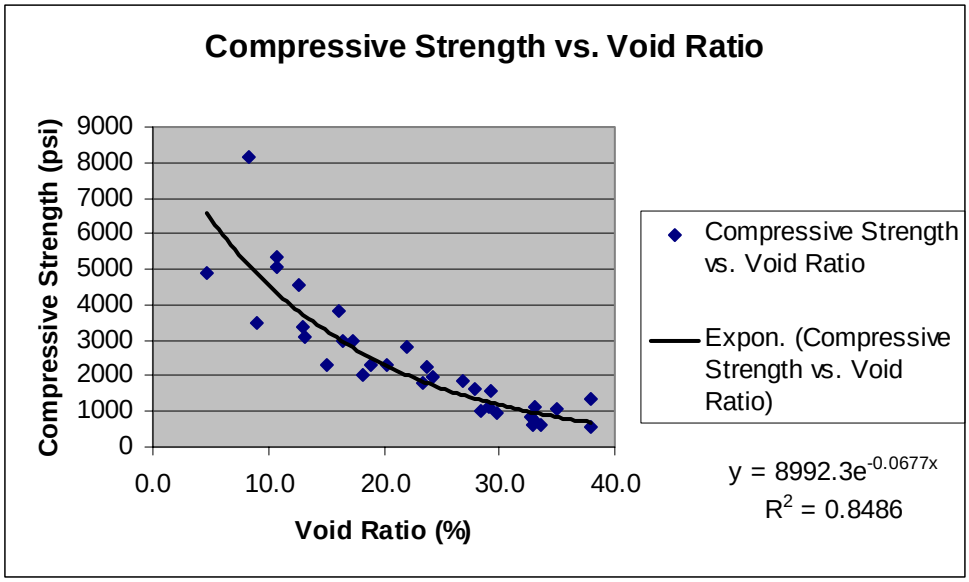
Figure 42: Relationship between Compressive Strength and Void Ratio

The relationship between compressive strength and void ratio has been documented by others, such as Schaefer et al. (2006), and is obviously strong.

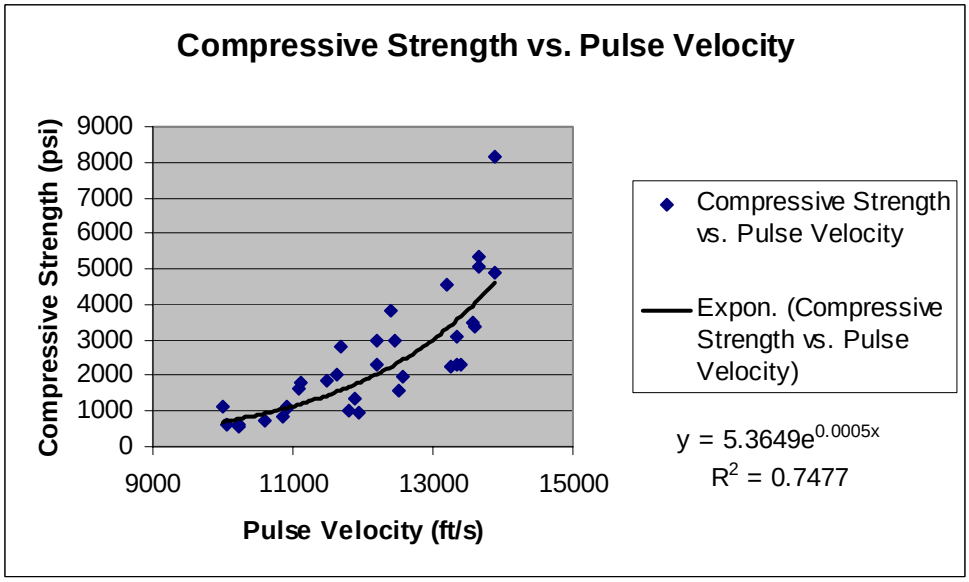
Figure 43: Relationship between Compressive Strength and Pulse Velocity

The relationship between pulse velocity and strength is also strong. The relationship would probably be improved without including one 8,000 psi outlier in the data. Therefore, UPV has potential for reliably predicting pervious concrete strength in the field.

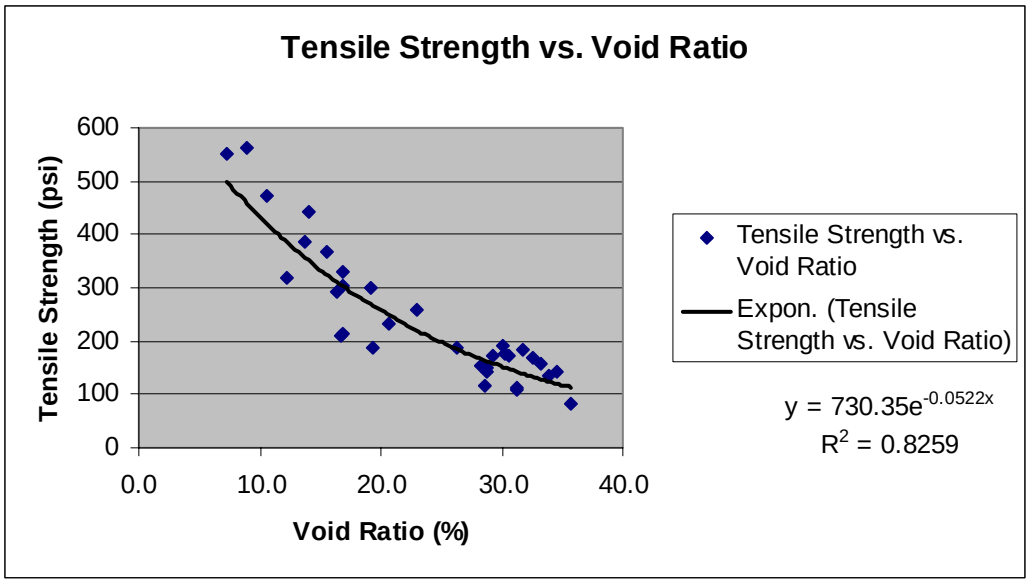
Figure 44: Relationship between Tensile Strength and Void Ratio

The relationship between void ratio and tensile strength is strong, as it is with compressive strength.

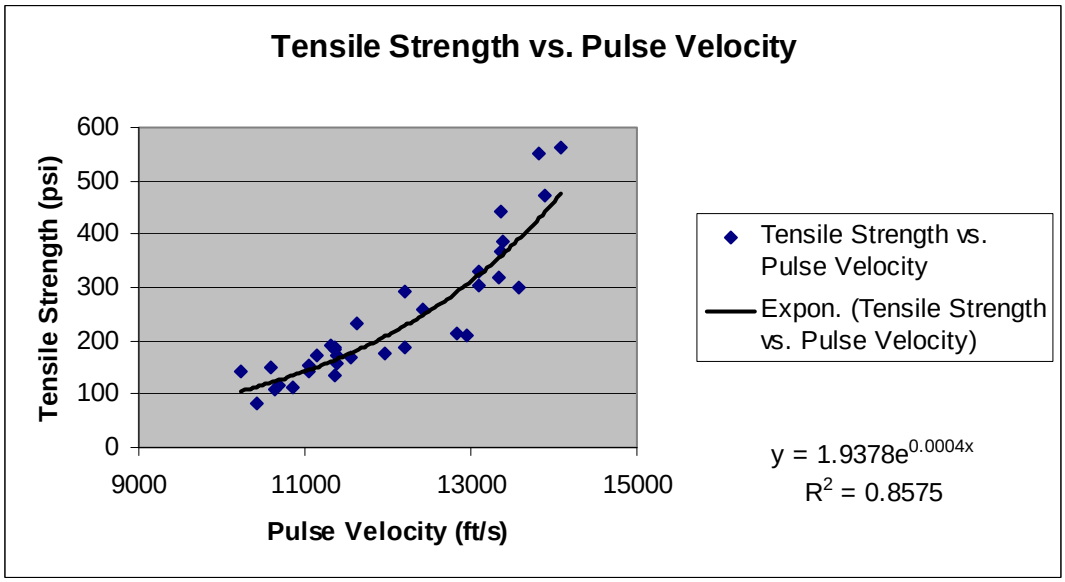
Figure 45: Relationship between Tensile Strength and Pulse Velocity

Results indicated that UPV can be a reliable predictor of tensile strength as well as compressive strength.

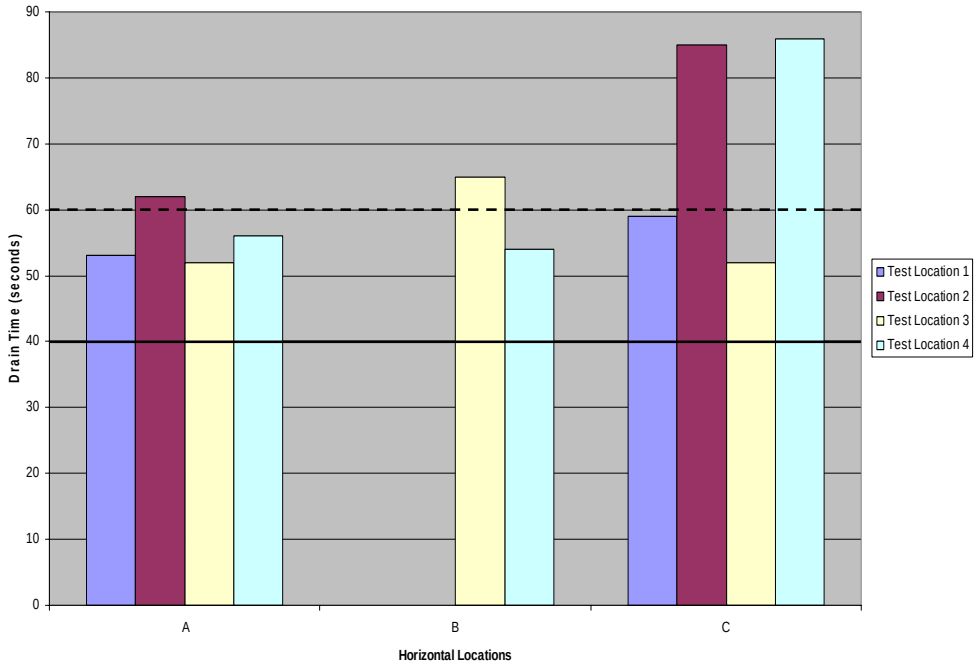
Figure 46: Drain time before Maintenance

The pervious concrete at the CSU Lot D has five parking stalls. The middle stall slightly slopes towards a manhole, and during rainfall water crosses surface of the pervious concrete and flows into the manhole. The research team attempted to restore the infiltration capacity of the middle stall with a 1,500 psi pressure washer. Before performing this maintenance trial, 10 drain time values were obtained in a grid formation. Drain time values before and after maintenance are shown in Figure 46 and Figure 47.

The middle stall was pressure washed for 30 minutes. The average drain time prior to the maintenance was 62 seconds. After maintenance, that average dropped to 40 seconds. The maintenance helped restore some of the infiltration capability, but sheet flow was visible even after the maintenance. Pressure washing of a severely clogged pervious concrete at the CSU Lot D improved the infiltration capability by about 35%.
