CANYON LAKE DAM STUDY/REPORT

PROJECT Canyon Lake Dam Maintenance Project

PROJECT NUMBER DR04 - 1433

DATE February 4th, 2008

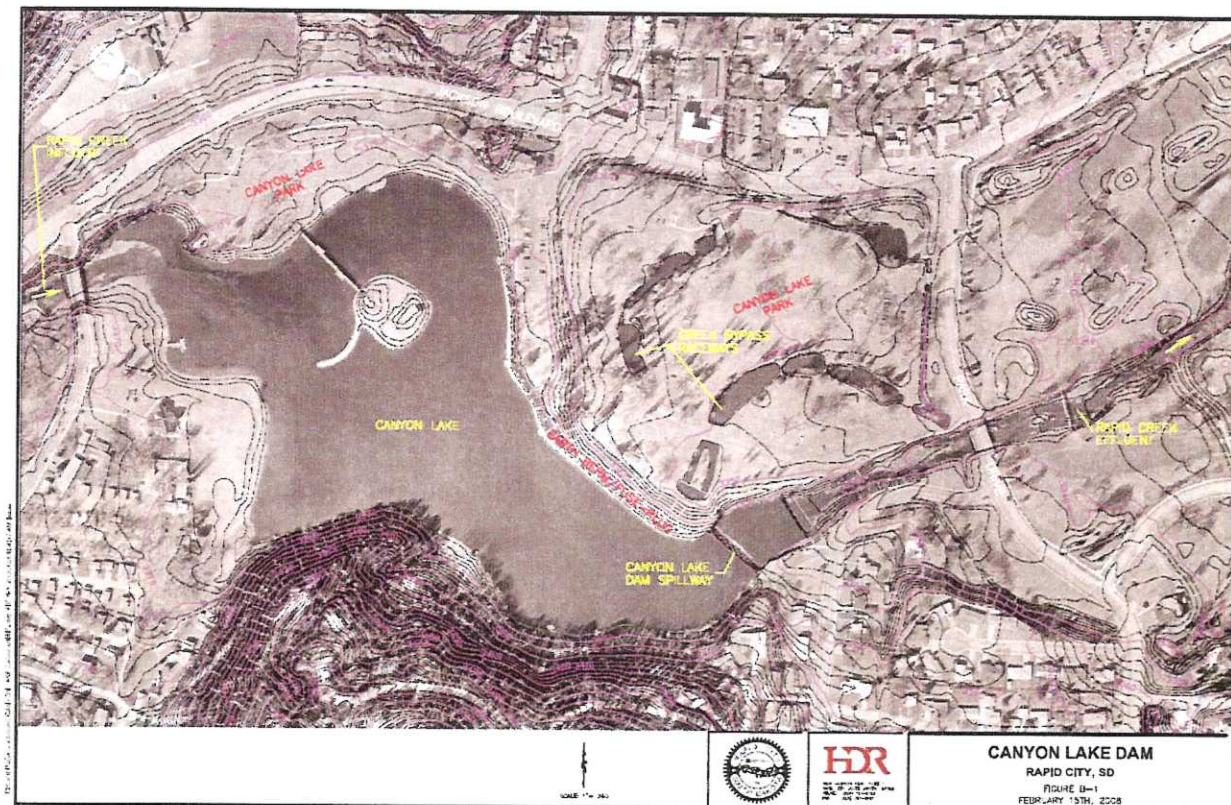
Figure B-1 – Canyon Lake Dam

The Canyon Lake Dam, as shown in Figure B -1 is on Rapid Creek located in Canyon Lake Park in the southwest corner of the City of Rapid City. The dam is classified as a Category I High Hazard Dam and has a normal storage capacity of 140 acre-feet with reservoir level at the spillway elevation and a maximum storage capacity of 610 acre-feet with the reservoir level at the top of dam elevation. An old dam structure was overtopped during the flood of 1972 and the existing dam was constructed in 1976. The current dam contains a 200' wide concrete faced ogee-crest spillway that is founded on bedrock at the right abutment and on a clay core material at the left abutment.
