October 31, 2013

**Project: City of Rapid City 2011 Storm Damage Recovery Project**

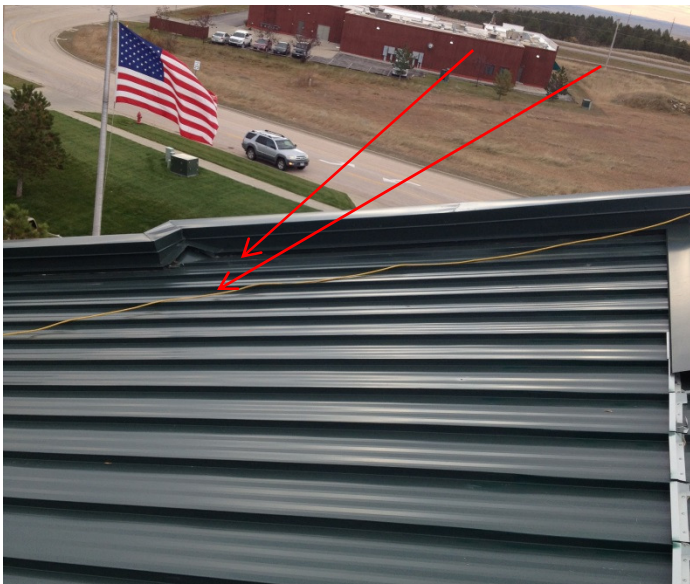
**Firehouse**

The two panels closest to the parapet wall will need to be removed so the new side wall flashing can be installed. This is due to the improper installation of the side wall flashing. This is the same for both sides of the roof.
