HISTORY AND CURRENT CONDITIONS
OF
BIG BEND POWER PLANT
Rapid City, SD

Building Condition

BIG BEND POWER PLANT

Cost Estimate for Stabilization & Window and Door Replacement

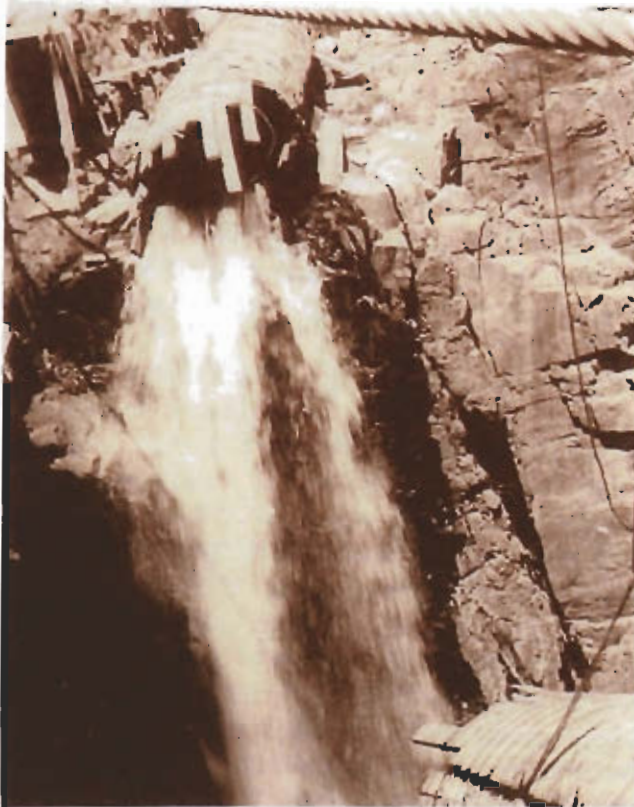
A common problem with the flume was leaks and damage because of weather or weak construction.

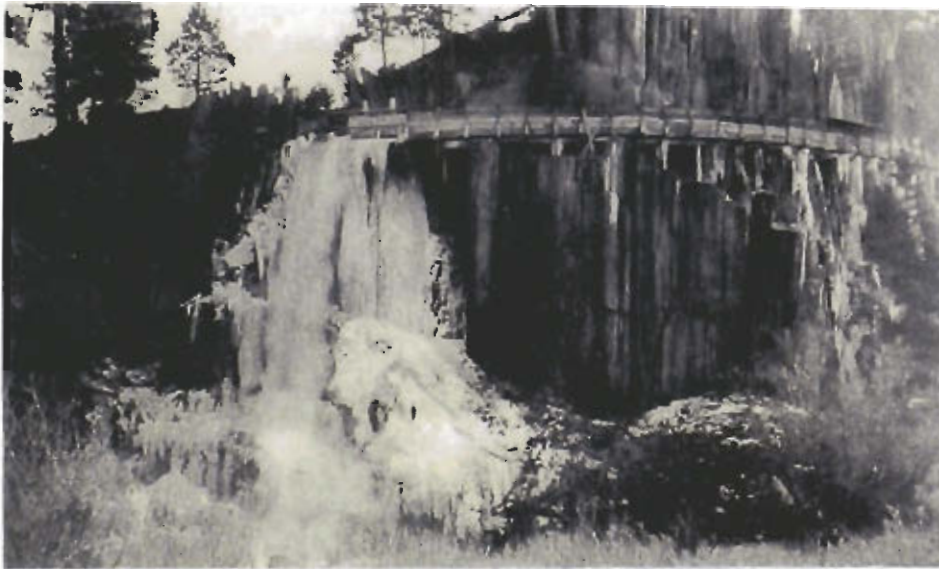
On very cold days the Big Bend Power Plant would shut down because of the frost build-up in the flume.

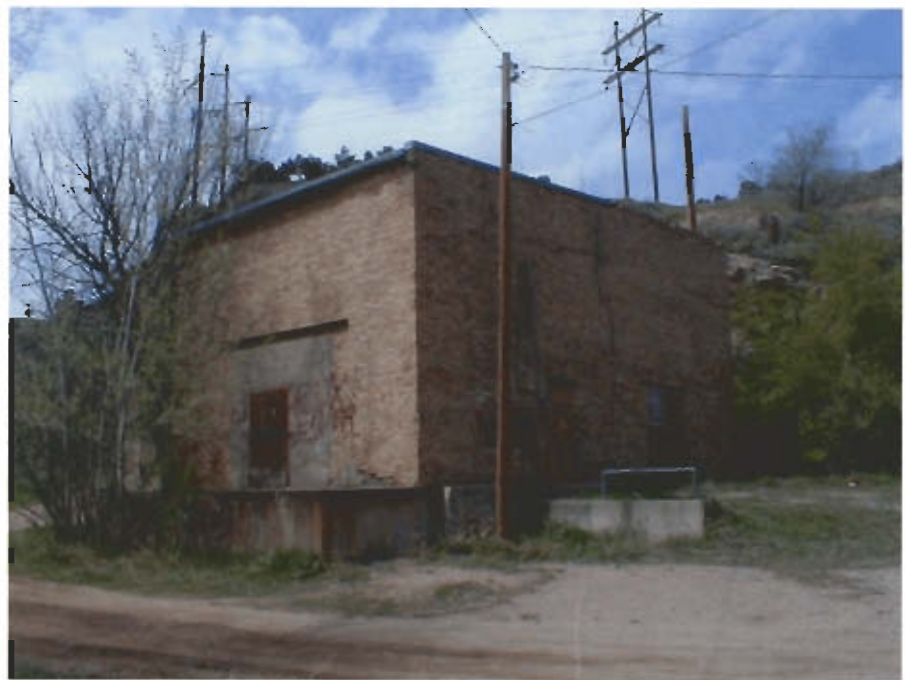
VIEW FROM SOUTHEAST

The south wall has some masonry deterioration at the bottom of the southeast corner, but is otherwise in generally good condition. The large opening has been in-filled with concrete block and a steel framed passage door.

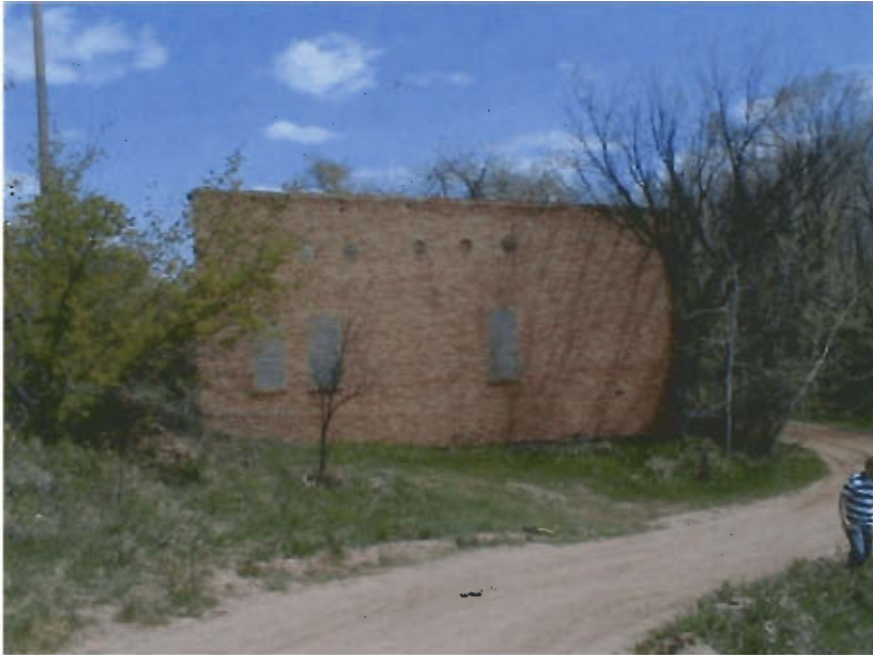
VIEW FROM WEST

The west wall is in generally good condition with two notable exceptions. The wall top has deteriorated as a result of the absence of metal cap flashing. At the southwest corner, a tree has grown to the point where it has begun to displace vertically the concrete foundation and the masonry. Previous openings have been in-filled with concrete block and/or brick.

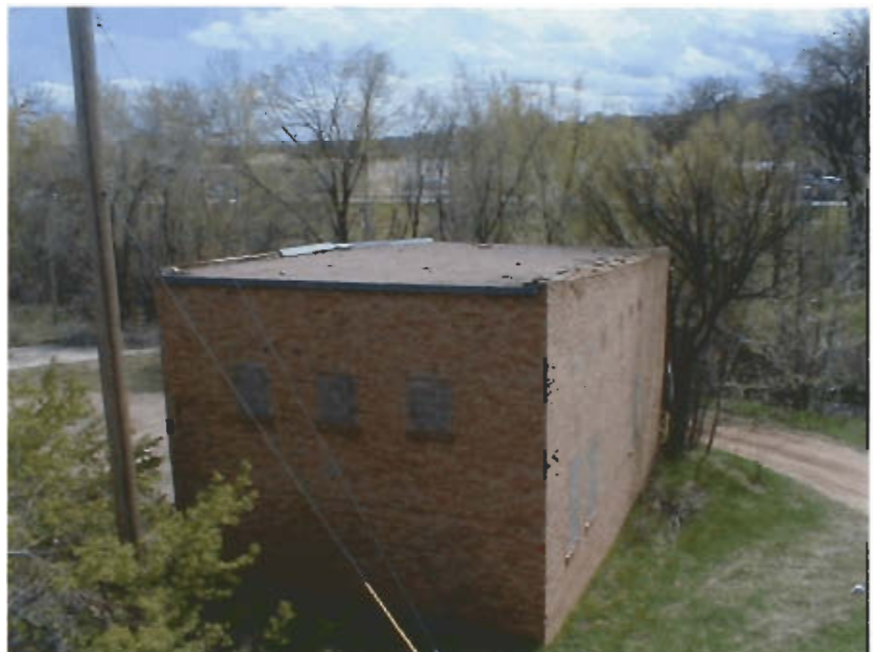
VIEW FROM NORTHEAST

The north wall is in generally good condition. Some repair has been done to the lower north east corner. The three original window openings have been in-filled with concrete block.
