SOUTH DAKOTA HISTORIC INVENTORY

Historic Name Haines Block

Location 507-15 6th Street

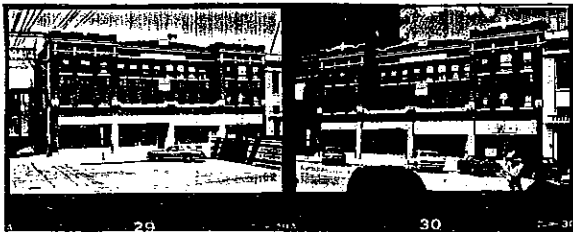
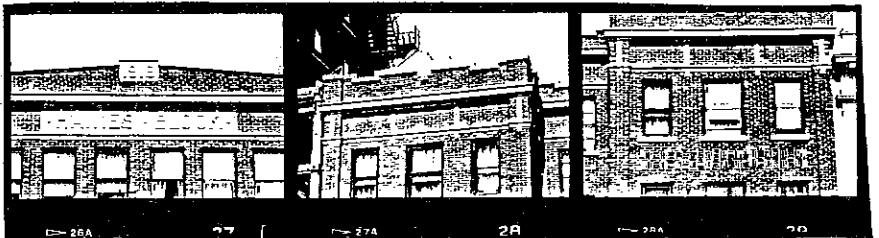
Roll # 136 Frame # 29-30; 27-29

The Haines Block is a three-story brick and stone building. The first floor is divided into four storefronts that have been altered. The second floor features an eight bay wide central setback with double hung windows overlooking a balcony. Flanking the central section are three bay wings with windows in both the second and third stories. Panels of soldier brick separate the second and third floors. A stone name plate with "HAINES BLOCK" is centered below the stone cornice. The crenelated parapet has a stone coping and 1918 datestone centered in the facade.
