Preliminary Site Plan

Aspen Medical Center South Parking

Rapid City, South Dakota

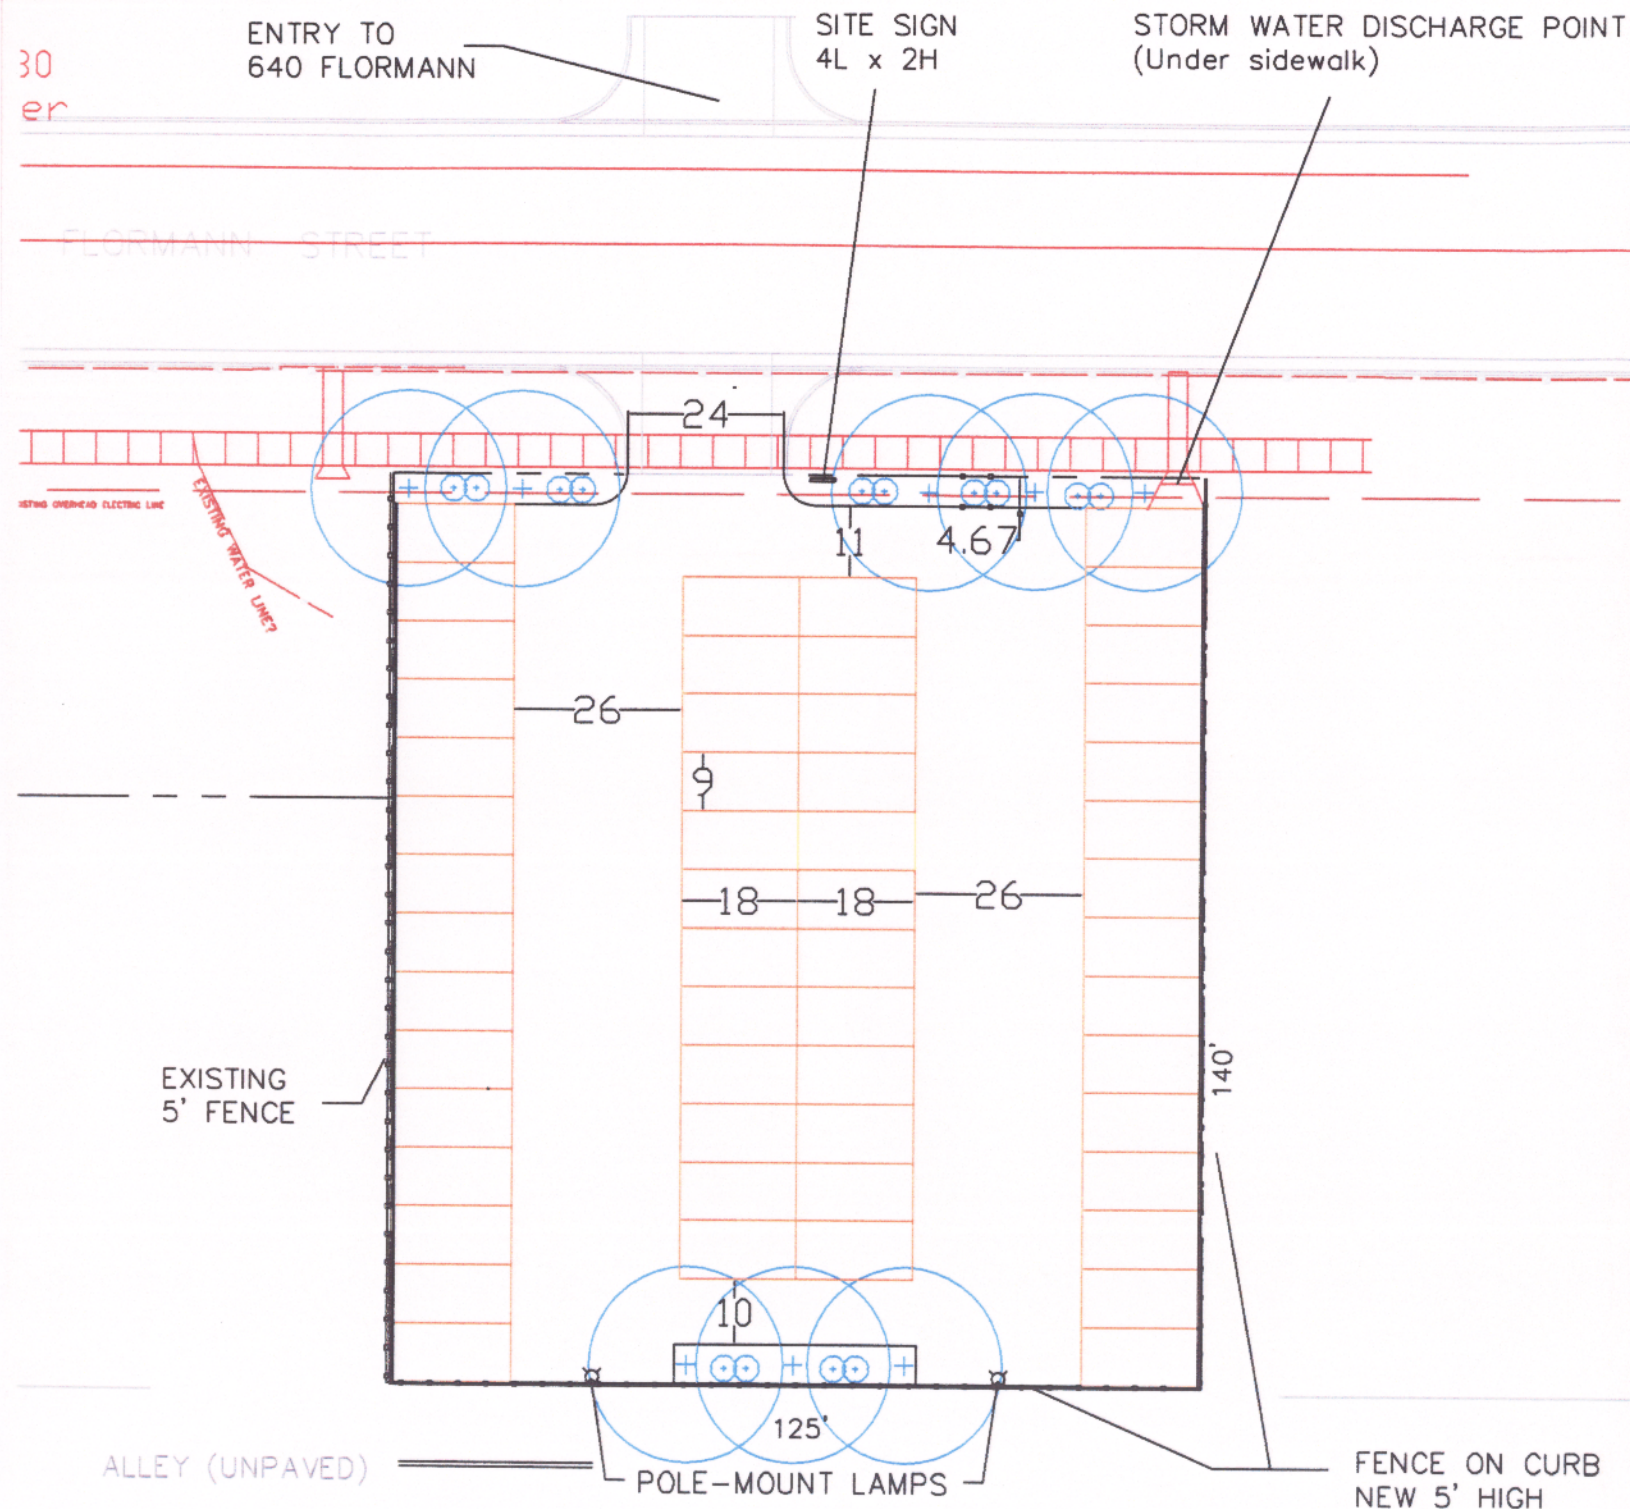
Parking spaces: 54.

This concept is based on parking stall size of $9'-0" \times 18'-0"$ with $26'-0"$ aisle width.

Driveway/Access: Single driveway, $24'-0"$ wide. The location of the driveway is dictated by City requirements that it be opposite the driveway on the North side of Flormann.

Entry and sidewalk: reinforced PCC paving (per code).

Parking area and curbing: asphalt paving $4"$ mat over $4"$ base-course, 4-5% slope draining to northeast corner (to concrete drainage chute under sidewalk and curb cut to gutter. Curbing only on alley and east edge to control drainage off-site.

Stall markings will be painted. Handicapped spaces are provided in existing parking.

Fencing: existing wood panel screening fencing, $5'-0"$ high ($4'-0"$ high for front 25 linear feet), along property line to west. Similar fencing will be installed along alley (125 linear feet) and east property line (140 linear feet). No retaining walls proposed.

Outdoor Lighting: two pole mounted lamps as shown, screened to reduce light in alley and to south.

Signage: 4 ft wide by 2 ft high, ground-mounted, as shown, four feet from driveway. Wood and metal construction.
