# Boundary Survey

Lot 11 and Tract A-1, Block 8  
of Signal Heights Addition  
Rapid City, South Dakota

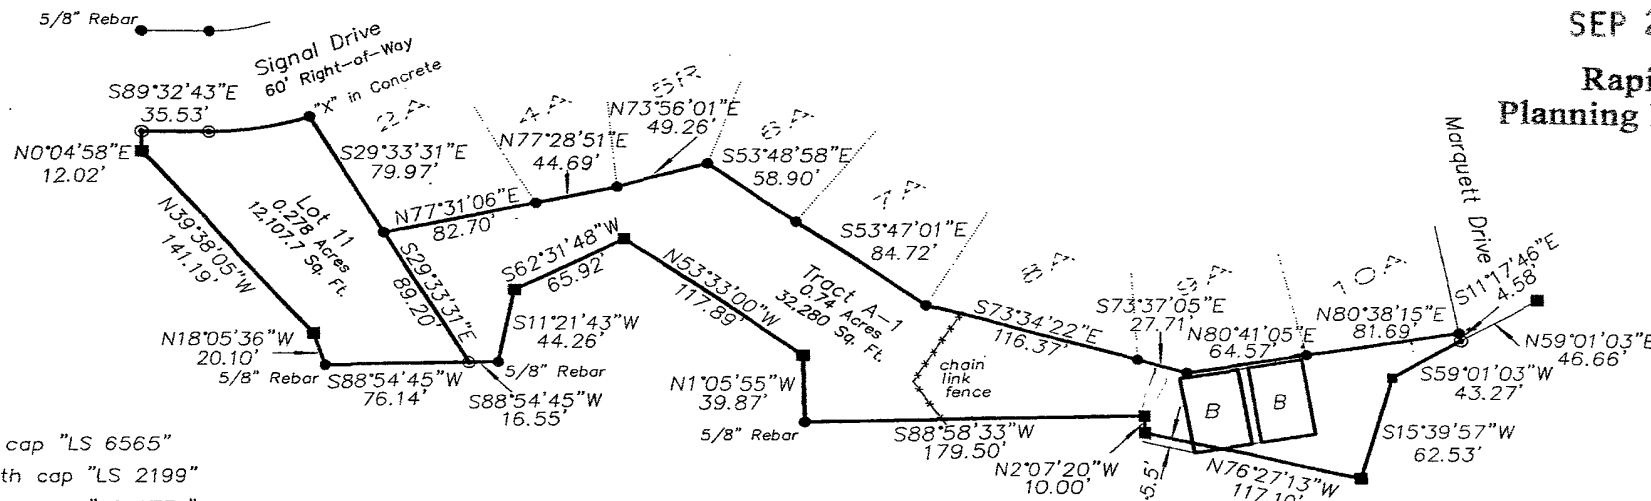
T R A C T A - 1 R E V I S E D

NOTE: A portion of the westerly structure on Tract A-1 is located on adjoining lands as shown.

NOTE: There are fences of various materials along the northern boundary of Tract A-1. These fences are not coincident with the actual boundary. No encroachments were found. A chain link fence crosses Tract A-1 and is shown hereon. No portions of the chain link fence are coincident with the property boundary.

The buildings shown hereon are approximately 45' x 30'. The eastern building setback is 2.0' from the north line of Tract A-1.
